UNITED STATES AIR FORCE
AIRCRAFT ACCIDENT INVESTIGATION
BOARD REPORT

MC-12W, T/N 09-0676

361ST EXPEDITIONARY RECONNAISSANCE SQUADRON
451ST AIR EXPEDITIONARY WING
KANDAHAR AIRFIELD (KAF), AFGHANISTAN

DATE OF ACCIDENT: 27 APRIL 2013

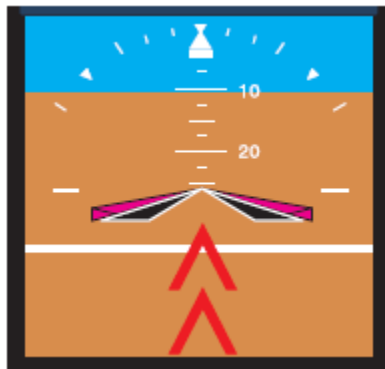
Figure 2. Declutter Display (Tab BB-30)

When an MC-12W's pitch angle exceeds 30 degrees nose-up or 20 degrees nose-down, or bank angle is greater than 65 degrees, the "declutter" function automatically removes non-critical information from the PFD. Additionally, warning chevrons appear, cueing the pilot to pull towards the depicted artificial horizon (see Figure 2). This mode automatically removes all data from the PFD with the exception of red chevrons that indicate which direction to maneuver the aircraft for safe recovery if the necessary data is being received by the AHRS to generate chevrons. The PFD reverts to the normal display when pitch angle is returned to less than or

equal to 25 degrees nose-up, 15 degrees nose-down, and 60 degrees bank angle (Tab BB-30 to BB-31).

In both “Declutter” and “NCD” display modes, the chevrons cue the pilot to raise the nose of the aircraft towards the horizon. Though this is useful in most unusual attitude conditions, it is opposite the direction of initial input required to recover from both spins and spirals (Tab DD-56).

The Pilot Flight Display in the MC-12W has “Declutter” and “No Computed Data” modes. During unusual aircraft attitude scenarios, these modes automatically replace the normal instrument display with a simplified recovery mode, which displays only essential data (“Declutter” and “No Computed Data” modes are discussed in detail in section 13 of this report). Pilots may be unfamiliar with the “Declutter” or “No Computed Data” modes since neither IQT nor MQT emphasize them, nor can they be safely replicated in the aircraft (Tabs V-2.6, V-13.7, and V-18.12). Unfamiliarity with the “Declutter” or “No Computed Data” modes could lead to confusion and delayed or improper stall/spin recovery (Tabs V-8.5 and V-9.4).
