**UNITED STATES AIR FORCE**  
**GROUND ACCIDENT INVESTIGATION**  
**BOARD REPORT**

**TYPE OF ACCIDENT: High Angle Belay Training Fatality**

**LOCATION: Kathmandu, Nepal**

**DATE OF ACCIDENT: 21 October 2014**

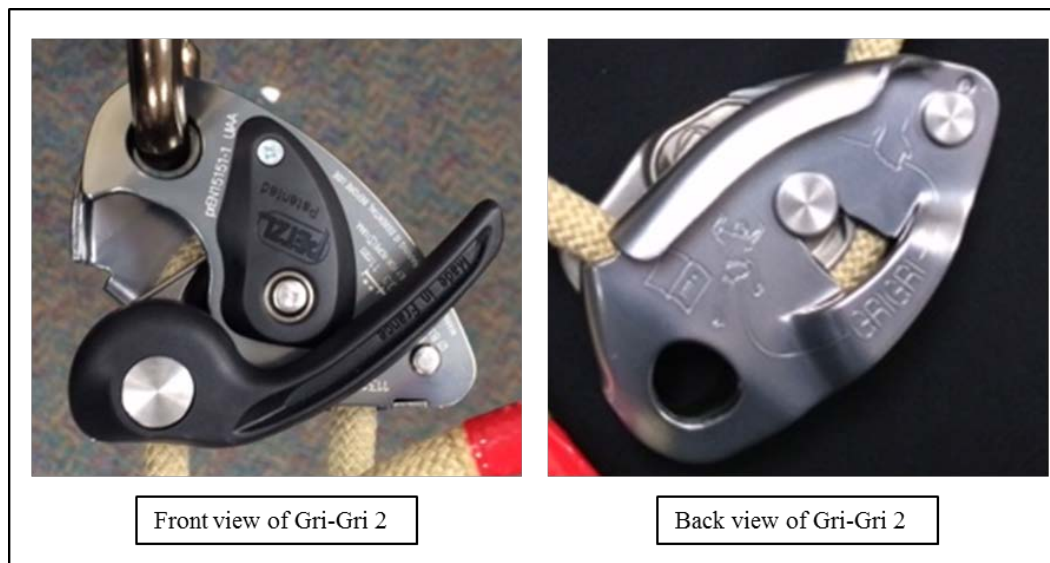
Figure 1: Front and back view of mishap Gri-Gri 2 (Tab CC-8 thru CC-9)

Upon inspection, the Gri-Gri 2 had minor surface scraps and dirt, but minimal wear (Tabs S-16 thru S-18, CC-4 thru CC-5). There was no deformation, crack, or traces of wear or corrosion (Tabs S-16 thru S-18, CC-4 thru CC-5). The diagram instructions were clearly visible on the outside and inside of the Gri-Gri 2 (Tab CC-9).

The Gri-Gri 2 appeared to be in good working condition, and there is no evidence to indicate it failed to function properly on the day of the mishap (Tabs CC-4 thru CC-5, CC-7 thru CC-11).

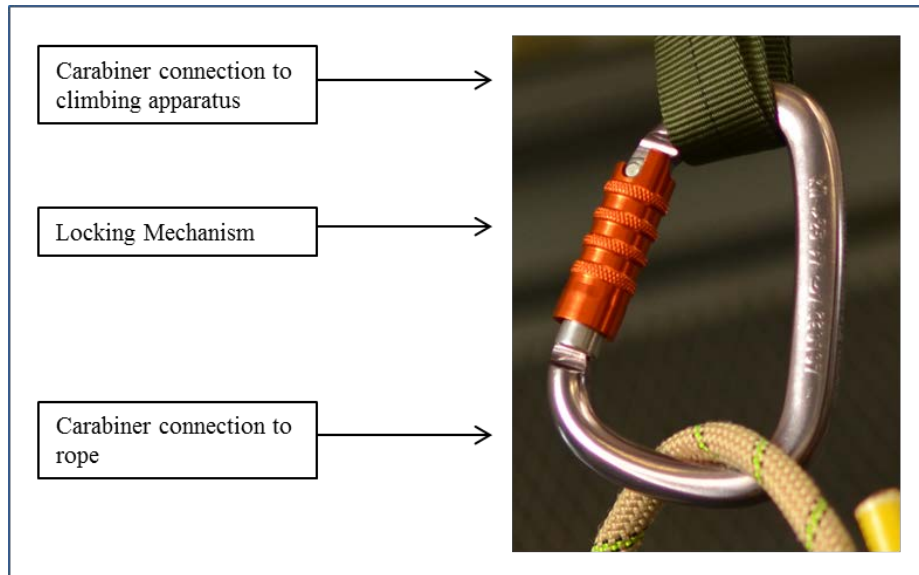
Figure 4: Mishap carabiner (Tab Y-13)

It is unclear which carabiner MPJ used to secure himself to the high angle belay system as three Petzl attache carabineers and three Black Diamond magna-lock carabineers were secured on MPJ's harness following the mishap (Tabs CC-12). PJA evaluated the carabineers for the open and closed gate-strength, excessive wear, deformation, nicks or deep scratches, and corrosion in accordance with published Black Diamond and Petzl inspection guidance (Tabs CC-5 thru CC-6, CC-23, CC-25 thru CC-28). The carabineers appeared to be in good working condition, and there is no evidence to indicate they failed to function properly on the day of the mishap (Tab CC-5 thru CC-6).

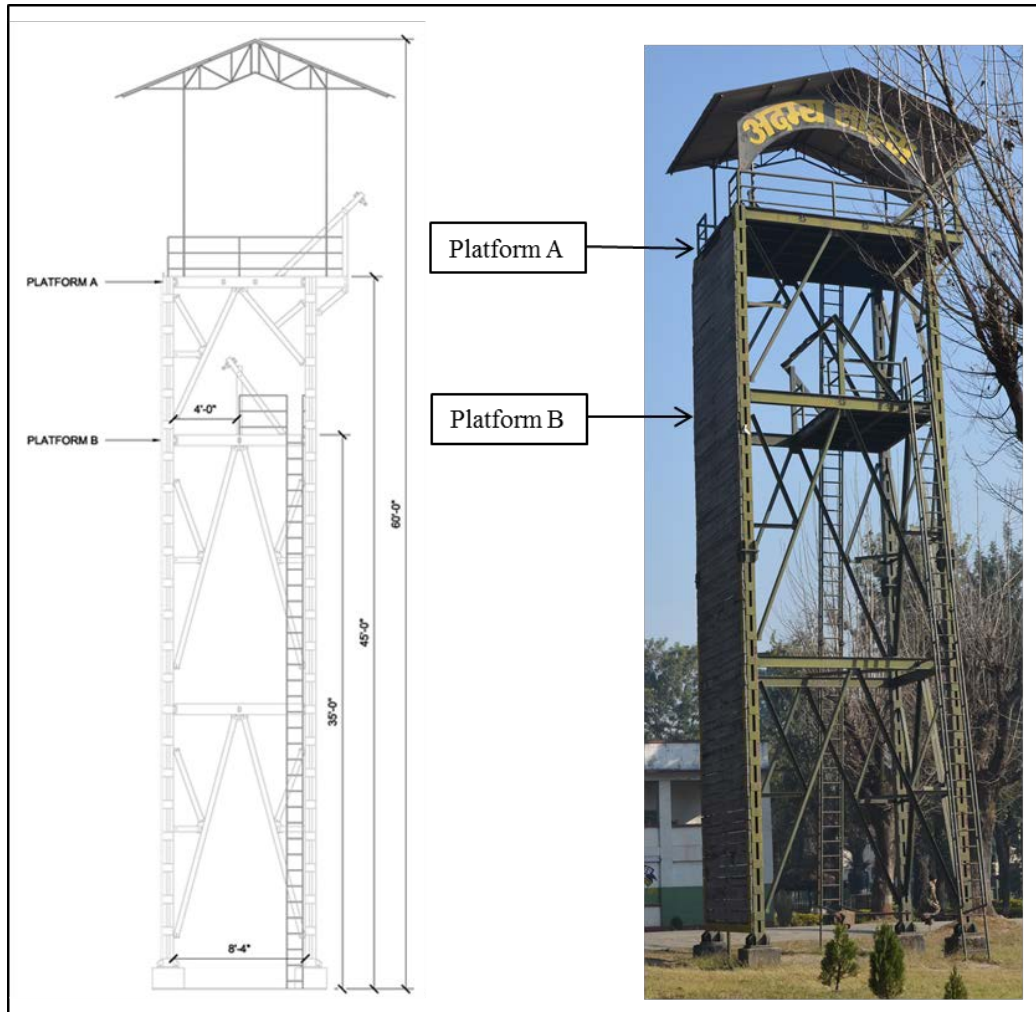
The MT was a 60-foot freestanding tower constructed of welded and bolted steel and wood with two metal platforms at 45 feet (Platform A) and 35 feet (Platform B) respectively (Figure 8, Tabs S-2 thru S-4, S-8, S-14, S-26 thru S-27, Y-3 thru Y-9, Y-15 thru Y-18). Platform A, located at the top of the MT, extended the entire width and length of the MT (Figure 8, Tabs S-2 thru S-4, S-8, S-14, S-26 thru S-27, Y-3 thru Y-9, Y-15 thru Y-18). Conversely, Platform B extended only four feet within the interior of the MT creating a four foot open air gap (Figure 8, Tabs S-2 thru S-4, S-8, S-14, S-26 thru S-27, Y-3 thru Y-9, Y-15 thru Y-18). The platforms accommodated training of personnel in various high angle rope climbing, rappelling and belaying techniques (Tabs R-4, R-12, R-21, V-2.17 thru 2.18, V-3.14). On 21 October 2014, Blue Team utilized both platforms simultaneously (Tabs V-3.13, Z-25). A sturdy wood wall separated the two areas of training (Figure 8, Tabs Y-3, Y-15). Additionally, two independent ladders provided access to the two separate training platforms (Figure 8, Tabs Y-3, Y-15).

Figure 8: Mishap Tower (Tabs Y-3, Y-15)

On 19 December 2014, the Ground Accident Investigation Board (GAIB) visited the Chaunni Military Barracks in Kathmandu, Nepal, to evaluate the mishap tower (Tab CC-3). PJA, a Special Tactics PJ, Static Line Jumpmaster and Instructor PJ trained in assessing and evaluating equipment, conducted the evaluation of the MT (Tab CC-3). PJA evaluated the following: (1) the overall condition of the tower; (2) the foundation of the tower; (3) the construction, safety and suitability of the tower; (4) accessibility through two ladders and the conditions of the ladders, steps and railings; and (5) potential anchor points, high points that aid in edge transitions, platforms and the fall lines (Tab CC-3). There was no evidence of any structural issues or concerns with the mishap tower (Tab CC-3).

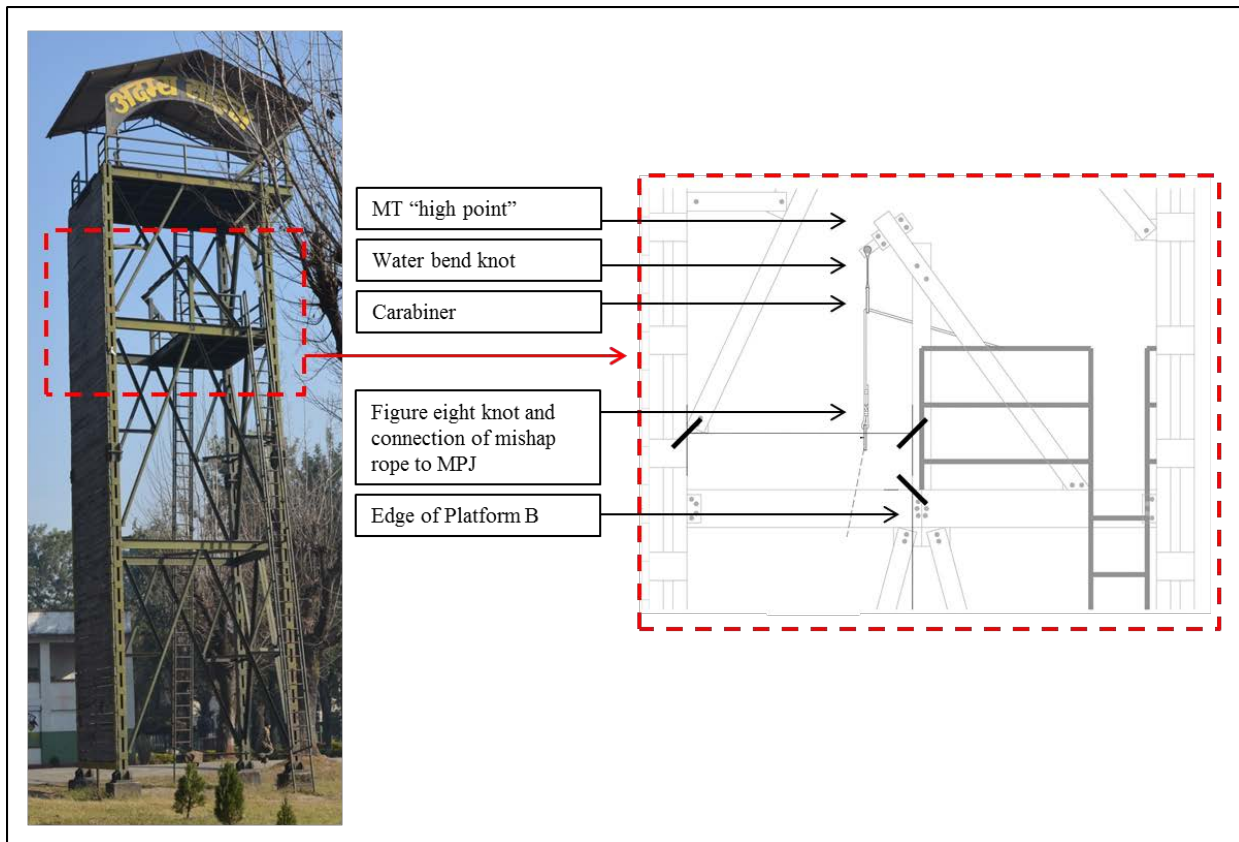
MPJ engaged the camming device on the Gri-Gri 2 by applying his weight to the rope (Figure 12, Tabs R-5, R-22, V-2.19, V-7.4).

Figure 12: MPJ connection to Gri-Gri safety line on edge of Platform B (Tabs Y-7, Y-15 thru Y-16)

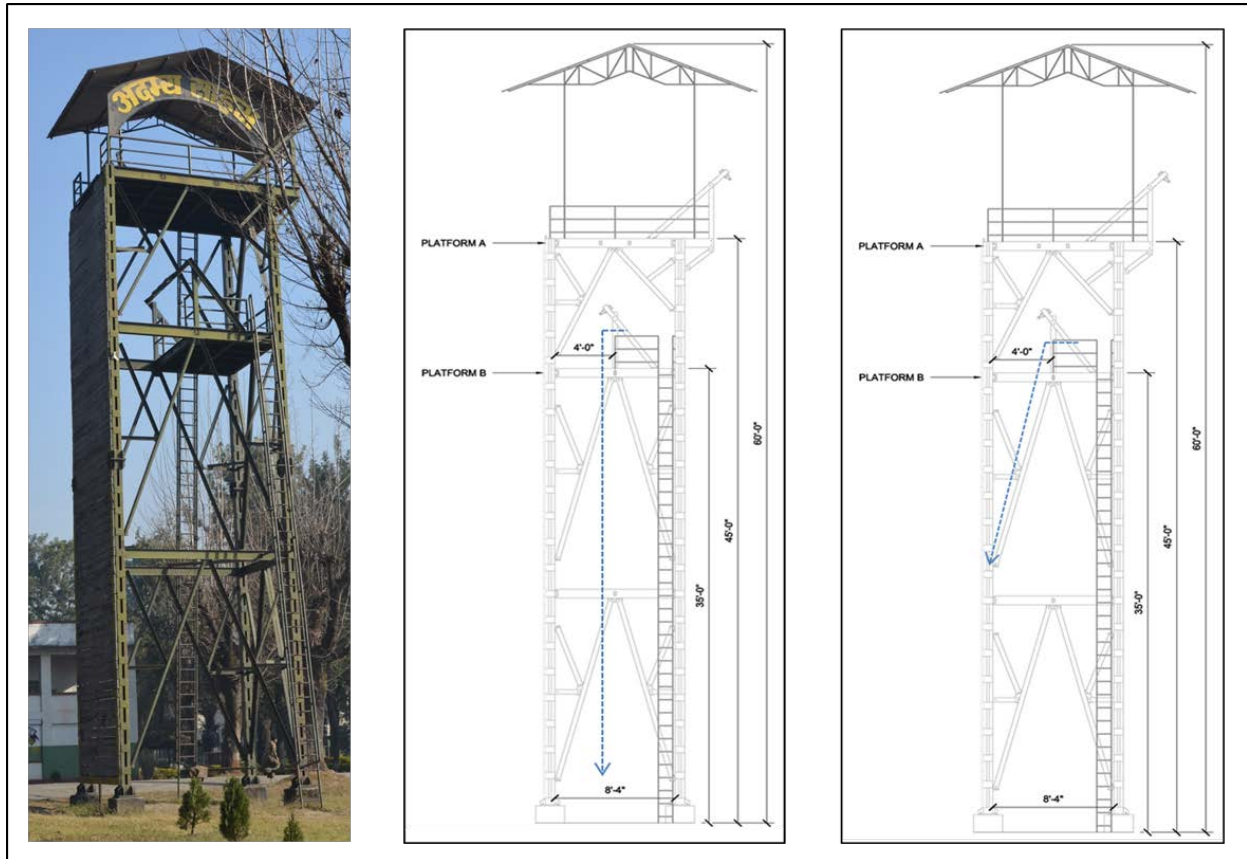
assumed that MPJ would descend straight toward the ground (Figure 13, Tabs V-2.20 thru V-2.21, Y-3, Y-6). However, BPJ1 and MPJ did not gauge the distance from the interior edge of the platform to the interior side of wall, or discuss the plan for the fast belay prior to MPJ descending (Tab R-17).

Figure 13: BPJ1 anticipated descent of MPJ (center) versus actual descent of MPJ during high angle belay (right) (Tabs V-2.20 thru V-2.21, Y-3, Y-6)

Instead, MPJ pushed off the edge of Platform B with his legs, and quickly descended on a downward angle toward the inside wall of the MT (Figure 13, Tabs R-5, R-22, V-2.21, V-7.6). The MT is eight feet wide, and Platform B extends four feet internally to the structure (Tabs Y-3, Y-15). However, MPJ's push off the edge of Platform B and the rope's fast rate of descent sent MPJ on a trajectory where he quickly covered the four foot lateral distance between Platform B and the inside wall of the MT (Tabs R-5, R-22, V-2.21, V-7.6). Following the mishap, Rangers located at the base of the tower stated MPJ impacted a metal I-beam approximately 17 feet down from Platform B and 18.5 feet from the ground (Figure 13, Figure 14, Tabs R-71, R-85, V-8.4 thru V-8.5).

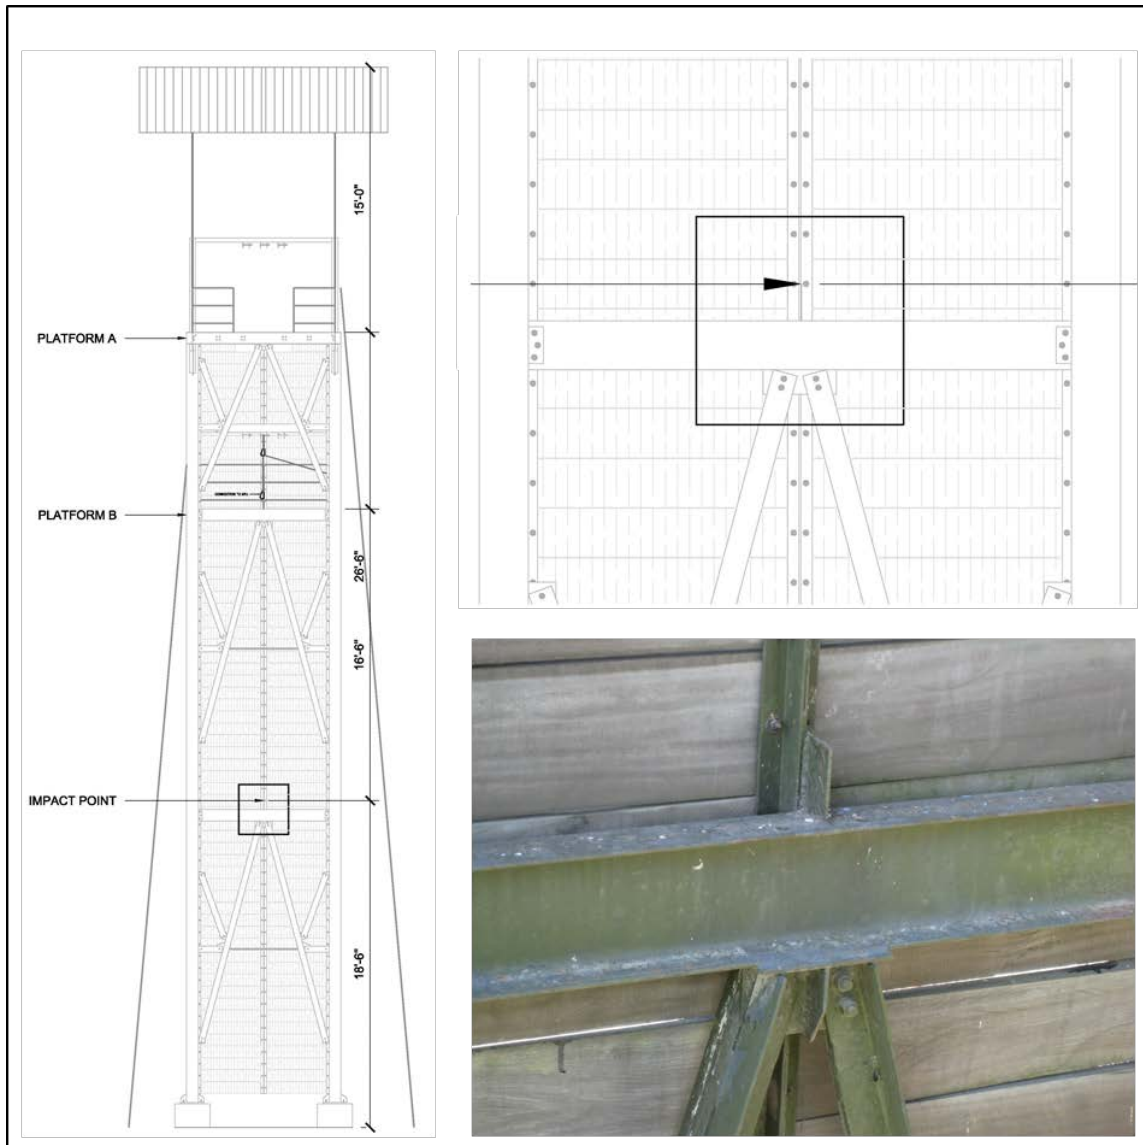
Figure 14: Detailed view of MPJ impact point on MT (Tabs R-85, S-14, Y-9)

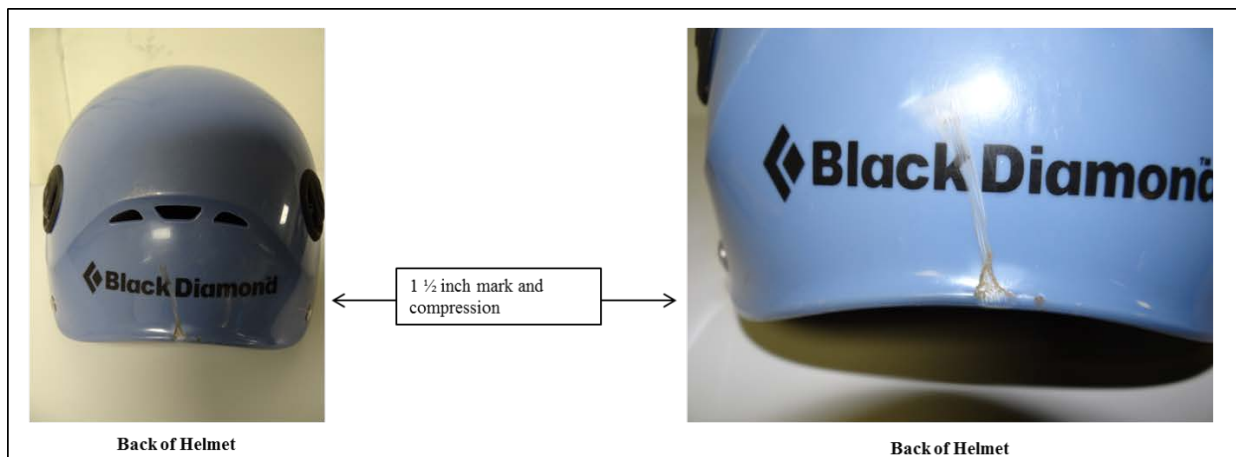
The mishap helmet was an adjustable Black Diamond Half Dome helmet, serial number A0568381 (Tabs CC-6, CC-33, CC-45). The GAIB conducted a visual inspection of the mishap helmet (Figure 20, Tab CC-6). The helmet had a 1 ½ inch in length mark and slight compression on the back of the helmet (Figure 20, Tab CC-6).

Figure 20: Back view of mishap helmet (Tabs S-20 thru S-21, CC-6)

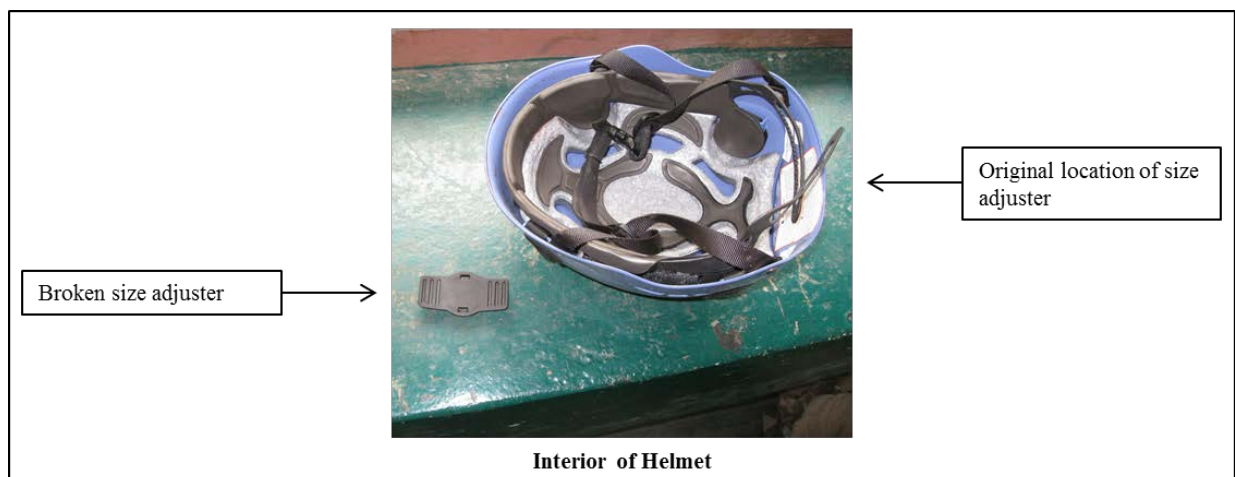
Additionally, the size adjuster was damaged and non-functional with a piece of the size adjuster missing (Figure 21, Tab CC-6). However, IO used the mishap helmet prior to the mishap and did not note any missing pieces or structural issues with the helmet (Tab V-8.3).

Figure 21: Interior view of mishap helmet (Tabs S-25, CC-6)

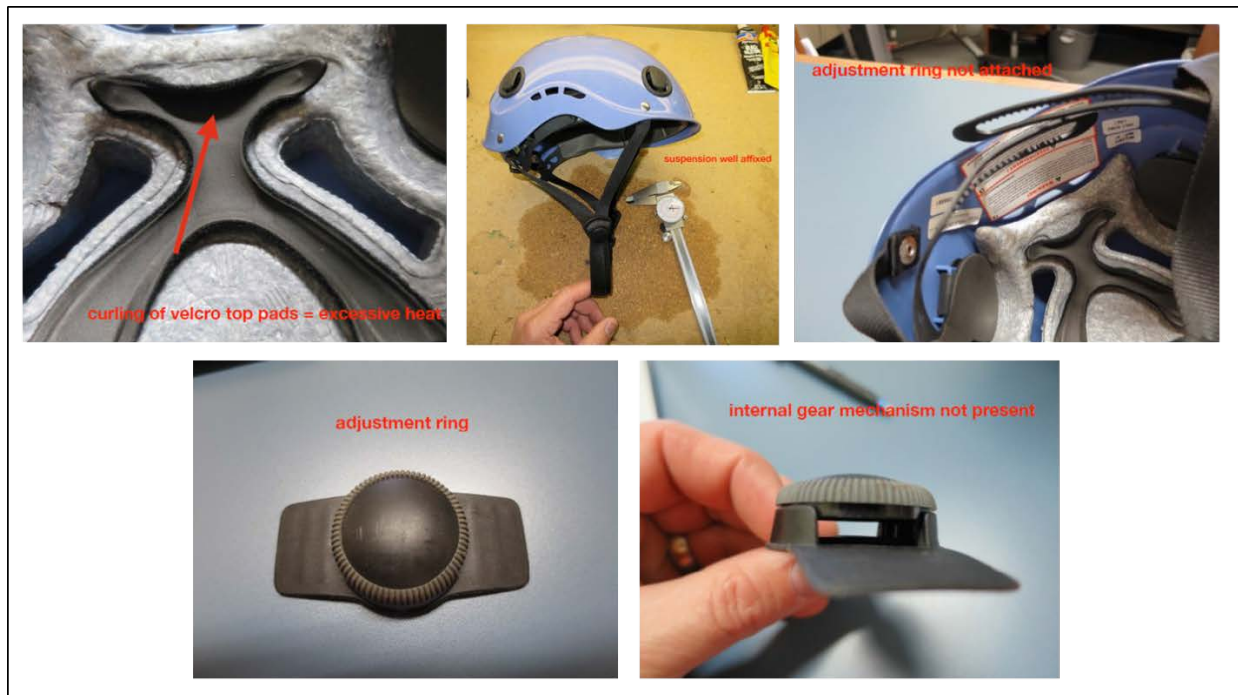
A visual inspection and comparative baseline analysis of the internal suspension harness determined the following: (1) the suspension harness was affixed to the acrylonitrile butadiene styrene (ABS) shell securely; (2) all webbing of the suspension harness appeared to be in good condition; (3) the Velcro top pads showed slight curling likely due to exposure to heat during use or storage; (4) the adjustment ring was not attached to the rear suspension fit band; (5) the internal gear mechanism on the adjustment ring was not present with the adjustment ring; and (6) the teeth on the rear suspension fit band appeared to be intact (Figure 22, Tab CC-36).

Figure 22: Visual inspection and comparative baseline analysis of the internal suspension harness on mishap helmet (Tab CC-36 thru CC-37)

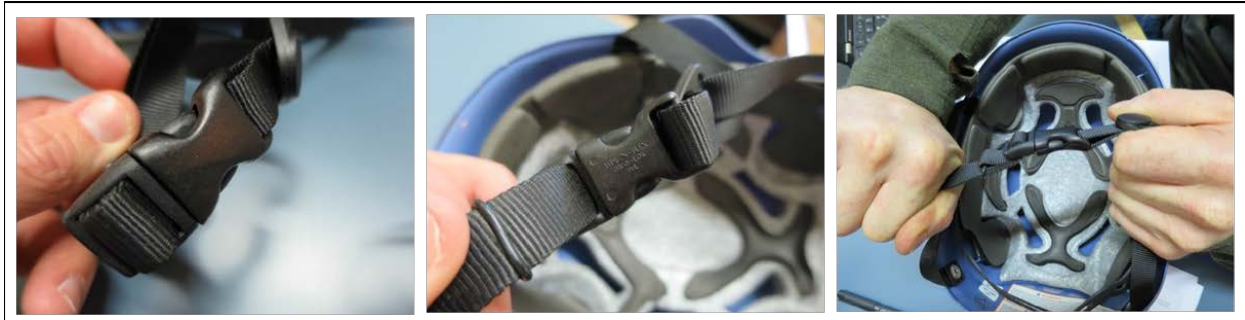
A visual inspection of the chin strap buckle determined the following: (1) the chin strap buckle showed no signs of wear and was in working order; (2) physically pulling on the chin strap buckle showed it continued to maintain a solid connection; (3) the elastic keeper strap was still

intact and functional; and (4) the chin strap adjustment sliders were still intact and functional (Figure 23, Tab CC-38).

Figure 23: Visual inspection of the chin strap buckle on mishap helmet (Tab CC-38)

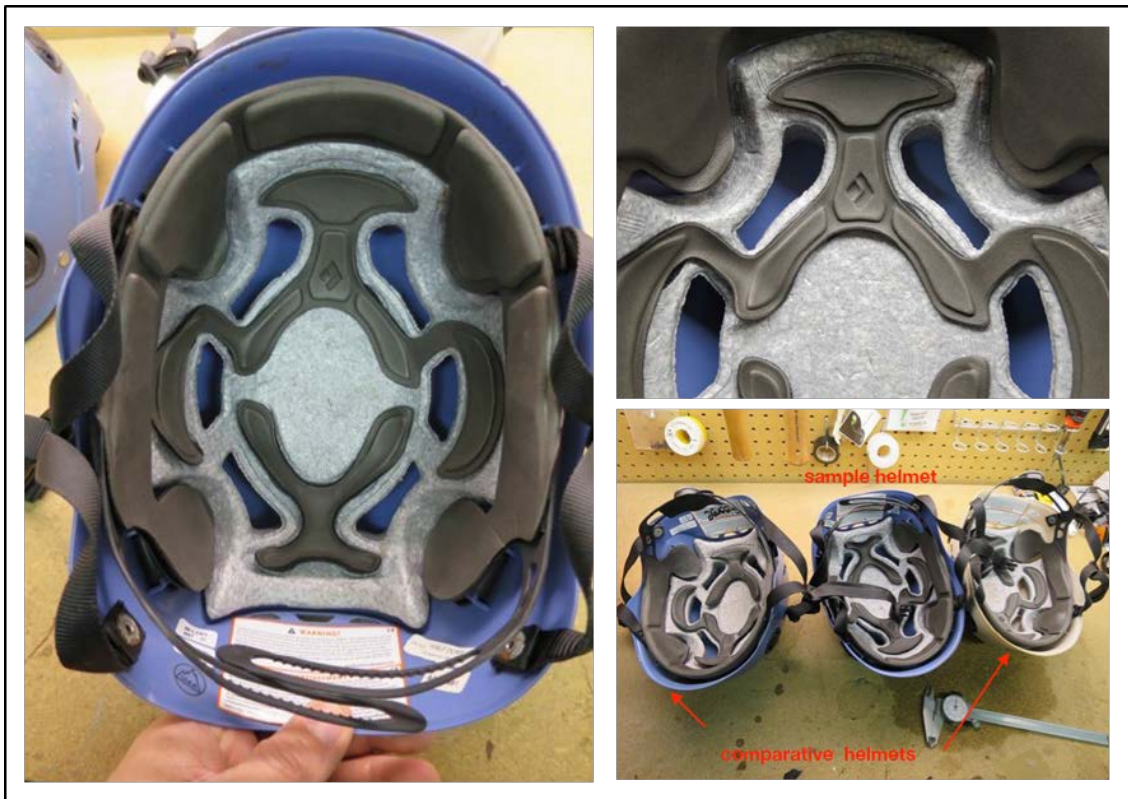
A visual inspection and dimensional inspection of the EPS liner determined the following: (1) there were no signs of significant cracking; (2) there was a slight denting and deformation in the front area of the helmet; and (3) the EPS liner remains well adhered to the ABS shell (Tab CC-39). Black Diamond was unable to obtain accurate dimensional checks of the EPS liner without disassembling the EPS liner from the shell (Tab CC-39). However, Black Diamond compared the mishap helmet to a stock helmet and determined that the EPS liner appeared to be in standards and within specifications (Figure 24, Tab CC-39).

Figure 24: Visual inspection and dimensional inspection of the EPS liner on mishap helmet (Tab CC-39)

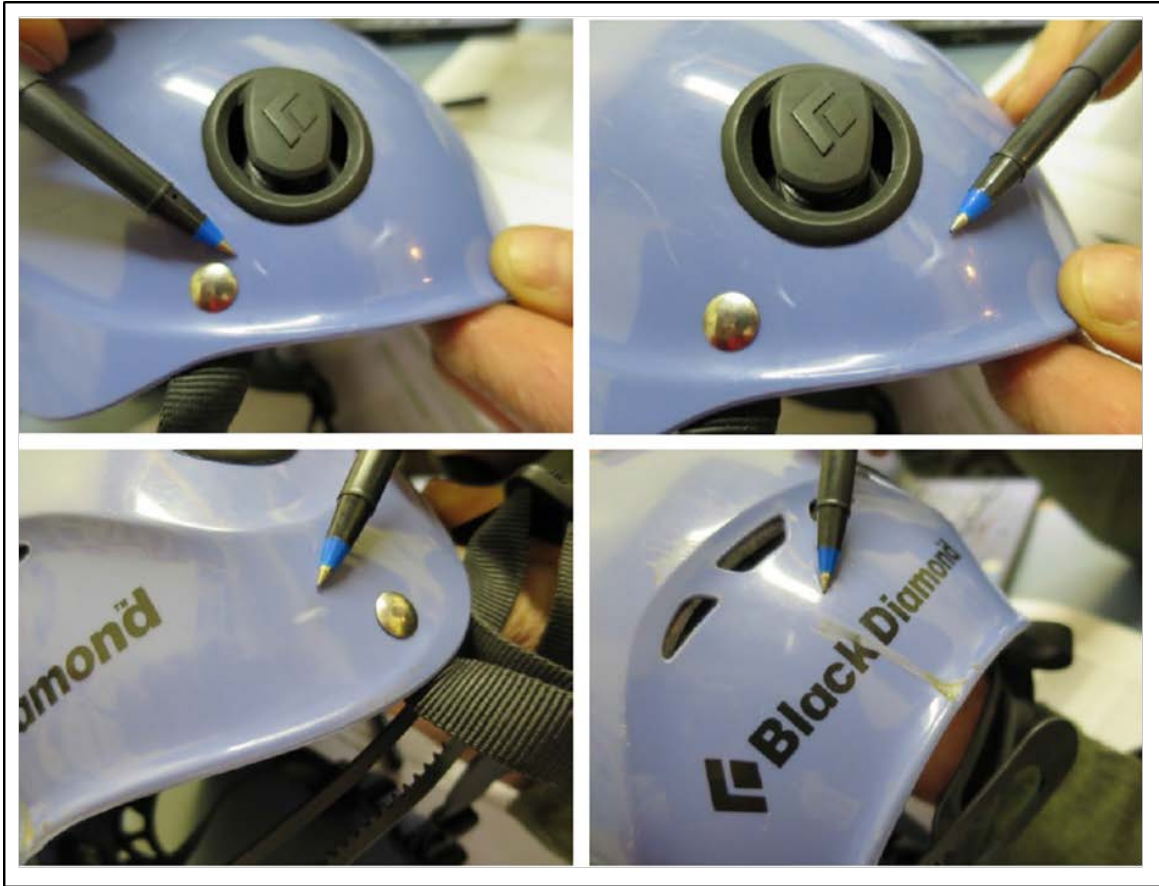
A visual inspection and dimensional inspection of the ABS shell determined the following: (1) overall the ABS shell was in good condition; (2) there was slight “crazing” where the fit band attached to the shell on the front right; (3) there was slight “crazing” near the rear right rivet; (4) there was slight “crazing” on the rear of the helmet left of center; and (5) there was an obvious impact point in the center back on the lower edge of the helmet (Figure 25, Tab CC-40 thru CC-41).

Figure 25: Visual inspection and dimensional inspection of the ABS shell on mishap helmet (Tab CC-40 thru CC-41)

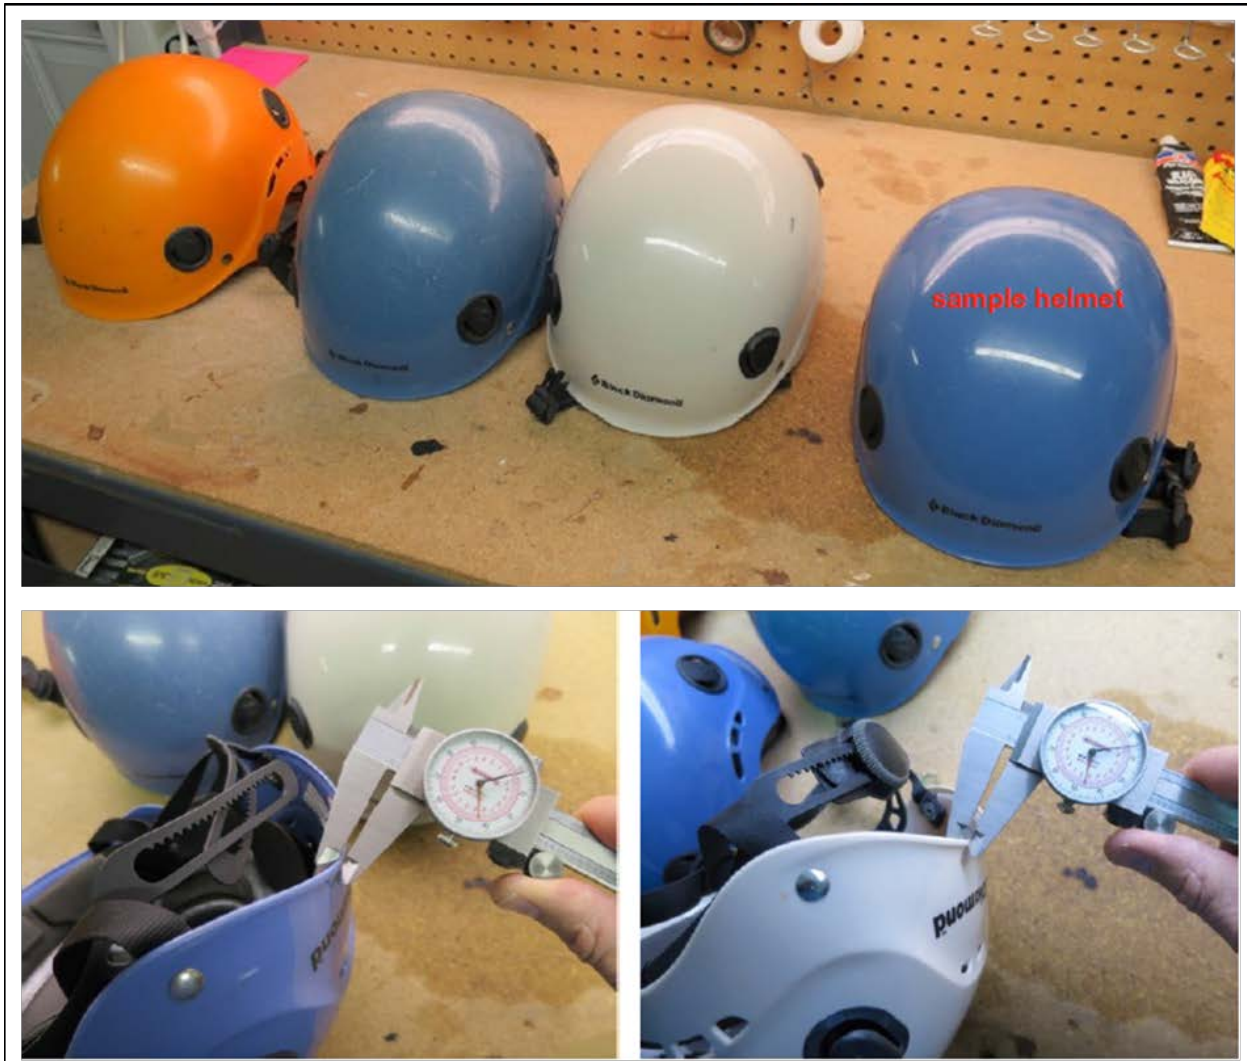
Black Diamond was unable to obtain an accurate dimensional check on the mishap helmet without disassembling the helmet and potentially destructively cutting it (Tab CC-40). However, Black Diamond compared the mishap helmet to stock helmets and determined that the ABS shell appeared to be of the appropriate outside dimension and thickness (Figure 26, Tabs CC-40, CC-42). Additionally, thickness tests of the ABS shell taken at several points along the mishap helmet appear to be similar to a comparative stock helmet (Figure 26, Tabs CC-40, CC-42). Finally, Black Diamond determined that when the mishap helmet was compared to a stock Half

Dome helmet of the same generation, it appeared the mishap helmet was dimensionally comparable (Figure 26, Tabs CC-40, CC-42).

Figure 26: Visual inspection and dimensional inspection of the ABS shell on mishap helmet (Tabs CC-40, CC-42)

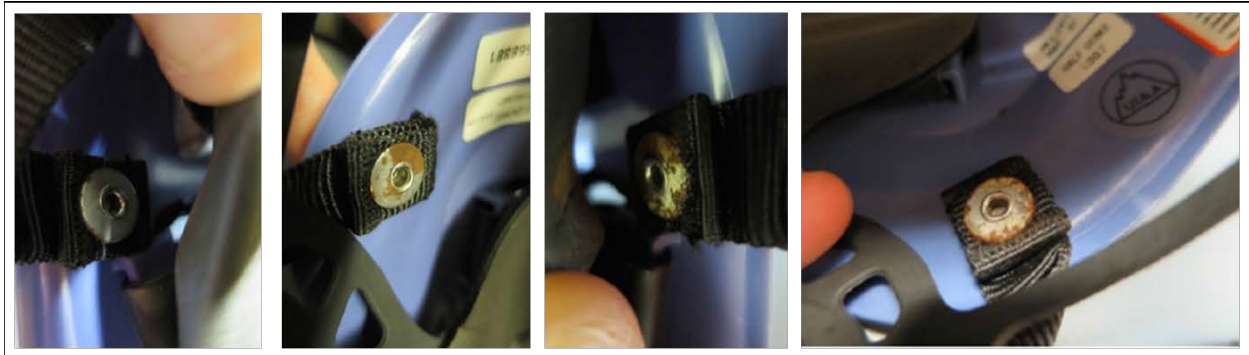
slight corrosion on the inside of all four rivets; and (3) all headlamp clips were intact and functional (Figure 27, Figure 28, Tab CC-43 thru CC-44).

Figure 27: Rivet inspection and comparison to baseline on mishap helmet (Tab CC-43)

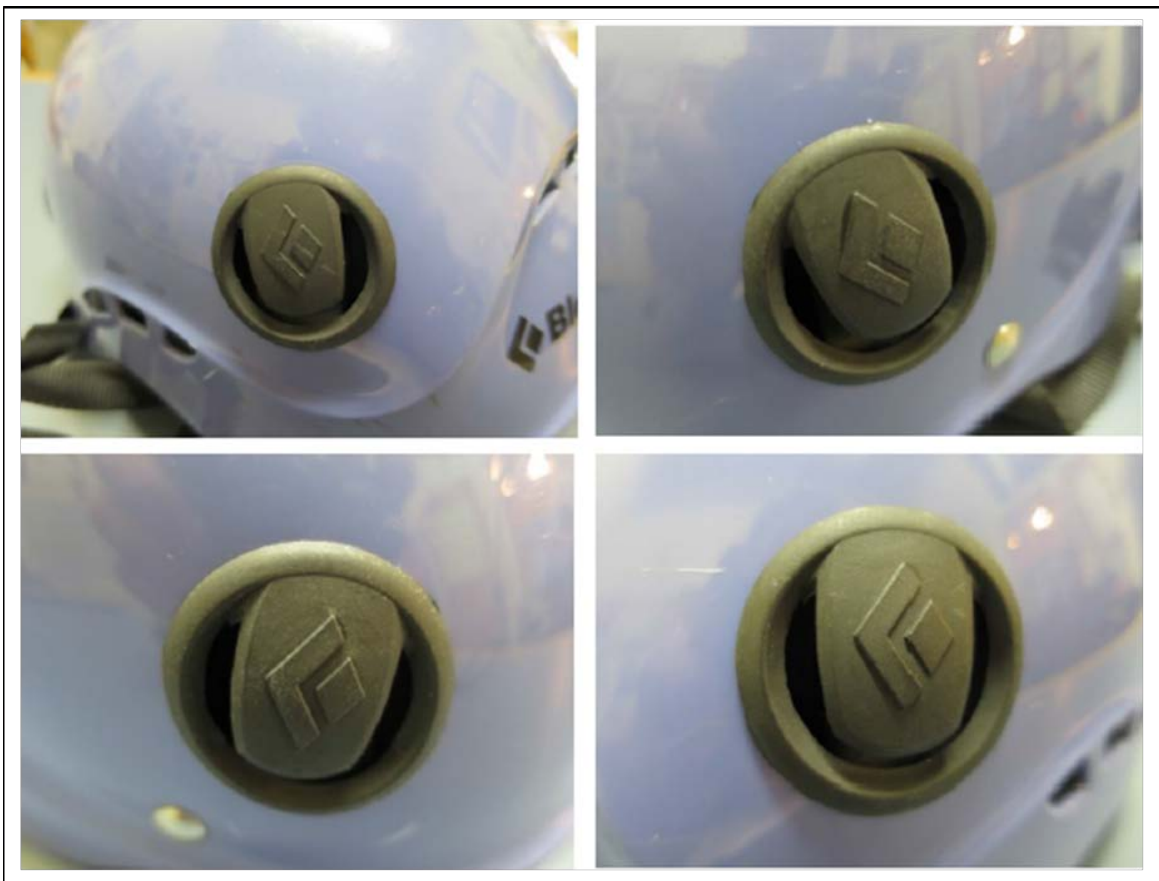
Figure 28: Headlamp inspection and comparison to baseline on mishap helmet (Tab CC-43 thru CC-44)

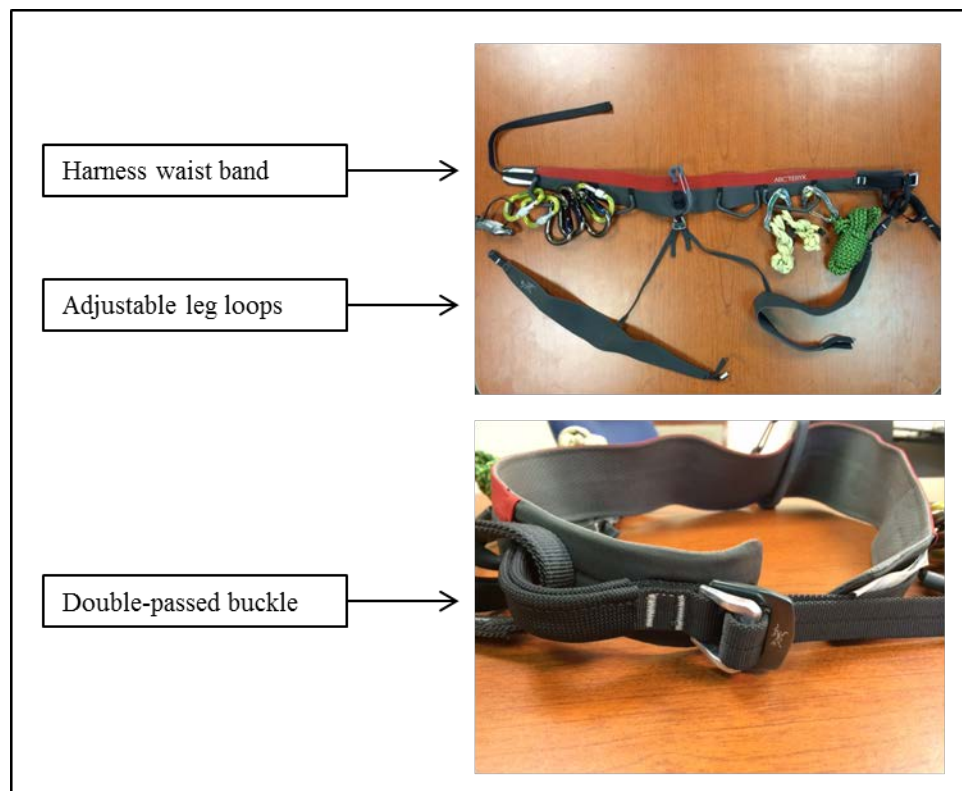
Figure 29: Arc'teryx R320a mishap seat harness (Tab CC-12)

Other than the post-mishap cutting of the leg loops, the harness appeared to be in working condition, and there was no evidence to indicate it failed to operate properly on the date of this mishap (Tabs CC-5, CC-12).
