**UNITED STATES AIR FORCE**  
**AIRCRAFT ACCIDENT INVESTIGATION**  
**BOARD REPORT**

**F-15E, T/N 90-0235**  
**391ST FIGHTER SQUADRON**  
**366TH FIGHTER WING**  
**MOUNTAIN HOME AIR FORCE BASE, IDAHO**

**LOCATION: SOUTHWEST ASIA**  
**DATE OF ACCIDENT: 28 MARCH 2012**  
**BOARD PRESIDENT: BRIGADIER GENERAL**  
**CHARLES L. MOORE, JR.**  
**Conducted in accordance with Air Force Instruction 51-503**

**EXECUTIVE SUMMARY**  
**AIRCRAFT ACCIDENT INVESTIGATION**  
**F-15E, T/N 90-0235, SOUTHWEST ASIA**  
**28 MARCH 2012**

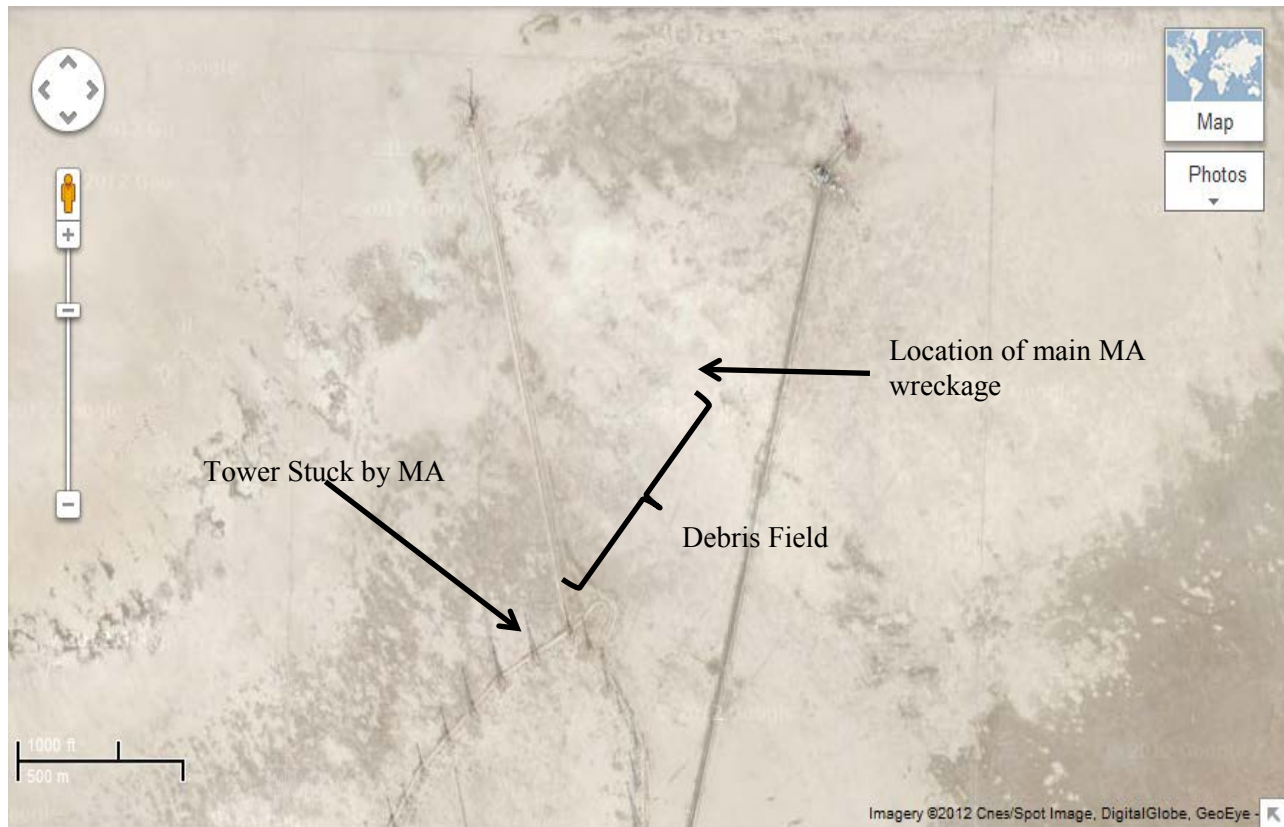
The MA impacted the terrain at approximately 16:03:30Z about 18 NM west, southwest of the deployed location in Southwest Asia (Tabs H-2 and GG-8). The MA was in the same configuration at impact as it was prior to take-off (Tab GG-8). The MA struck a 377-foot tall radio tower and crashed approximately 0.5 NM northeast of the tower (Tab H-2). Based on the damage to the MA, it appears the right wing of the MA struck the radio tower (Tab J-3). The impacted radio tower was part of a large tower array just north of a major east-west running well-trafficked highway (Tab J-64).

**Figure 3. Mishap Site Location**

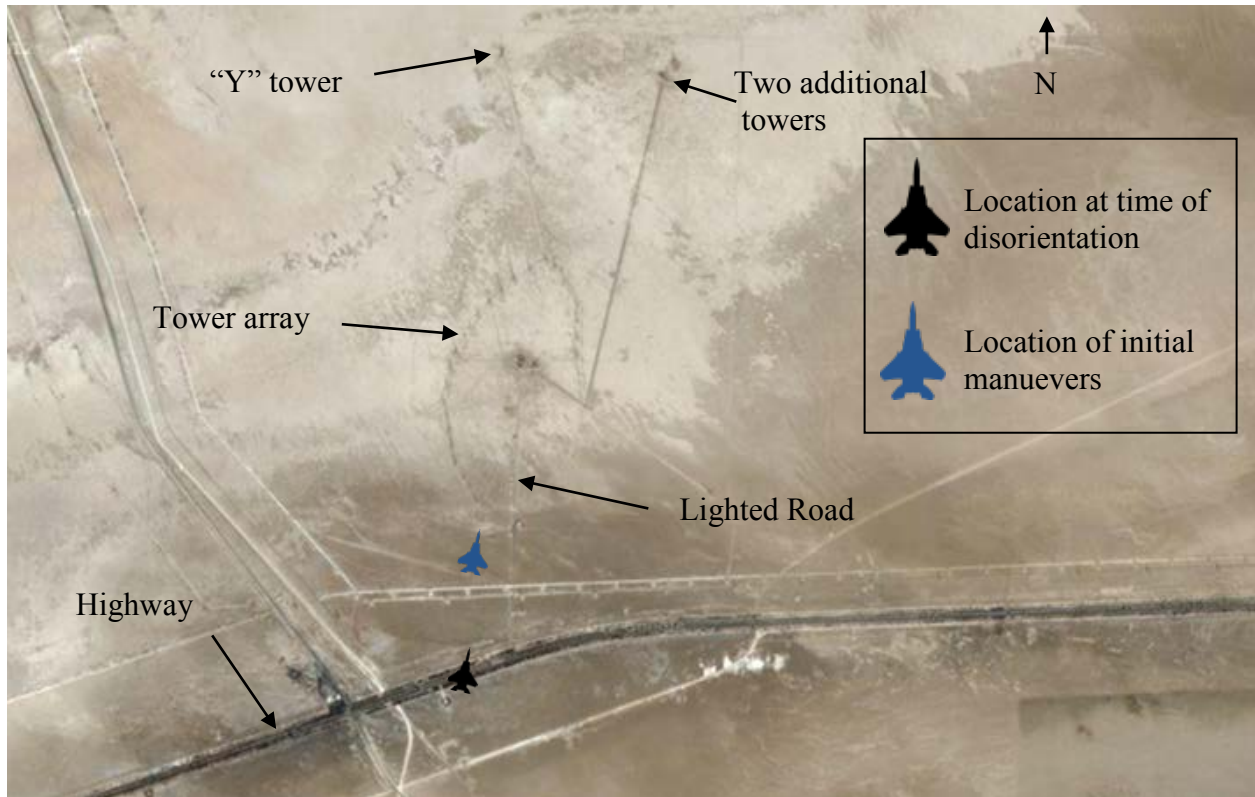
Witnesses described the night of the mishap as very dark with no discernable horizon. Additionally, the MP was briefed that the recovery arc would be dark with no cultural lighting. Of note, there were no discussions pertaining to highway lights or radio towers (Tab V-1.14 and V-3.9). The mishap occurred at an isolated radio tower array 18 NM west, southwest of the base (See Figure 4). This array forms a horseshoe shape and consists of 31 primary towers. These towers are of varying heights with the tallest being 377 feet in height (Tab Z-3). Each radio tower contains one or two closely spaced steady red lights at the top of the tower and two to four steady red lights at the midpoint (See Figure 5) (Tab EE-3 to EE-4). There is one distinct "Y" shaped tower 1,403.31 meters to the north of the main tower array (Tab Z-3). Directly east of this tower are two additional towers with buildings at their base. There are several buildings in the center of the tower array, which all have white security lights. A lighted road leads out of the horseshoe south towards a major east-west running well-trafficked highway (See Figure 4) (Tab EE-4 to EE-5).

**Figure 4. An aerial view of the mishap location**

Secondly, the MP may have perceived the tower lights located on left side of the array as a false horizon (Tab HH-3 to HH-5) (See Figure 4). The flickering lights of the highway would have entered the MP's peripheral vision at the same time the lights of the "Y" tower would have entered his focal vision. When the MP pushed the nose of the MA over in an attempt to orient himself to the "Y" tower's lights, the left line of tower lights would have also come into his focal view. The MP may have attempted to correct to this false horizon by placing the line of lights in the center of his vision and rolling left to situate the lights in a more traditional horizontal orientation.

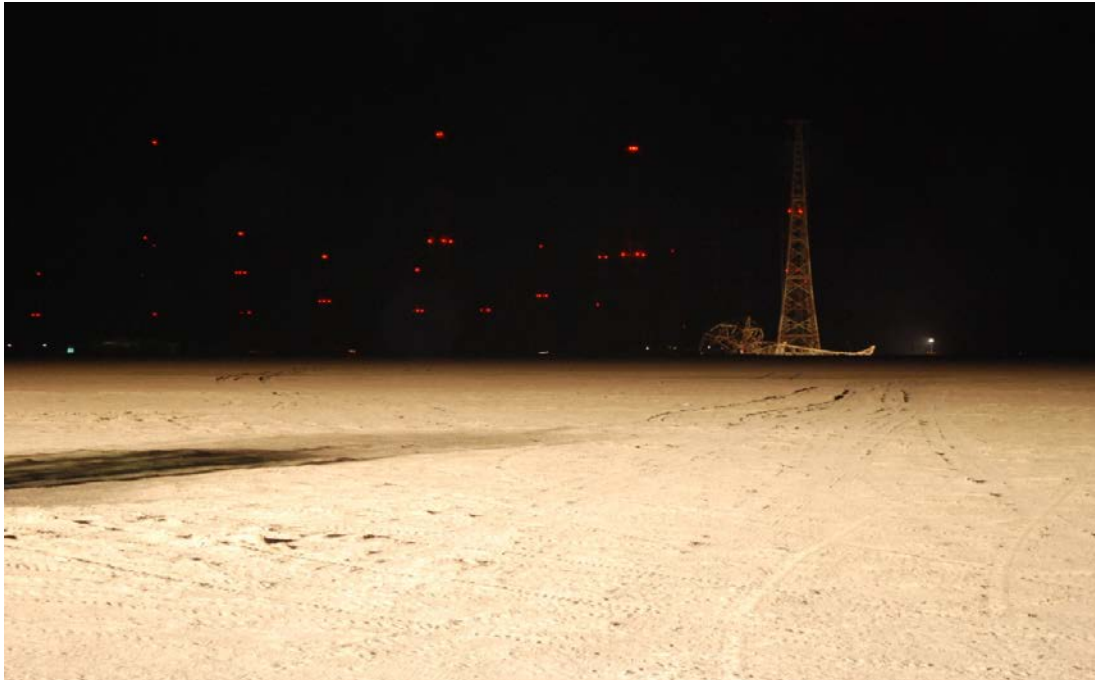
**Figure 5. An image of tower lights at night with one to two red lights on top and two to four red lights midway up the tower (photographed on 5 April 2012)**

First, the radio tower lights that came into the MP's focal view may have been perceived as the position lights of another aircraft (Tab HH-4). The MA was behind an aircraft on the recovery arc, which the MP had identified on the SIT(P). The expected location of the aircraft per the SIT(P) was left of the MA's midline just below the horizon (See Figure 8) (Tab GG-7). If the MP misinterpreted the two lights on top of the "Y" tower as that aircraft, then that image would have conflicted with what he expected because it appeared right of the MA's midline and 10 degrees low (See Figure 7). As a result, the MP incorrectly perceived the MA as inverted (See Figure 10).

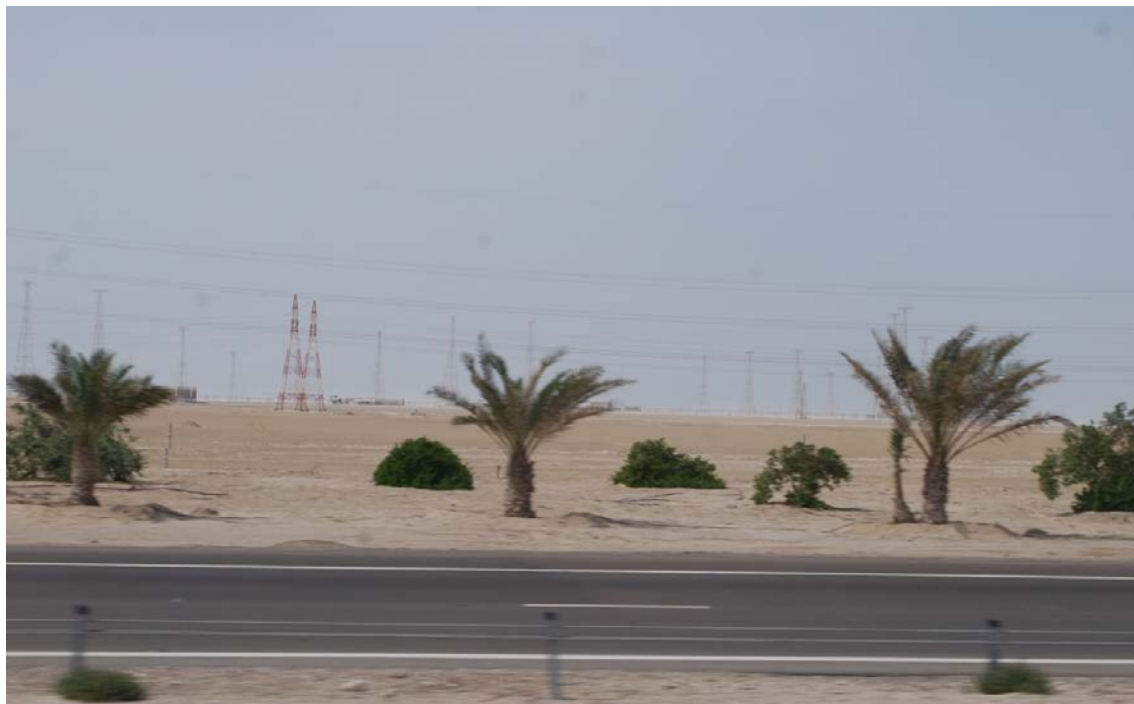
There is a heavily trafficked, lighted highway south of the radio tower array. There are palm trees planted at a set interval along the side of the highway, which causes a flickering image at night due to the headlights of passing vehicles (See Figure 6) (Tab V-6.10). In addition, many of the trucks commuting along this road have flashing yellow lights on the top of their freight (Tab R-5).

**Figure 6. A view of the palm trees planted along the road. The radio tower array can be seen in the background.**

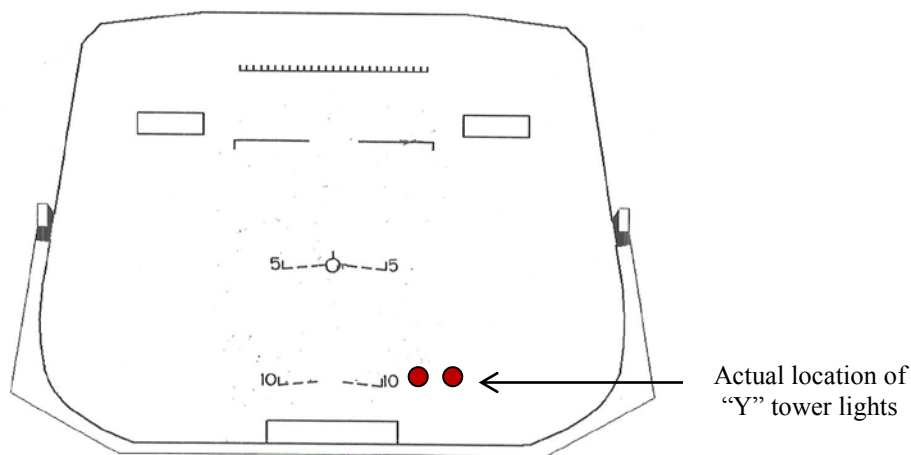
**Figure 7. Actual representation of MA HUD**

Based on what he was seeing on the SIT(P), the MP expected the aircraft in front of him to be to his left (Tab GG-7). A tower light misinterpreted as an aircraft would have appeared to be on the MP's right. This perceived inverted image of the expected scene, along with the peripheral lighting of the highway below, could have caused the MP to become disoriented (See Figures 7 to 10).

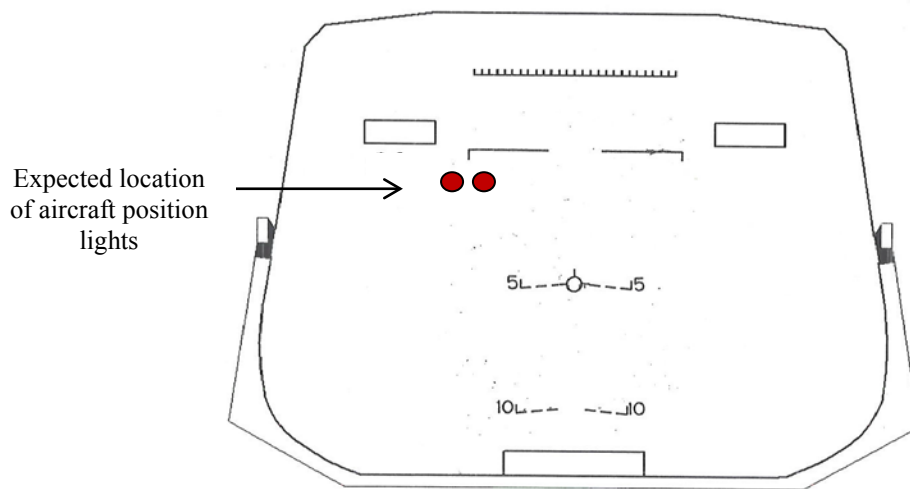
**Figure 8. A representation of what the MP expected**

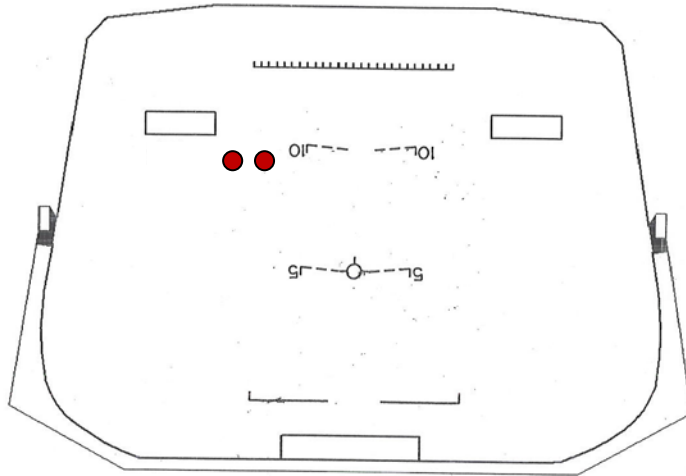
**Figure 9. A representation of the HUD if the MA was truly inverted**

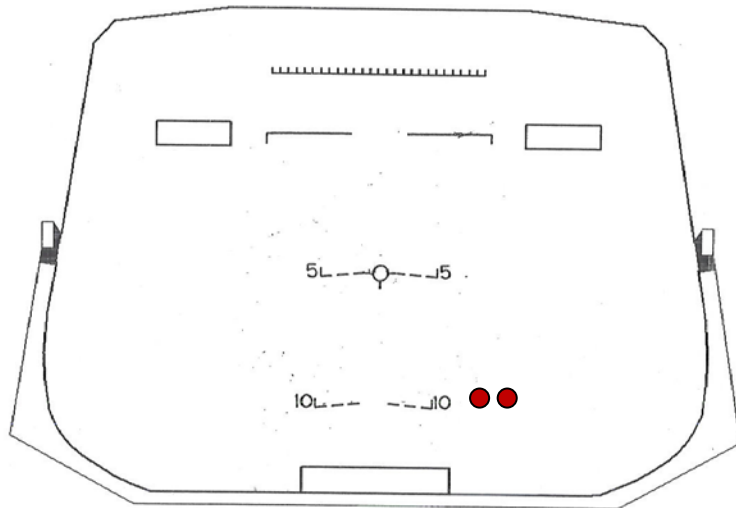
**Figure 10. A representation of what the MP may have mistakenly perceived due to a visual illusion (inverted and five degrees nose low)**

The MP's disorientation caused him to believe that he was inverted and five degrees nose low. The MP attempted to level the MA to his perceived horizon by pushing forward on the MA controls (Tab J-10). The MP expected this maneuver to push the nose of the MA toward the horizon. In reality, the MA acted in accordance with the forward stick input and pitched further away from the horizon (Tab J-10). This increased nose low attitude contradicted the MP's expectation of what the MA should have done. The MP likely was then attempting to identify why the MA did not follow his command, which would have caused further disorientation.

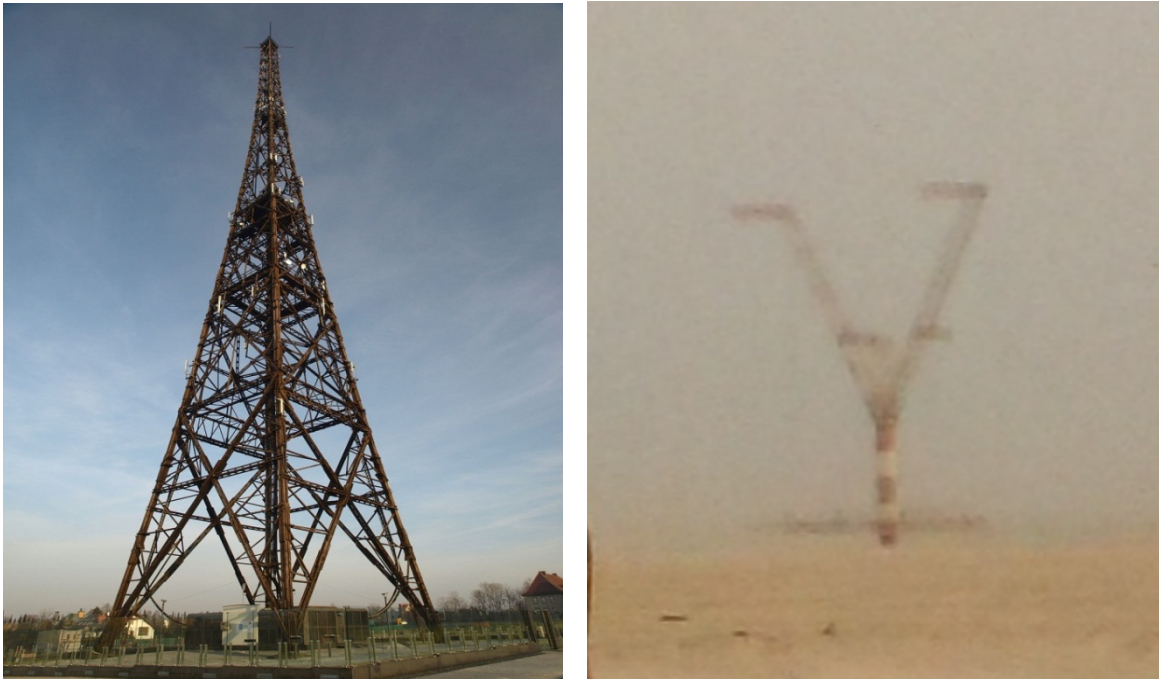
This would be due to the aforementioned highway lighting in his periphery and the atypical orientation of this isolated “Y” tower. This radio tower in the MP’s focal view would have been an unfamiliar shape, wide at the top and narrow at the bottom. A typical radio tower would be the opposite shape, with a wide base and a narrow top (Figure 11). Instead of realizing he was viewing an unusual “Y” shaped tower, the MP may have thought he was viewing a “typical” tower that appeared like a “Y” because he was inverted.

**Figure 11. The left image shows a “typical” tower, wide at the bottom and narrow at the top. The right image shows the “Y” tower located north of the tower array.**

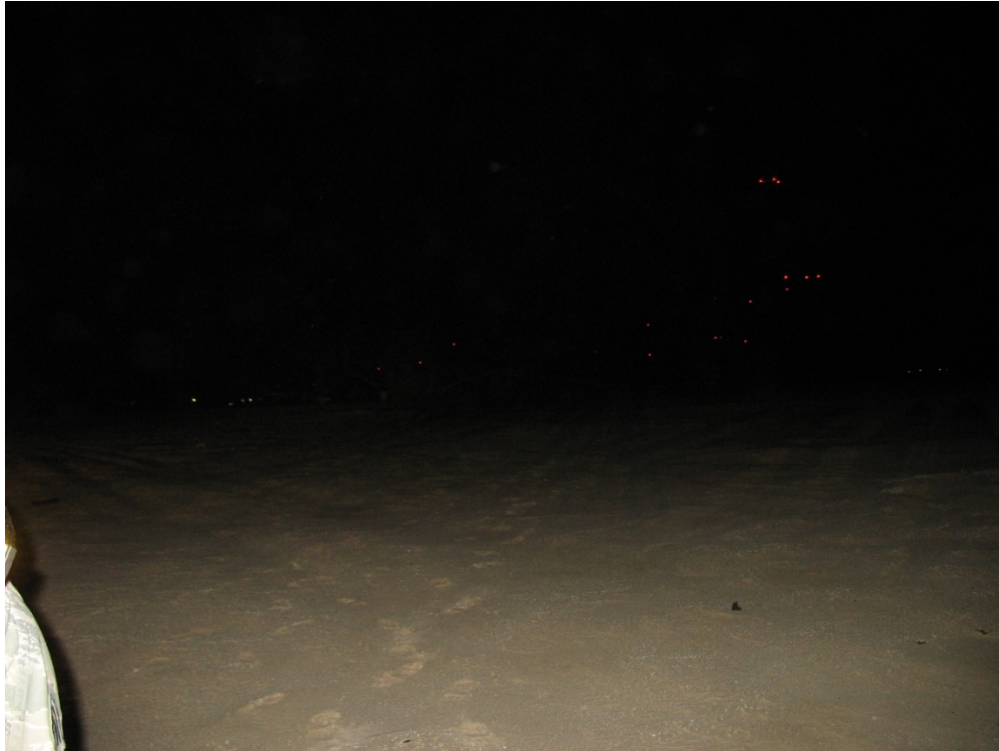
Visual references provide the most important sensory information to maintain spatial orientation during flight. These visual references provide information about distance, speed, depth and orientation. As the MA approached the towers and highway, lights once blocked by poor visibility and distance suddenly became visible to the MP. These lights would have been his

only point of reference for visual orientation. It is possible the MP based his false orientation solely on these lights due to the lack of reliable visual cues (e.g., horizon, city lights). It would have been difficult for the MP to maintain his attitude in this environment without an instrument crosscheck using the EADI or standby ADI.

**Figure 12. Photograph of mishap location 28 March 2012. The foreground light was utilized by the recovery team and was not present at the time of the mishap.**
