UNITED STATES AIR FORCE
AIRCRAFT ACCIDENT INVESTIGATION
BOARD REPORT

B-1B, T/N 85-0085

34TH BOMB SQUADRON
28TH BOMB WING
ELLSWORTH AIR FORCE BASE

DATE OF ACCIDENT: 4 JANUARY 2024

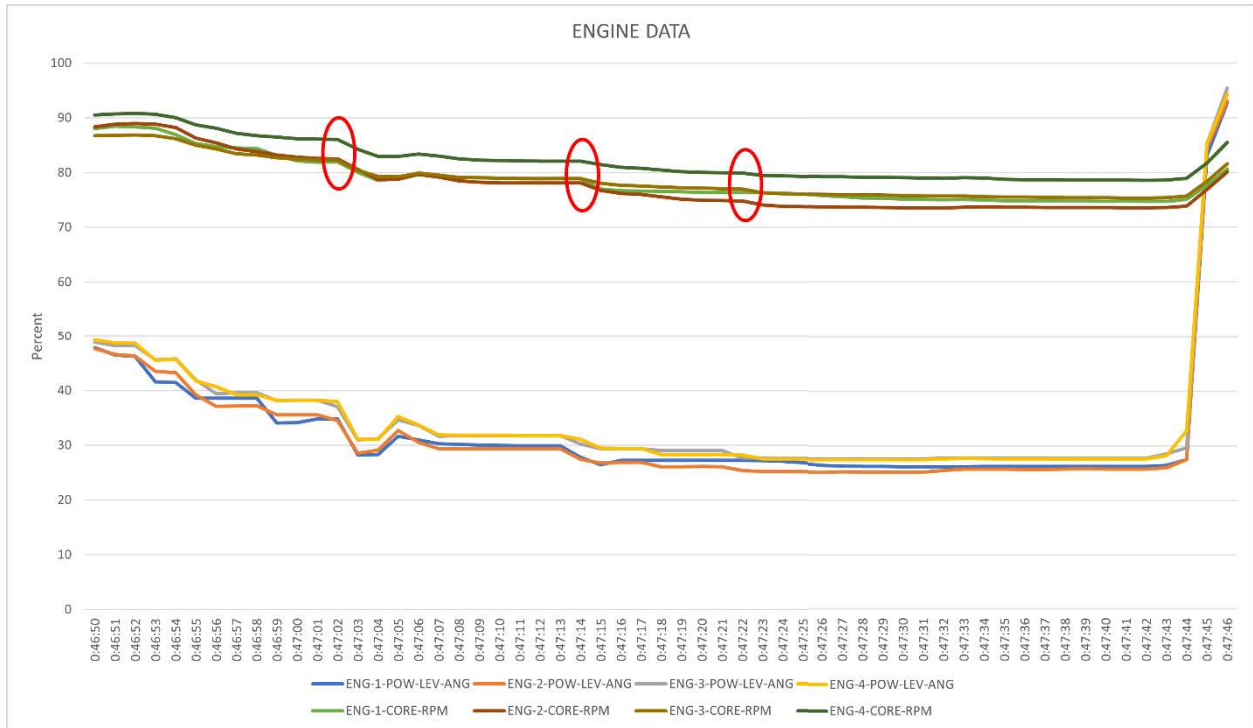
**Figure 1. MA’s MFOQA Engine Data, Core RPM and PLA.
(Each red circle corresponds to a reduction in core rpm) (Tab AA-4)**

During the last 55 seconds while descending, the winds rapidly shifted from a 340-cardinal direction at 11 kts to a 190-cardinal direction at 5 kts within 25 seconds (Tab AA-4). This is “performance enhancing” directional wind shear. Flight data shows the MA’s airspeed increased by approximately 12 kts during this wind shear event from 164 KIAS to 176 KIAS. Performance-enhancing wind shear was evidenced by increased airspeed as the MA was now flying faster through the airmass around it (Tab AA-4). Throttle reductions are commonly required with performance-enhancing wind shear to mitigate the increasing airspeed, and this reduction in the MA’s throttles is reflected in the Military Flight Operations Quality Assurance (MFOQA) collected data (Tab AA-4). The wind data was collected from onboard tactical displays showing the wind velocity and direction readout. Flight data and engine data are derived from the MA’s MFOQA data (Tab AA-4). The MP reduced power three notable times throughout this period (Figure 1, below). The first power reduction was at 17:47:02L by approximately 5 percent core revolutions per minute (rpm), the second power reduction was at 17:47:14L and approximately 3 percent core rpm, and the final power reduction was at 17:47:22L and approximately 1-2 percent. Core rpm reductions are required to counter airspeed increases. However, once the wind stabilized at 5 kts crosswind, the MP did not increase the core rpm as the airspeed decreased toward the approach speed to “catch” the approach speed of 164 KIAS (Tab AA-5). This power input never occurred, resulting in a thrust deficient condition (Tab AA-5).

The MA airspeed trended downward with each power pull, markedly decreasing after the third power reduction at approximately 17:47:22L (Tab AA-4). No notable power increases are recorded from that time until just before impact (24 seconds). Contrary to recorded data, the MP recalled in his testimony that they were within 3 kts of their calculated approach speed of 164 KIAS for the duration of their approach (Tab V-29.11). In Figure 2 below, the green line is the calculated approach speed, and the blue line is the kts calibrated airspeed (KCAS) (in the B-1B, KCAS is KIAS) (Tab AA-5). If the approach were flown within 3 kts of the calculated approach speed, the blue KCAS line would be approximately the same as the green calculated approach speed line in Figure 2 rather than arching above and sinking below. Additionally, Ground Speed (GS) will be approximately the same as that of KCAS when winds are calm (Tab AA-5). This is seen in Figure 2 when the blue KCAS line aligns with the yellow GS line, beginning at approximately 17:47:22L. Before this time, Figure 2 shows the yellow GS line above the blue KCAS line. This indicates a tailwind, which decreases until approximately 17:47:22L (Tab AA-5).

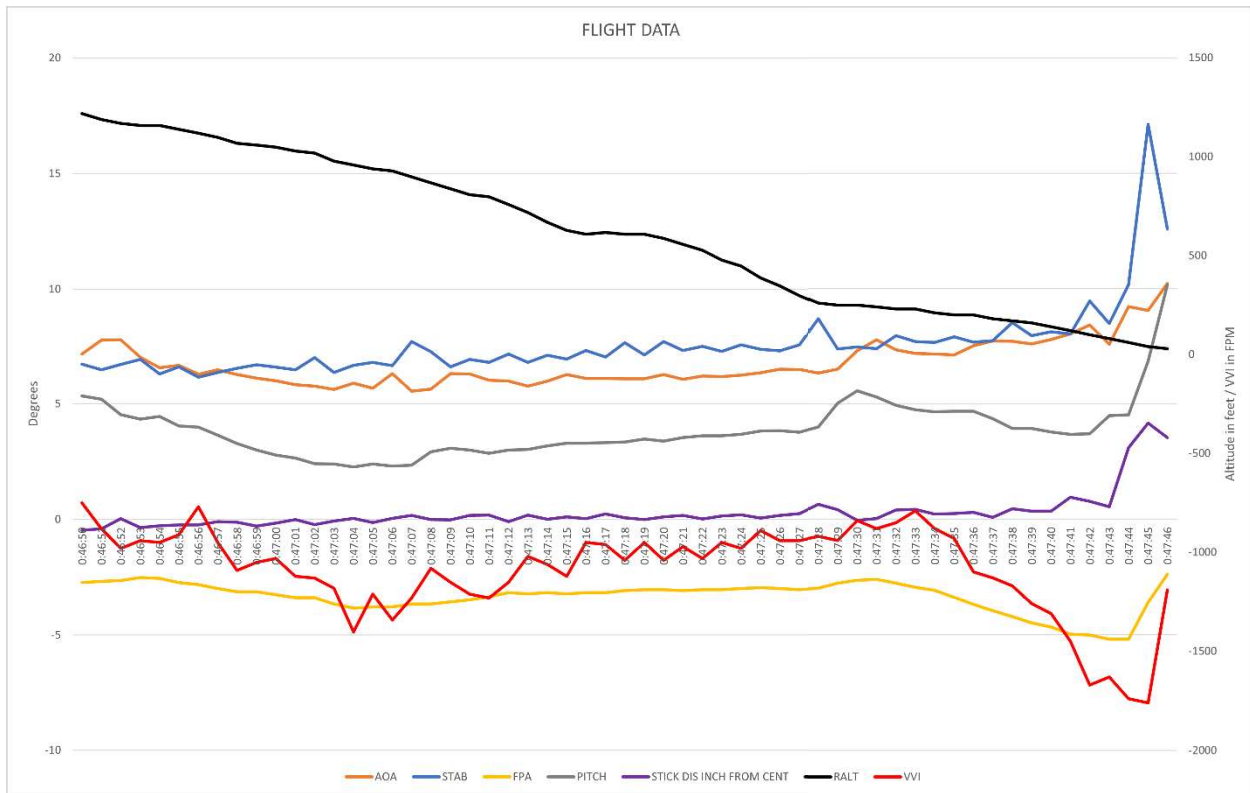
Figure 4. MA's MFOQA Flight Data. (Tab AA-7)

From 17:47:30L to 17:47:44L, there was a slight aft stick motion from approximately one-half-inch aft stick deflection to one-inch aft stick deflection. During this same time, the MA's angle of attack (AOA) increased from 7.7 degrees (ideal is 7 degrees) to 9.2 degrees, and the MA's pitch indication decreased from 5.5 degrees nose high (NH) to 3.7 degrees NH (Figure 4 below and Tab AA-7). Moving the control stick aft while the AOA increases and pitch decreases indicates the aircraft is approaching stall onset due to thrust deficiency (Tab AA-6). Additionally, the MP never briefed the vertical velocity indicator (VVI) as required by the B-1B Flight Manual, so the aft station MOSO and MDSO would not have known what VVI indicates a normal VVI for the approach (Tabs N-4 and AA-7). Furthermore, they were not instructed to monitor VVI for the approach (Tab N-4). The aft station can reference VVI in "Prime Data" at the top of the tactical display but would have to select VVI to be displayed as it is normally not shown (Tab AA-7). The radar altimeter was turned on during the Descent Before Landing checklist, but the "bugged," or commanded, altitude was never changed from 400ft to an altitude that would assist on the approach in accordance with B-1B procedures, typically 200ft (the DA) (Tab AA-7). Had either pilot set the radar altimeter bug to 200ft, they would have received a MIN DESN HGT (minimum decision height) light when the radar altimeter indicated 200ft AGL, corresponding to the DA for the approach to Rwy 13 (Tab AA-7 to AA-8). Additionally, neither the MP nor the MIP bugged their altitude MSL for what they believed to be the DA for the ILS approach to Rwy 13 (Tab AA-7 to AA-8). Instead, their altitude bug was set to 5,300ft MSL, which did not assist with the final segment of the approach (Tab AA-8). The MDSO testified he was not performing a crosscheck on the final approach and, instead, referencing the After Landing checklist on his EFB (Tab V-31.10).

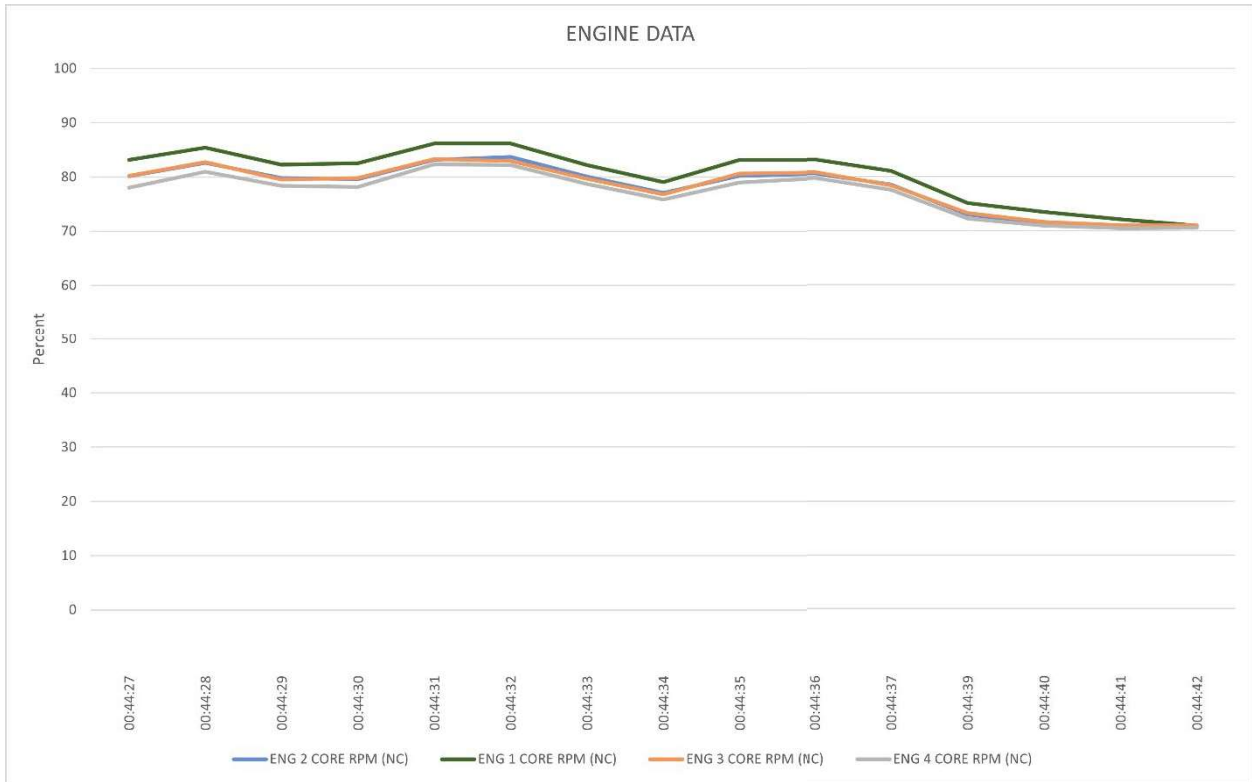
Figure 5. FELON 01 MFOQA Engine Data (Last 15 Seconds). (Tab AA-17)

FELON 01’s flight data, compared to the MA’s engine data, shows a stark juxtaposition. In the final 15 seconds of flight for FELON 01, their core rpm increased and decreased several times, indicating a proper composite crosscheck from the LP (Figure 5 below) (Tab AA-7). In the final 24 seconds of the MA’s flight, their Power Lever Angle (PLA) and core rpm do not notably change, even though the MA’s performance indicators are trending in a sub-optimal direction. This indicates a lack of composite crosschecking from the MP and MIP. Figure 5, below, is FELON 01’s engine data for the last 15 seconds of their flight. Figure 6, below, is the MA’s engine data for the last 24 seconds of their flight.

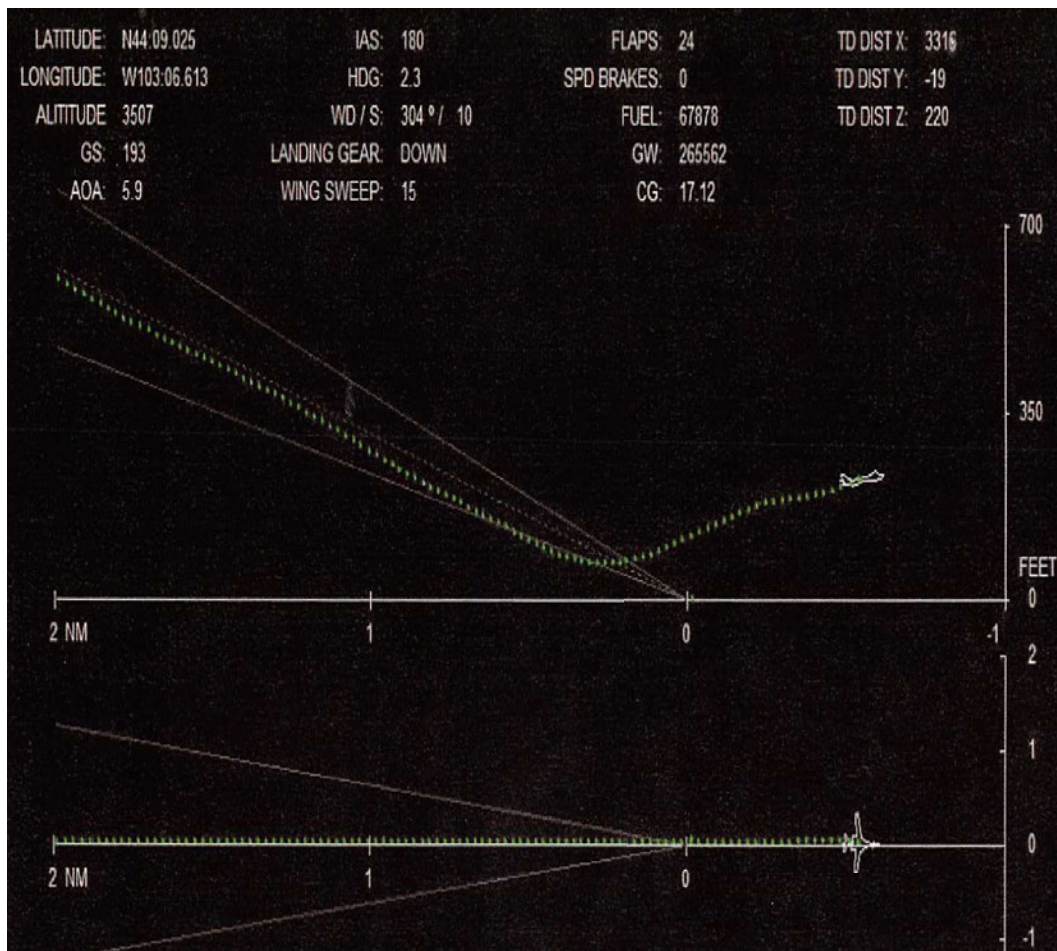
Figure 7. “Go around” simulation at 180ft AGL. (Tab AA-15)

The MIP called “climb, climb, climb” at 17:47:42L (Figure 8, below, at Tab S-23) and again “climb” at 17:47:44L (Figure 9, below, at Tab S-23) (Tabs N-9 and V-39.12). After the final “climb” call, the MP selected MAX (afterburner) on the throttles and pulled the control stick aft at 17:47:44L (Tabs V-29.5, V-39.12, and AA-6). Due to the excessive sink rate and late recognition, the MA was unrecoverable and out of control (Tab AA-15). Based on the Board’s reconstruction in a flight simulator, as shown in Figure 7, the MA would have been recoverable had a “go around” been initiated 20ft below the DA and at 17:47:38L (Tab AA-15). In the simulator, the Board initiated the “go around” from below the appropriate glideslope but prior to excessive sink rate development (Tab AA-15). The “go around” was successful in military (MIL) power, or the highest engine power without afterburner (Tab AA-15). The aircraft’s descent was arrested at 50ft AGL, and the aircraft was able to climb away from the ground safely (Tab AA-15).

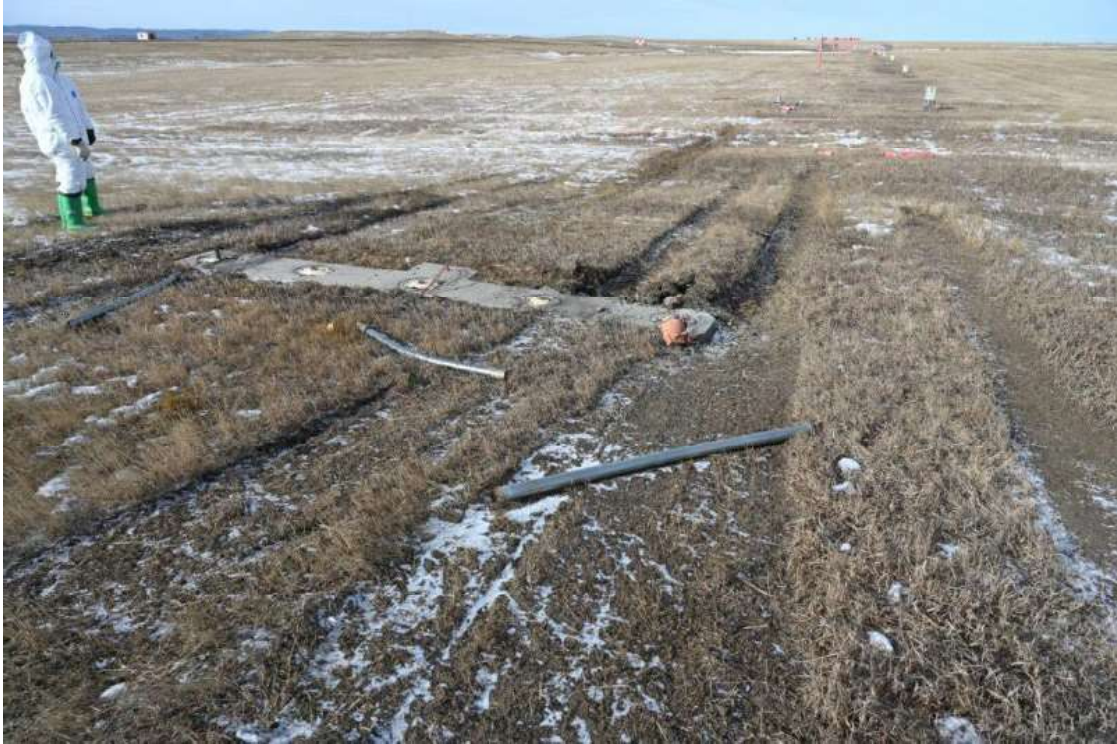
The MA impacted the ground prior to the overrun for Rwy 13 at 17:47:45L (Tabs S-2 and AA-7). The MDSO felt two distinct impacts (Tab V-31.11). The aft radome struck the ground due to exceeding 9 degrees AOA at approximately 17:47:45L and 100ft prior to the overrun for Rwy 13 (Tabs S-2, S-9, and AA-9 to AA-10). The second impact felt by the MC was from the main landing

gear striking the ALS 90ft prior to the overrun at approximately 17:47:46L (Figure 10, below, and Tab S-2). According to testimony, the crew compartment lost power after the first impact and went dark (Tabs V-29.5 and V-31.11). The MA continued to skid along the ground, over the overrun, and onto Rwy 13. From the initial touchdown, the MA continued for approximately 5,000ft along the runway with a slight left (easterly) vector (Figure 11, below, and Tab S-7) and eventually came to a rest between taxiway Foxtrot and taxiway Delta on the infield (Figure 12, below, and Tab S-6). The aircraft fuselage was engulfed in flames, and the MA is deemed a total loss (Tab P-4).

Figure 10. Initial Touchdown Point 100 feet Prior to Rwy 13 Overrun (looking North). (Tab S-2)

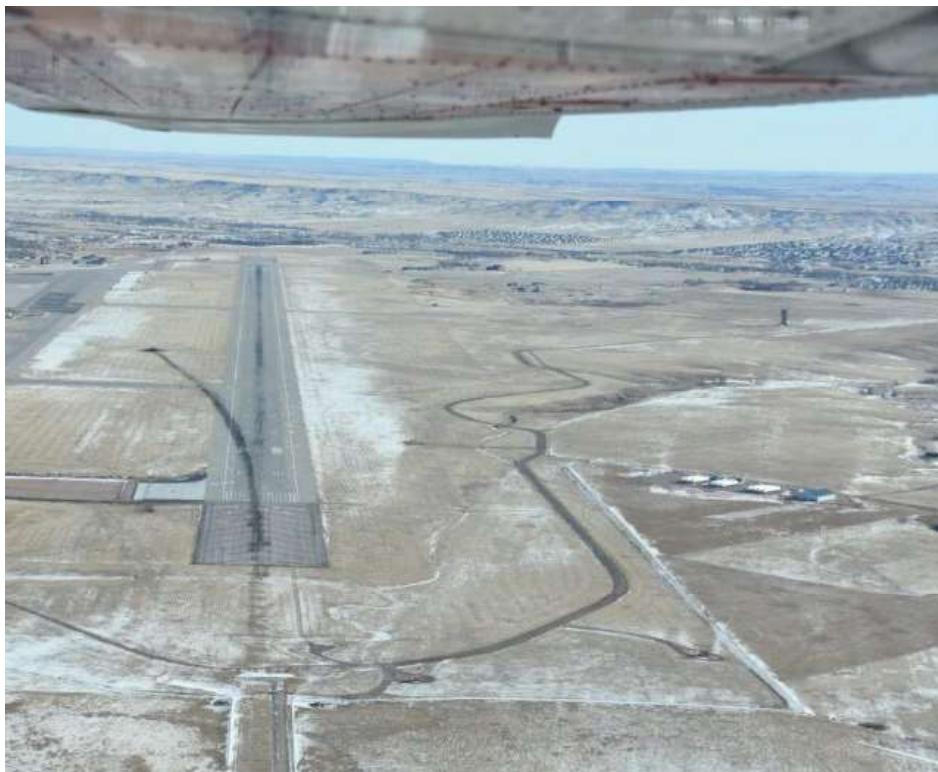
Figure 11. Final Trajectory of MA (looking South). (Tab S-7)

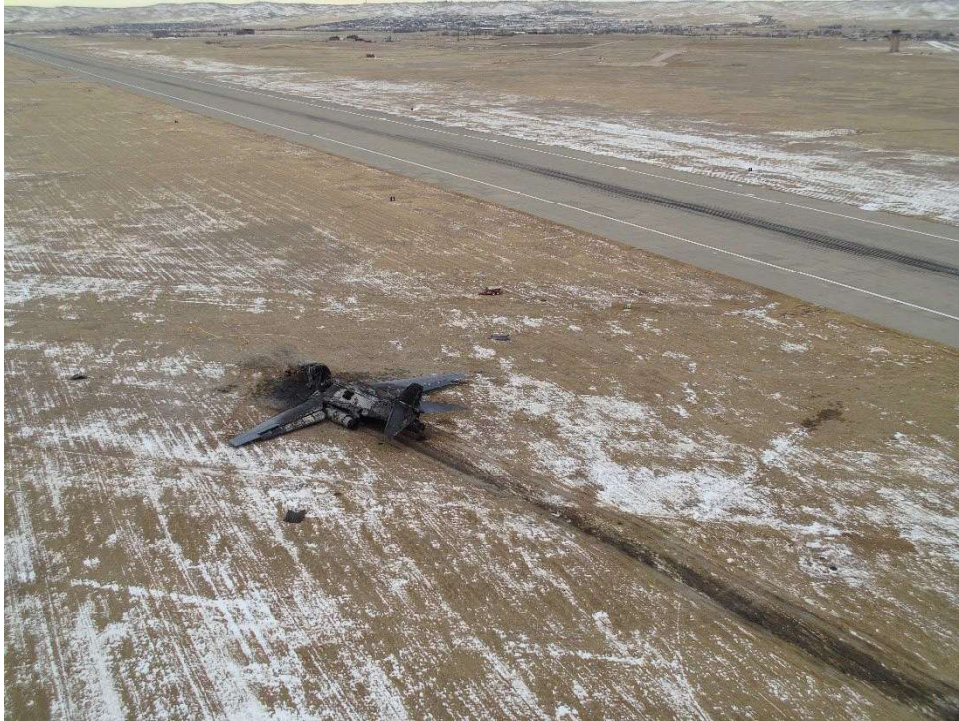
Figure 12. Final Resting Place of MA. (Tab S-6)

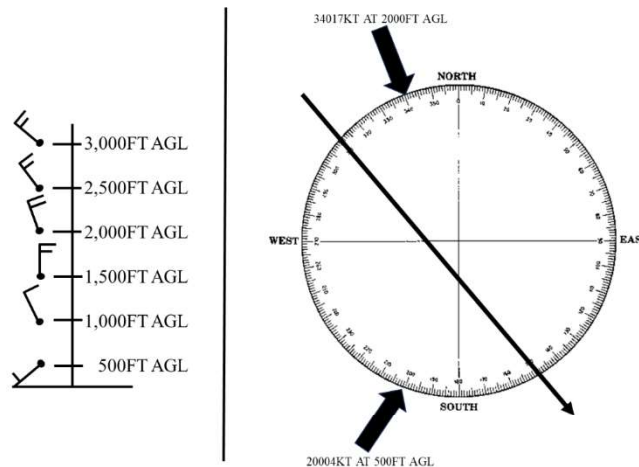
Figure 12. Performance Enhancing Wind shear (Tab AA-4)

During the MA's descent, the winds shifted from north-northwest at 15-20kts aloft to south-southwest at 0-5kts near the surface. As a result, the MC experienced a transition from a 17kt tailwind to a 4kt crosswind (Tab AA-4). When an aircraft crosses the shear plane and loses the tailwind, lift increases, and the aircraft climbs above the glide path. The pilot's reaction can be an overcorrection, which can lead to a descent below the glide path without enough altitude to correct. The result in these situations is often the classic high sink rate and hard landing (Tab W- 12 to W-21).

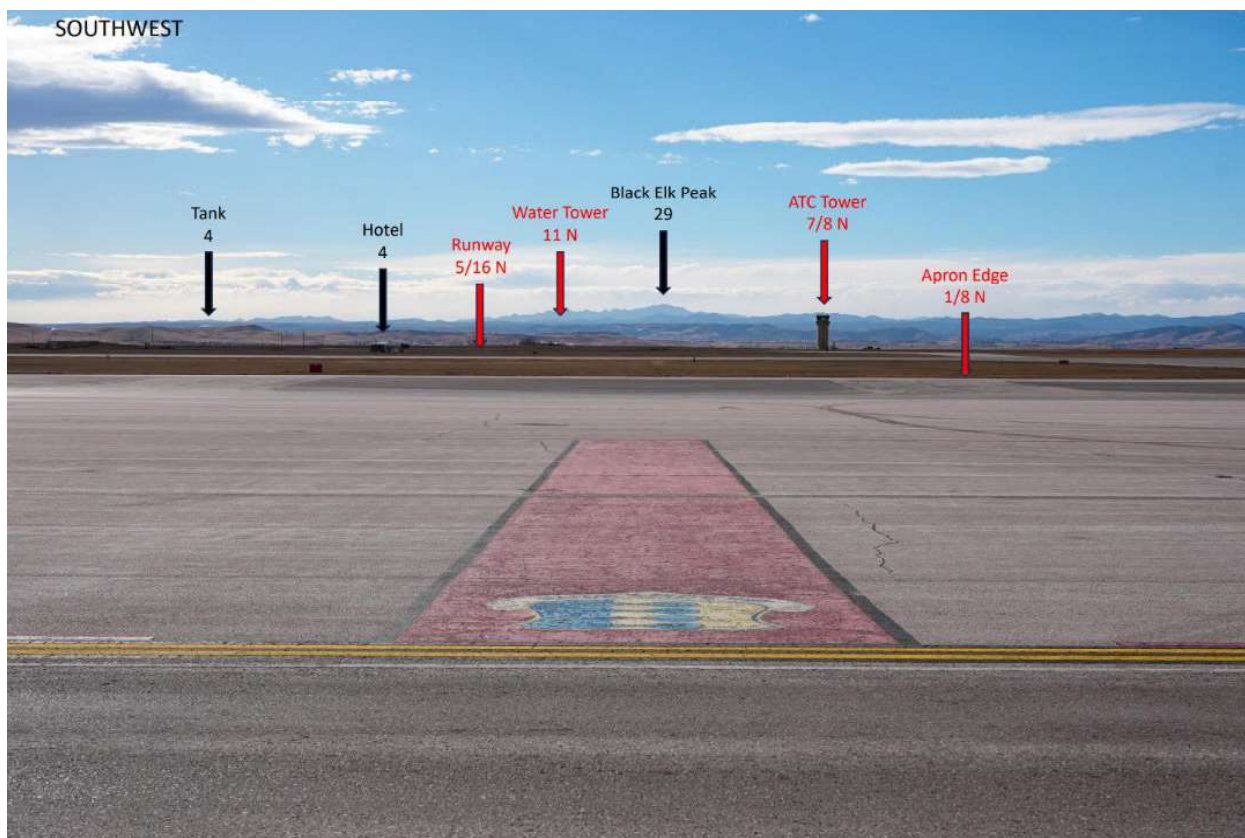
Figure 14. Weather Flight Visual References (Tab F-29)

The weather flight primarily completed visibility observations via a manual observing method (Tabs V-16.5 and V-21.5). Prevailing visibility is observed with un-aided vision (i.e., no binoculars or night vision goggles) from a designated point of observation that permits the weather technician to evaluate the horizon circle at the surface (Tab BB-10.10). The weather flight's designated point of observation is toward the middle of the airfield, slightly closer to the threshold of Rwy 31 (Tab F-21 to F-32). From the observation point, weather technicians cannot see the exact touchdown zone of either runway, which has limited visibility to the northeast and southeast due

to buildings (Tab W-5). From there, a visibility reference tool is utilized to complete these manual observations where the distance and direction from the observation point are marked and whether the markers are day or nighttime aids (Tab BB-10.5).
