**UNITED STATES AIR FORCE**  
**AIRCRAFT ACCIDENT INVESTIGATION**  
**BOARD REPORT**

**CV-22B Osprey/ T/N: 08-000039**  
**27TH SPECIAL OPERATIONS WING**  
**CANNON AIR FORCE BASE (AFB), NEW MEXICO**

**LOCATION: INYOKERN AIRFIELD, CA**  
**DATE OF ACCIDENT: 17 AUGUST 2023**  
**BOARD PRESIDENT: COLONEL JEFF D. MCMASTER**  
**Conducted IAW Air Force Instruction 51-307**

**CV-22B, TN 08-000039  
INYOKERN AIRFIELD, CALIFORNIA  
17 AUGUST 2023**

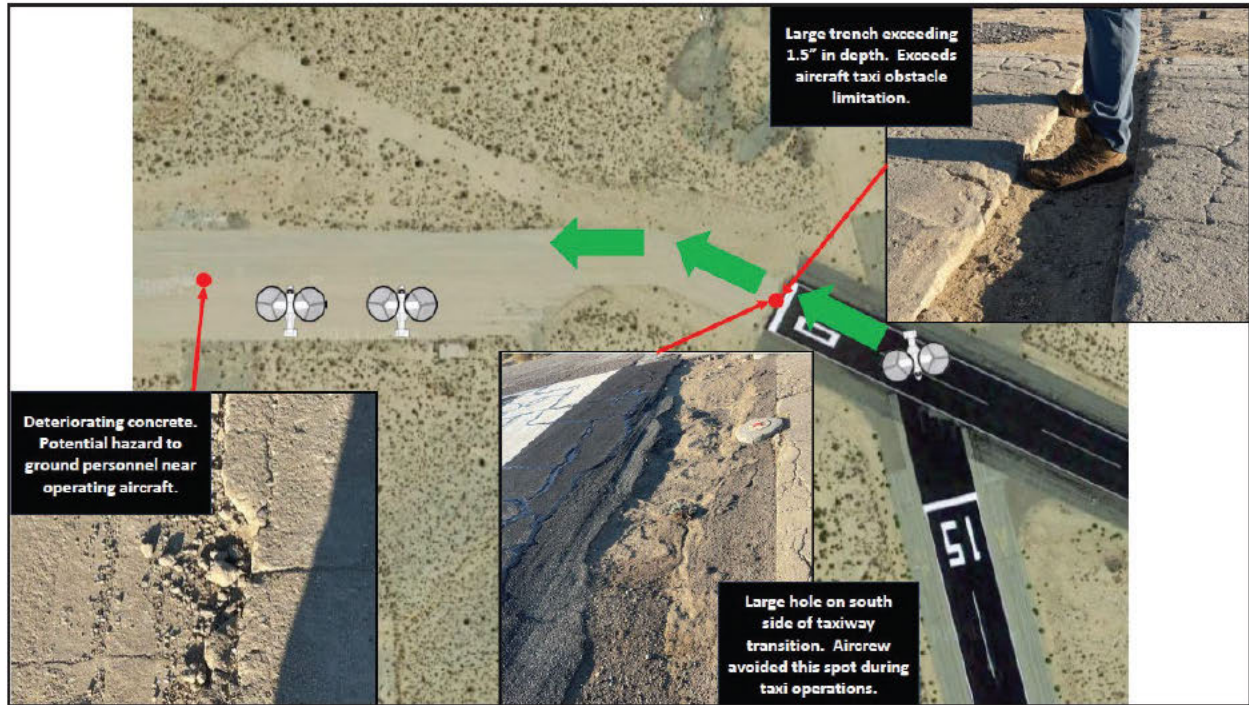
Figure 2.1 – Ramp Conditions

Inyokern also has a large concrete apron located on the Northern end of the airfield off the approach end of RWY10 (Figure 1.0) (Tab Z-1). This parking location is not used during normal airfield operations. No taxi lines or airfield markings are present, and no airfield lighting is available for nighttime operations (Figure 2.3). The apron’s concrete surface is deteriorating with loose gravel, uneven surfaces, large cracks, and chunks of concrete prevalent throughout (Tab Z-1). Additionally, an approximately two-inch deep trench separates the parking apron from the approach end of RWY10 (Tab Z-1). On the south side of this transition is a larger hole requiring aircrew to offset to the north side of the taxiway to avoid (Tab Z-1). This trench exceeds the 1.5-inch taxi obstacle height restriction listed in the 1V-22(C)B-1 aircraft technical orders; “traversing or taxi over obstacles greater than 1.5 inches in height is prohibited” (Tab BB). Parking apron conditions are shown in Figure 2.1 below (Tab Z-1).

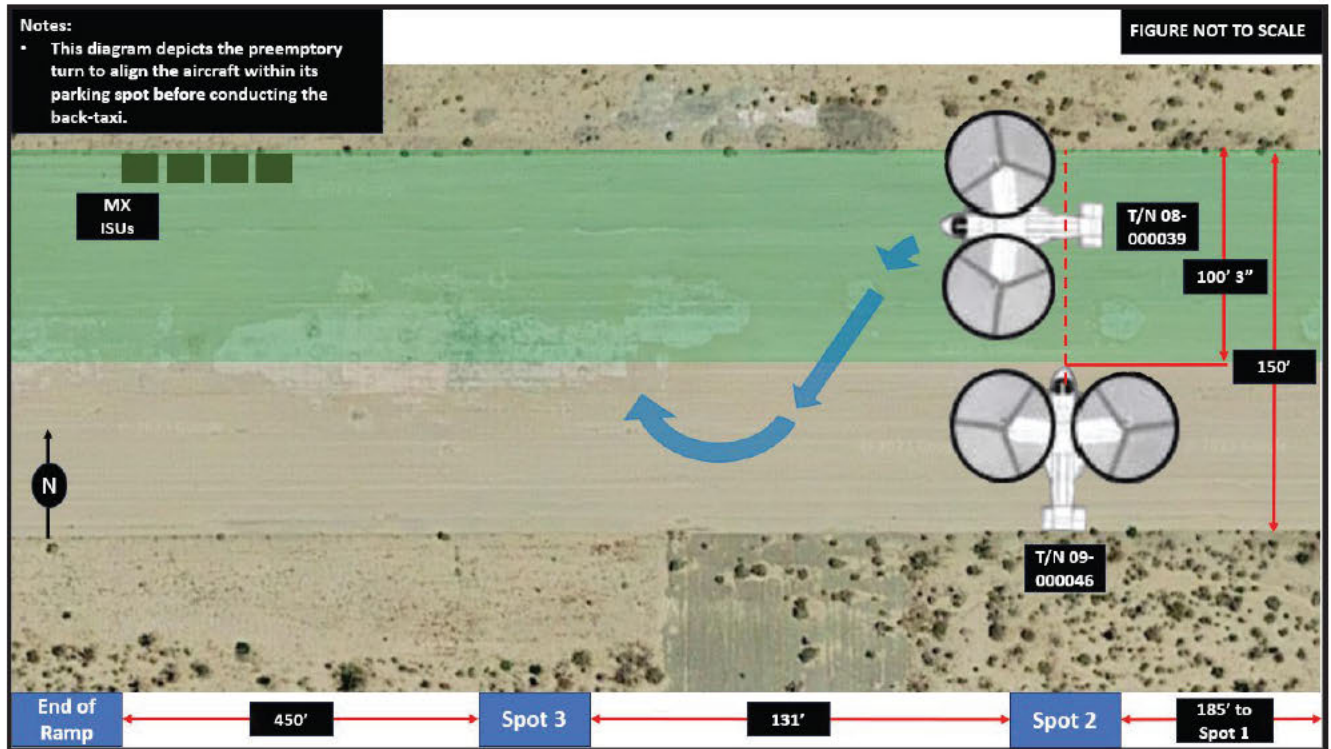
Figure 3.0 – Parking Ramp w/Preemptory Turn

Taxiing west to park, the MC offset to the northside of the parking ramp to provide sufficient taxi clearance from the two parked aircraft on the southern side of the parking apron (Tab N-1 and Tabs V-1 to V-2). After passing abeam T/N 09-000046, the aircraft parked in Spot 2, the MCP executed a left-hand turn—towards the south—to position the aircraft for reverse taxi into park, as shown in Figure 3.0 (Tab V-1 to V-3, and Tabs V-6 to V-8). Prior to initiating the left-hand turn, the MCP announced “left turn” (Tab N-1). The MP, sitting in the left seat, responded with “Roger” but never confirmed that the aircraft was clear of the adjacent aircraft (Tab N-1 & Tab V-1). The MP also remembered feeling “uncomfortable” during the execution of this maneuver (Tab V-1). The aircraft’s proprotors contacted the proprotor of T/N 09-000046, resulting in significant damage to both aircraft (A-3). Debris from the MA’s spinning proprotors was thrown toward MM1, positioned on the south side of parking Spot 3 (Tab A-3 and V-6). MM1 dove for cover hitting his head on the ground, was transported to the hospital, and was diagnosed with a right shoulder injury and a concussion (Tabs V-6 and V-11).

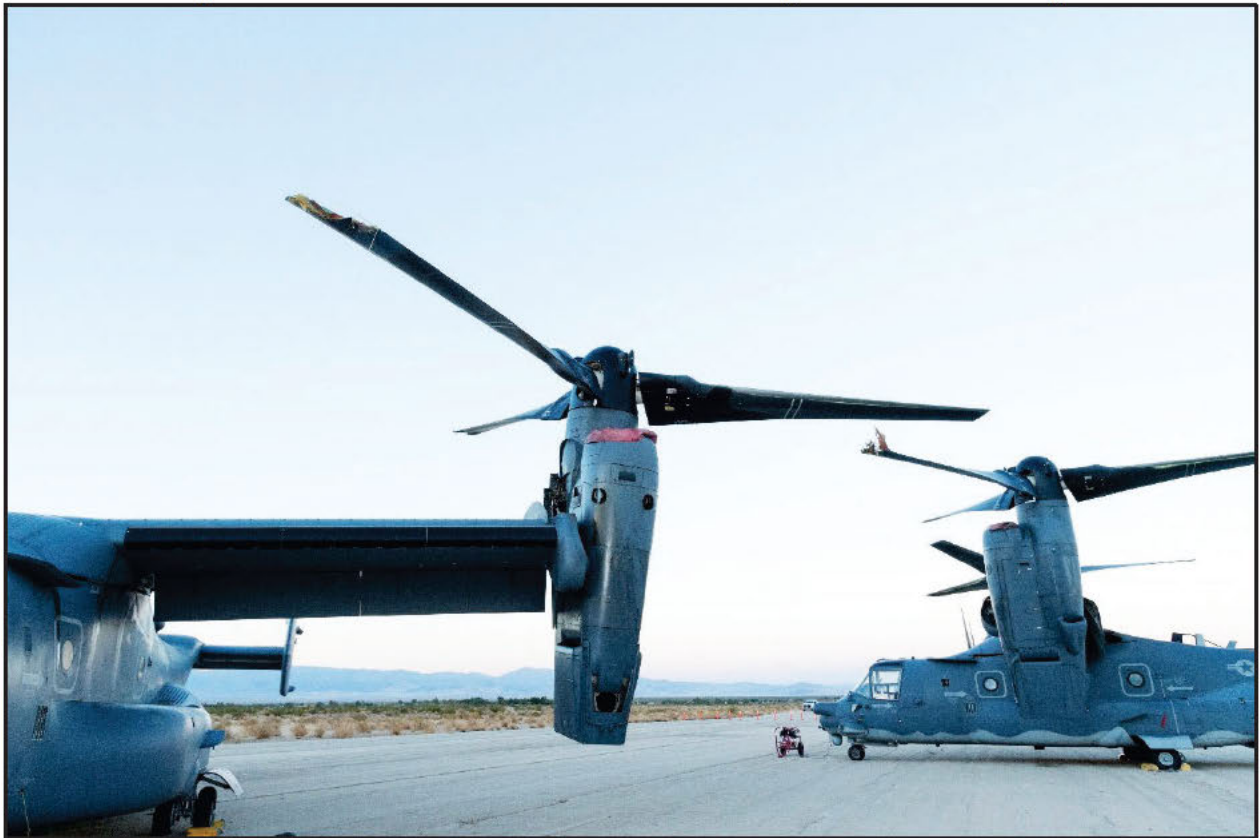
Figure 7.0 – MA's and Parked Aircraft's Proprotor Blade Damage

Two of the MA's left-hand proprotor blades were damaged beyond repairable limits (Tab P-1). The parked aircraft's left-hand green proprotor blade was damaged beyond repairable limits (Tab P-1). No other airframe structures were affected by the incident. All aircraft systems were operating within allowable limits at the time of the mishap; no further checks were conducted (Tab D-1).

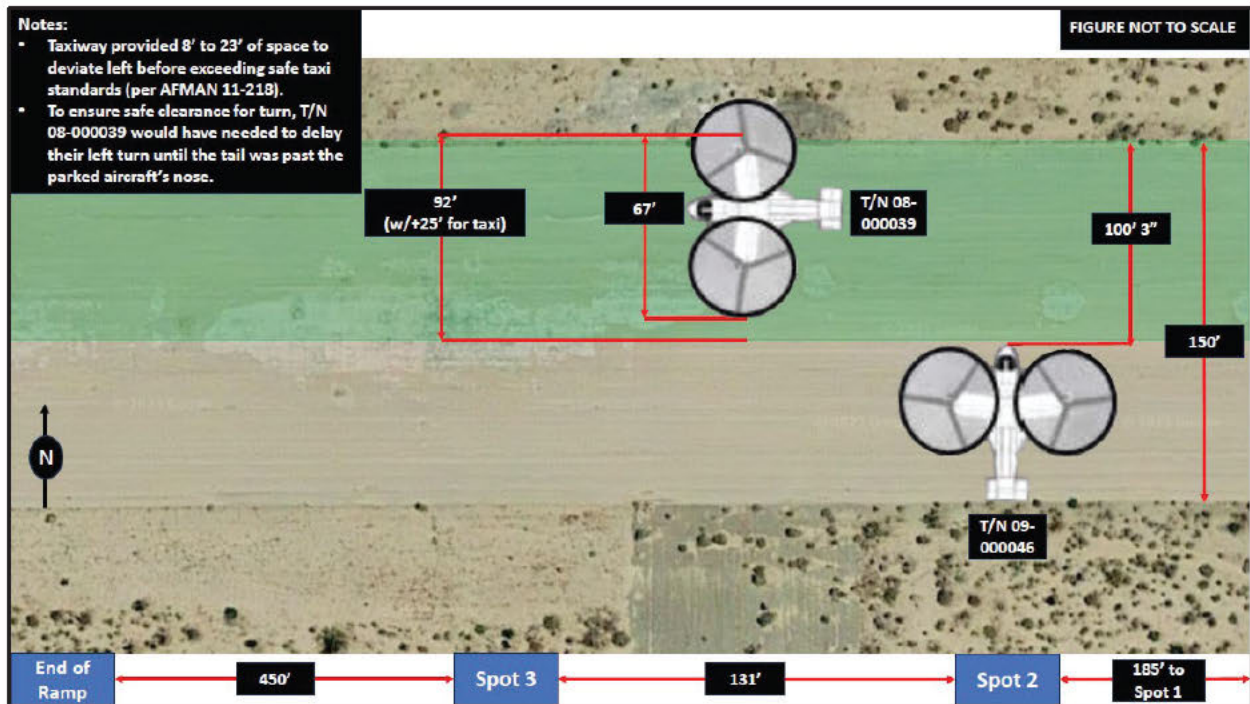
Figure 8.1 – Parking Ramp Dimensions

The MC failed to ensure adequate horizontal taxi clearance with the stationary aircraft as directed by AFMAN 11-218. While maneuvering the MA into position to reverse-taxi, the MCP initiated a pre-mature left-hand turn before the MA had obtained sufficient clearance past the parked aircraft. This placed the MA on a trajectory that would penetrate the required 10 horizontal feet of taxi clearance necessary—when taxiing with wing walkers—as directed by AFMAN 11-218.

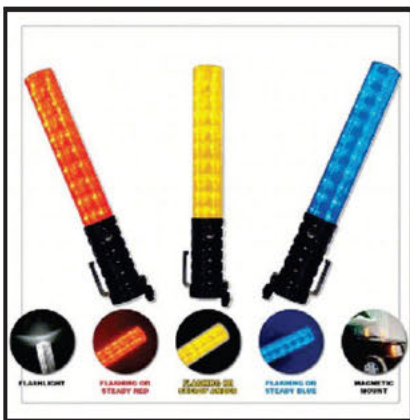
**Figure 9.0 – Daylight Fluorescent Wands**

As an example, the wing walkers typically provided either no signal or inconsistent hand signals to notify taxiing aircrew of sufficient obstacle clearance while taxiing. This is in deference to the “Affirmative” signal with the right hand raised as directed by AFMAN 11-218 to confirm adequate clearance between aircraft during taxi operations (Figure 5.1). This lack of standardization introduced a false sense of security by the crew when no signals were provided by the wing walkers. Additionally, the aircraft marshaller and wing walkers did not use the required daylight-fluorescent wands available in their deployed kits as directed by AFMAN 11-218 for signaling by all participating ground personnel during daylight hours. Figure 9.0 shows an example of daylight-fluorescent wands directed for use by AFMAN 11-218 and Figure 9.1 shows the wands available to maintenance personnel at the time of the mishap. The inconsistent hand signals by ground personnel and lack of directed marshalling equipment were significant contributing factors in this mishap.
