UNITED STATES AIR FORCE
AIRCRAFT ACCIDENT INVESTIGATION
BOARD REPORT

F-16C, T/N 87-0358

DATE OF ACCIDENT: 30 APRIL 2024

SUMMARY OF FACTS AND STATEMENT OF OPINION
F16C, T/N 87-0358
HOLLOMAN AFB, NEW MEXICO
30 APRIL 2024

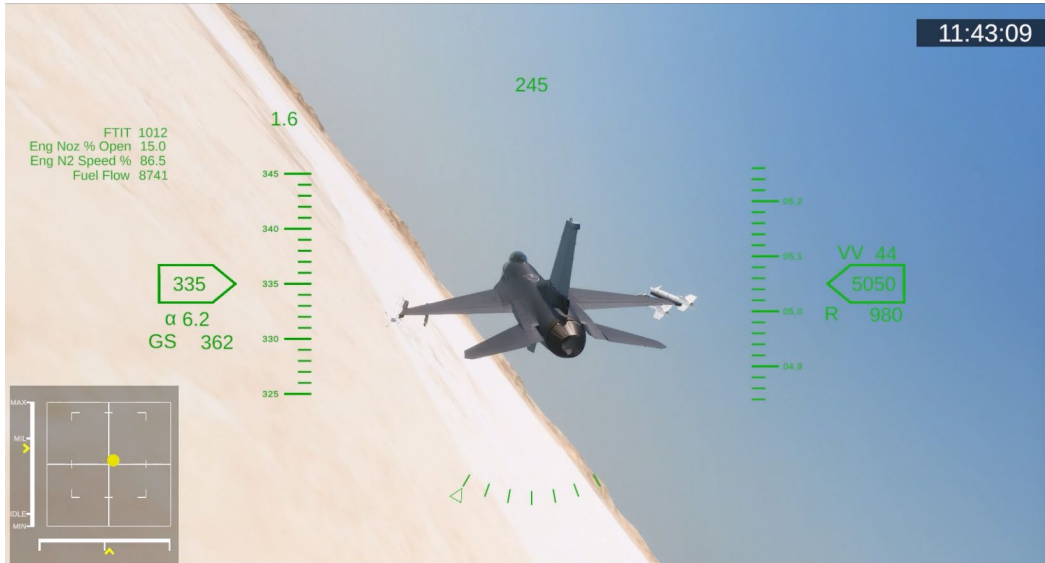
Figure 1. Recorded flight data animation frame capture at “bang” (Tab Z-6)

(Mil) power, or full engine output without AB augmentation. (Tabs V-1.7, Z-5, Z-6, and DD-1). The MP said he then heard a loud bang and felt a loss of thrust, violent shaking, and engine vibrations, so he immediately rolled out of his left, slightly climbing, turning to maintain aircraft control and analyze the situation. (Figures 1 and 2) (Tabs V-1.6 to V-1.8, Z-6, and BB-2 to BB-5).

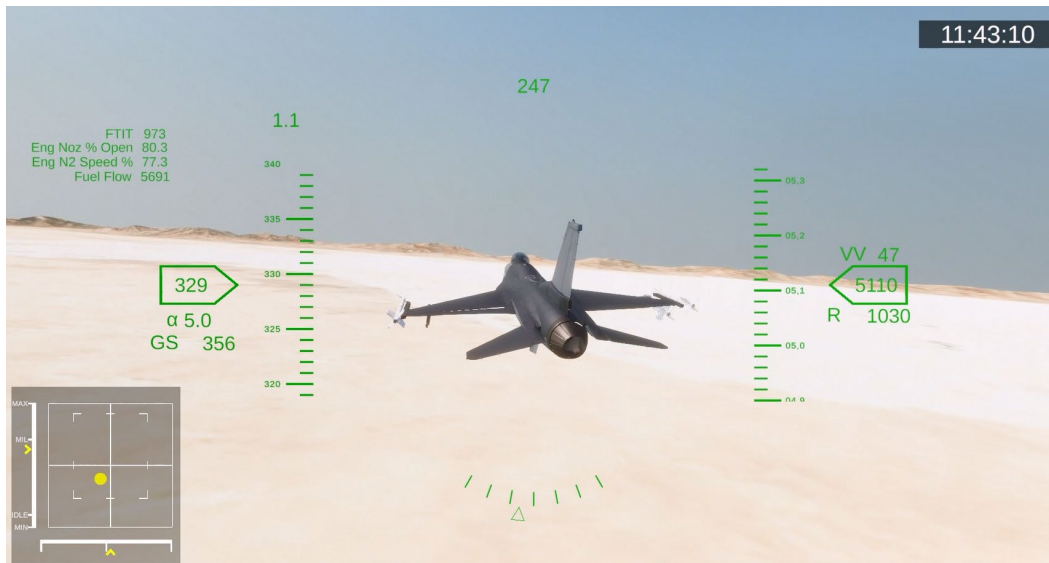
Figure 2. Recorded flight data animation frame capture right after “bang” (Tab Z-6)

When the MP heard the bang, felt the shaking, and began his roll-out, the MA was at 1,030 ft AGL with 329 KCAS about one nautical mile from the departure end of Runway 25 on a magnetic heading of 247 degrees. (Tabs V-1.6, V-1.8, Z-1, and Z-6). Recorded engine data showed subsequent rapidly decreasing engine revolutions per minute (RPMs) and a failure of the engine to respond to throttle movement. (Tabs V-1.8 and Z-7 to Z-10).

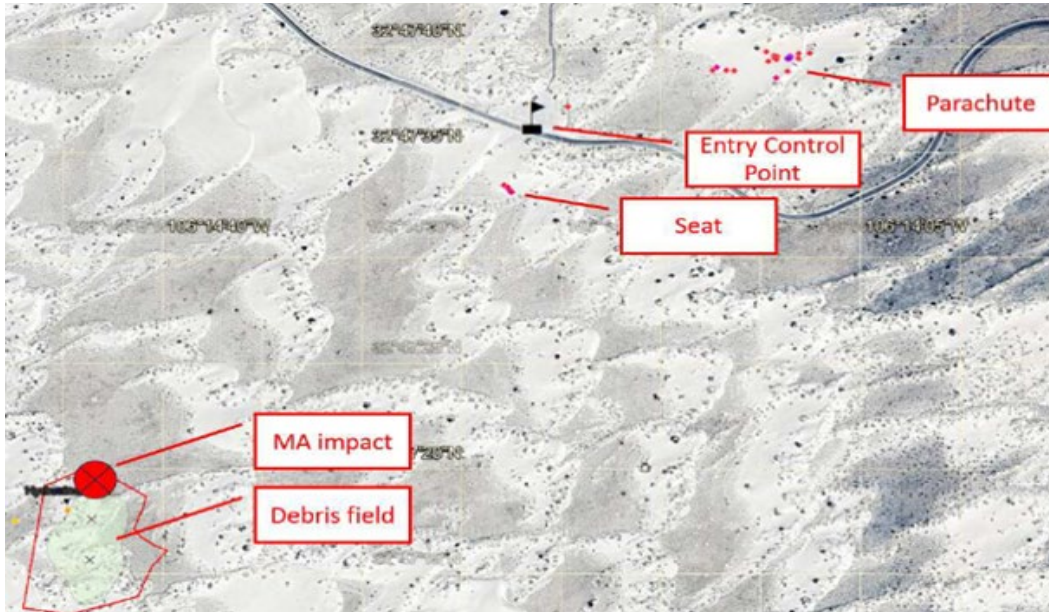
Figure 3. White Sands National Park impact and debris area (Tabs J-7 and Z-12 to Z-23)

L-1 to L-2). Within a minute, the MA crashed in White Sands National Park six and a half nautical miles southwest of the departure end of Holloman AFB's Runway 25. (Figures 3 and 4) (Tabs J-7, L-1 to L-2, N-9, N-14, and Z-11). The MA impacted a dune nose first and relatively level. (Tab S-1). A debris field spanned a large fan-shaped area with aircraft pieces scattered over 500 ft away. (Tabs J-6 and Z-12 to Z-23). There was a localized post-impact fire at the impact site. (Tabs N-5, N-9 to N-11, N-17, S-2, V1.10, and V-6.3). The seat, canopy, and centerline fuel tank were scattered to the northeast. (Tab J-7).

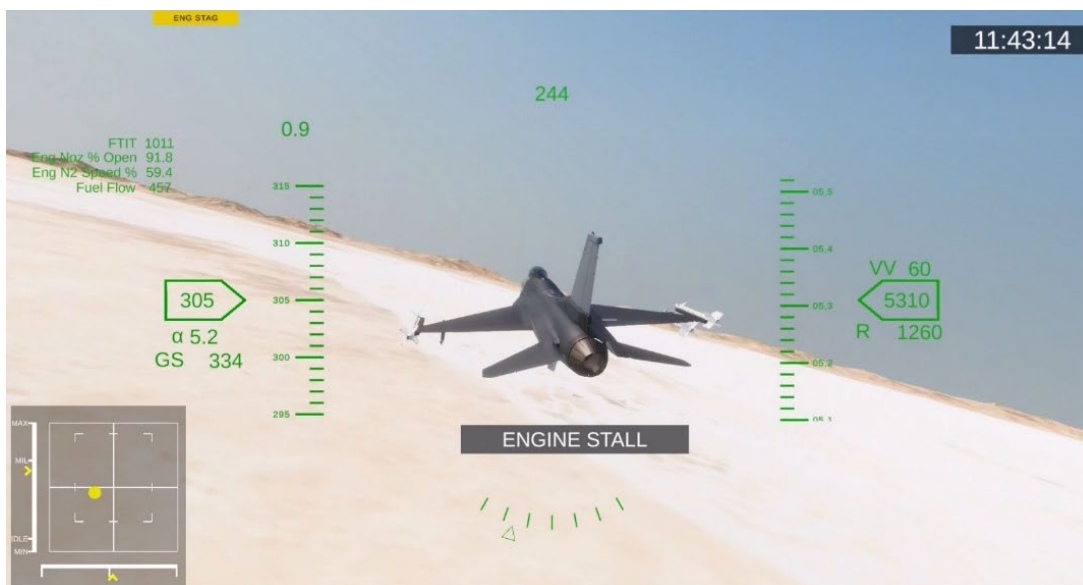
Figure 7. Recorded flight data animation frame capture (Tab Z-7)

Data recovered from the CSFDR showed that sixteen seconds after the MP moved the throttle from AB to the Mil power setting, the MA registered an engine loss of thrust. (Figure 7) (Tabs J-12 and Z-7). Data before that point showed normal in-flight engine parameters. (Tab J-12).

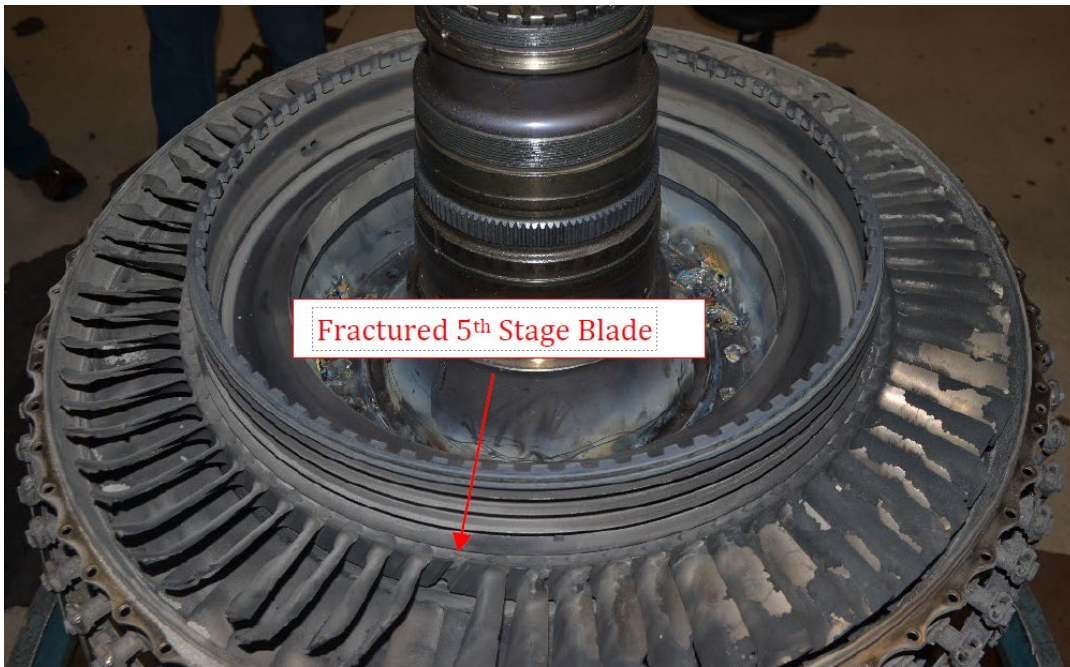
Figure 8. Fifth stage separated (or “fractured”) HPC blade (Tab J-57)

The AFLCMC Propulsion Directorate at Tinker AFB assisted in the teardown and inspection of the MA's recovered engine. (Tabs J-57, J-68 to J-69, and DD-2). The technical and engineering analysis showed no pre-impact damage forward of the fifth stage. (Tab J-69). The report concluded the single fifth stage HPC blade separated, (Figure 8) causing severe secondary damage to other blades in the fifth stage and several following stages. (Tab J-68).

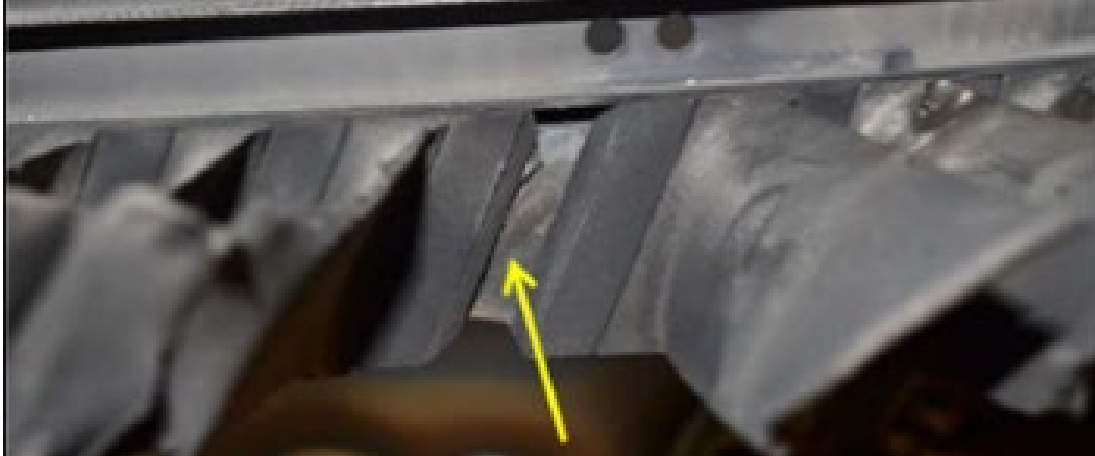
Figure 9. Fifth stage separated (or “fractured”) HPC blade (Tab J-75)

As the engine manufacturer, P&W concluded the engine loss of thrust was caused by a significant disruption of airflow due to the fifth stage HPC blade separation. (Figure 9) (Tabs J-72 and J-73).

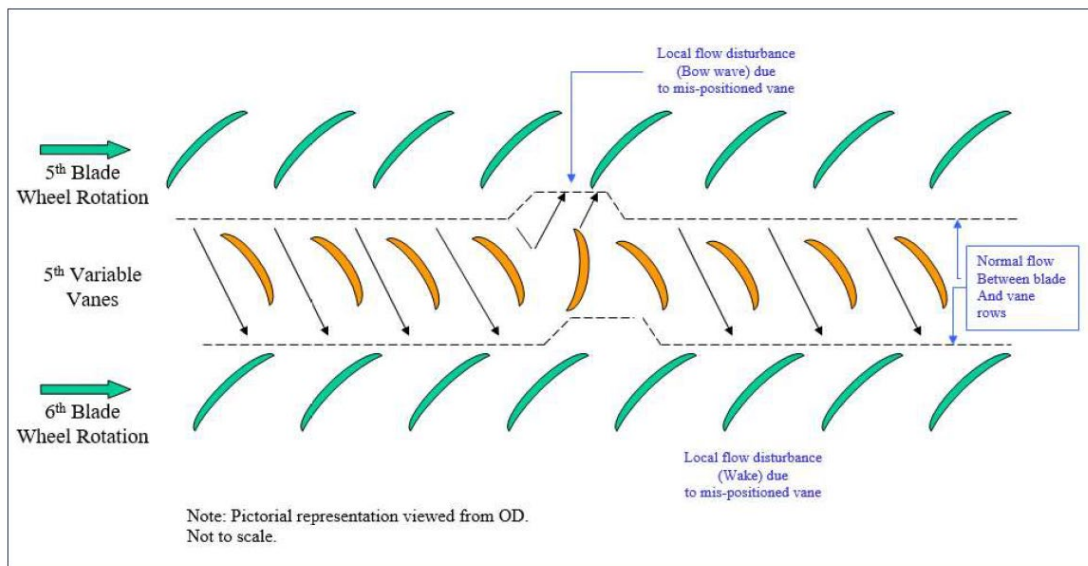
Figure 10. Representation of a turned fifth stage variable vane effect on blades (Tab J-106)

However, P&W also found airflow disturbances from a turned fifth stage variable vane, which over time, resulted in high-cycle fatigue of the blade. (Figure 10) (Tabs J-101 and CC-3 to CC-4).

The turned fifth stage variable stator vane produced abnormal aerodynamic forces, resulting in high-cycle fatigue and eventual separation of the fifth stage HPC blade. (Tabs J-73 and CC-3 to CC-4). Low amplitude, high-frequency elastic strains characterize HCF – an example would be an airfoil subjected to repeated bending. (Tab CC-4). The debris from the HPC blade separation caused a significant airflow disruption causing the engine loss of thrust at 1,030 ft AGL. (Tabs J-73, L-1 to L-2, and Z-6).

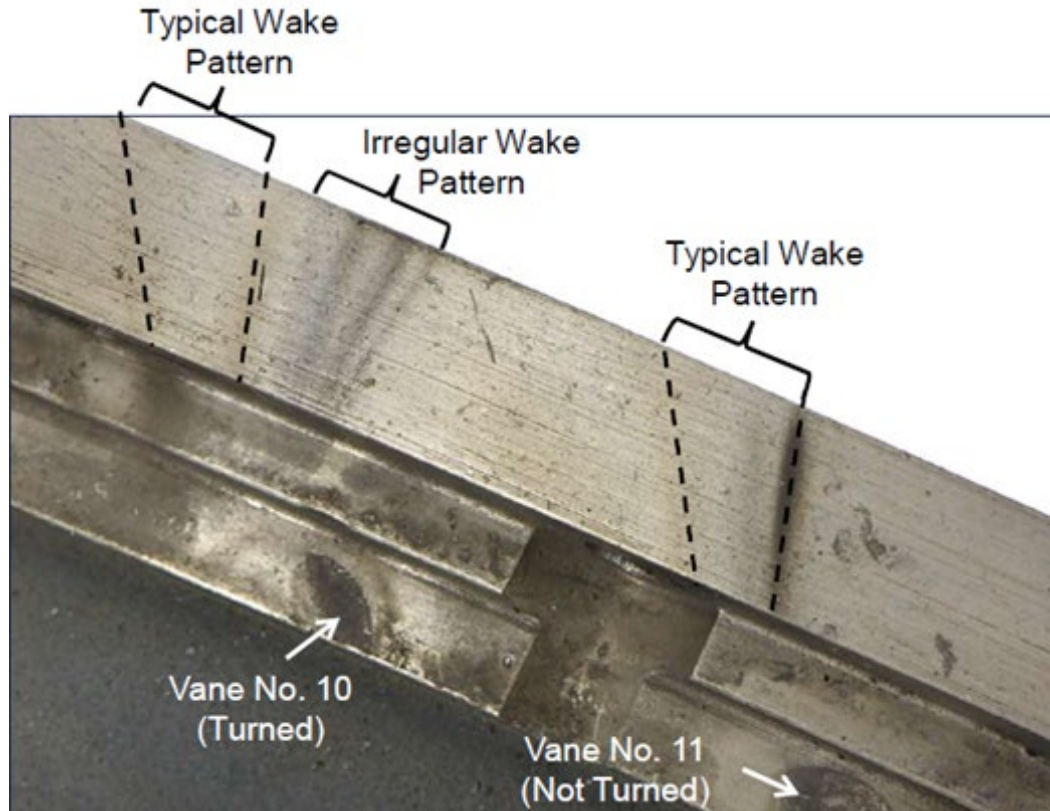
Figure 11. Irregular wake pattern from Vane No. 10 (Tab J-101)

A faint vane wake mark pattern (*i.e.* dirt deposits that occur during flow separation of upstream air) on the vane set’s shroud, or housing, was irregular, suggesting the number ten position vane operated in the turned position (about twenty-five degrees more open than adjacent vanes) before the blade fracture event. (Figure 11) (Tabs J-97 and J-101).

I find by a preponderance of the evidence that the aircraft mishap was caused by a misaligned or turned number ten position variable stator vane in the fifth stage of the MA's F100-PW-220 engine, resulting in the separation of a fifth stage fan blade.

The known “blind spot” of not inspecting the fifth stage when field procedures do not indicate damage in adjacent stages requires a deliberate risk assessment by the F-16 system program office. The risk assessment is based on the historical and anticipated probability of damage before scheduled maintenance compared to the severity of possible adverse effects. This deliberate risk assessment is informed by the limited time, manpower, and funding available to pull an engine out of an aircraft in the field, ship it to depot-level maintenance, perform a teardown, inspect it and make repairs (if any), reassemble it, ship it back to the field, and reinstall it into an aircraft.
