UNITED STATES AIR FORCE
GROUND ACCIDENT INVESTIGATION
BOARD REPORT

TYPE OF ACCIDENT: Pool Bathhouse Wall Mishap

LOCATION: Heritage Pool Bathhouse, Robins AFB, Georgia

DATE OF ACCIDENT: 22 July 2024

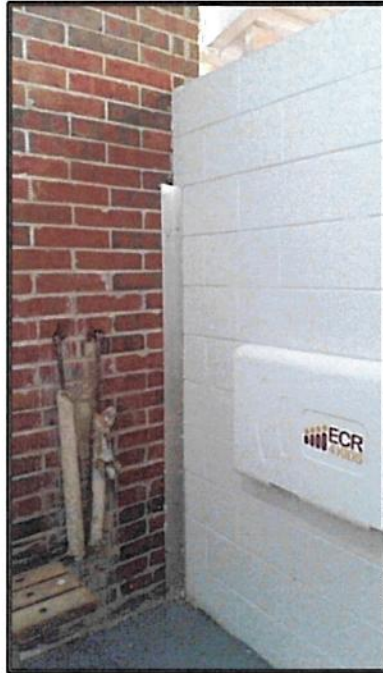
Figure 5.1: Emergency Repair to Block Wall in Women’s Restroom (Tab Z-13)

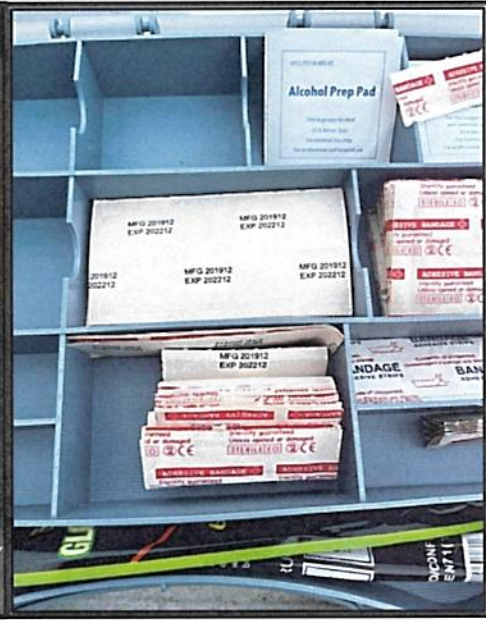
Figure 6.2: Expired First Aid Kit

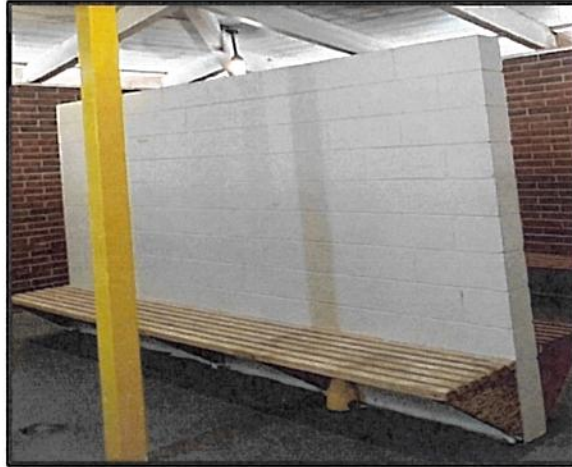
Figure 6.7: Partition Wall Prior to Mishap (Tab Z-9)

The MW was in the men's side of the facility and was an interior, non-load bearing wall constructed of hollow CMU block (Figure 6.7) (Tabs EE-7, and EE-10). The MW weighed approximately 3,308 pounds (Tab EE-20). The original design shows a single bench on the west side of MW; however, the actual MW, as pictured, has a wooden bench on each side (Tabs EE-8, and Z-9). One bench appears to be original, and the other appears newer (Tab EE-20). The base could not produce any records for installation of the second bench (Tab V-5.8 to V-5.9). Furthermore, evidence indicates no major work was accomplished at the bathhouse or to the MW since initial construction in 1969 (Tab V-1.4).

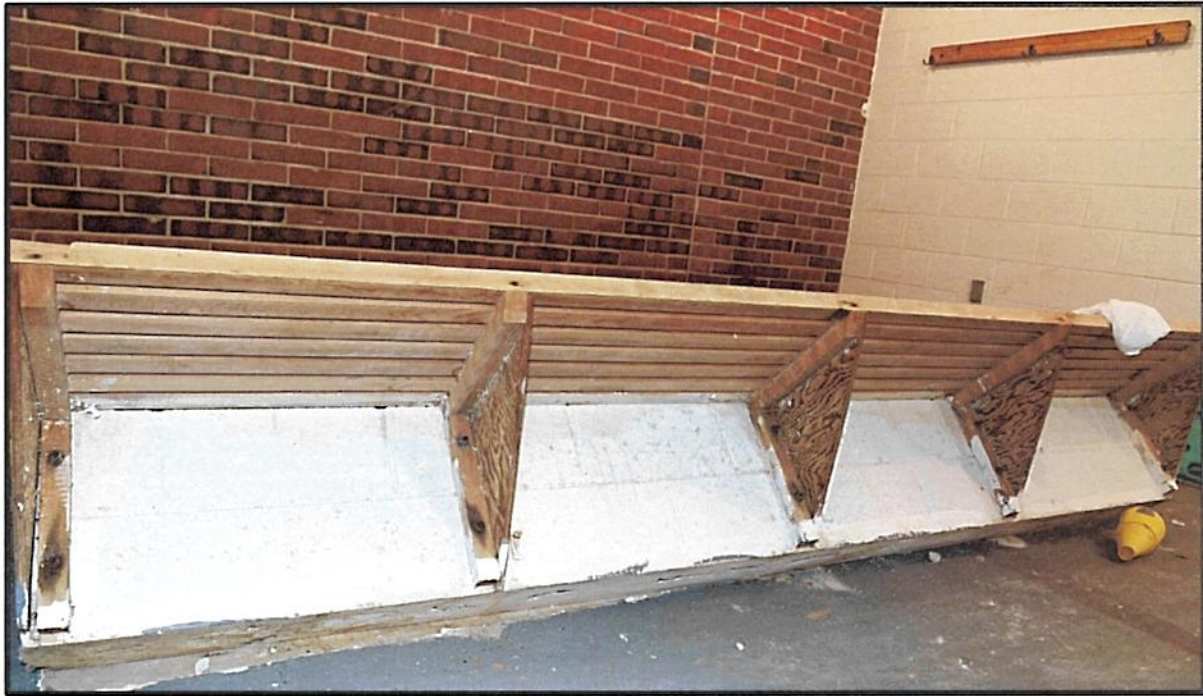
Figure 6.8: Partition Wall after Mishap (Tab Z-19)

Witness testimony and records review indicate no reported or known deficiencies with the MW prior to the mishap (Tab V-1.13, and V-5.9). At approximately 1500L on 22 July 2024, the MW fell in a westward direction (Tab EE-13). A structural evaluation and investigation concluded the designer of record did not follow the code requirements of the *Standard Building Code*, 1965 Edition (Tab EE-24). IAW the *Standard Building Code*, the non-load bearing hollow CMU partition wall required some type of lateral support, which was absent, such as rebar anchors connecting the base of the MW to the floor or vertical supports attaching the sides of the MW to the floor and/or ceiling, to prevent overturning (Figure 6.8) (Tab EE-11, and EE-24). Nonetheless, the MW should not have fallen without an external force being applied to it (Tab EE-20 to EE-21, and EE-24).

As a result of the MW falling, the MW broke along 5-6 separate horizontal joints (Tab Z-4). Additionally, several individual blocks or pieces of block separated from the MW because of the fall and/or recovery operations to free MM1 and MM2 (Tabs V-7.17 to V-7.18, and Z-4). The MW is not repairable. (Tab Z-4). The bench attached to the back exterior wall is also damaged, presumably due to the impact of the MW striking the bench (Tab Z-4). No other visible damage occurred to the facility beyond the MW and bench (Tab Z-4).

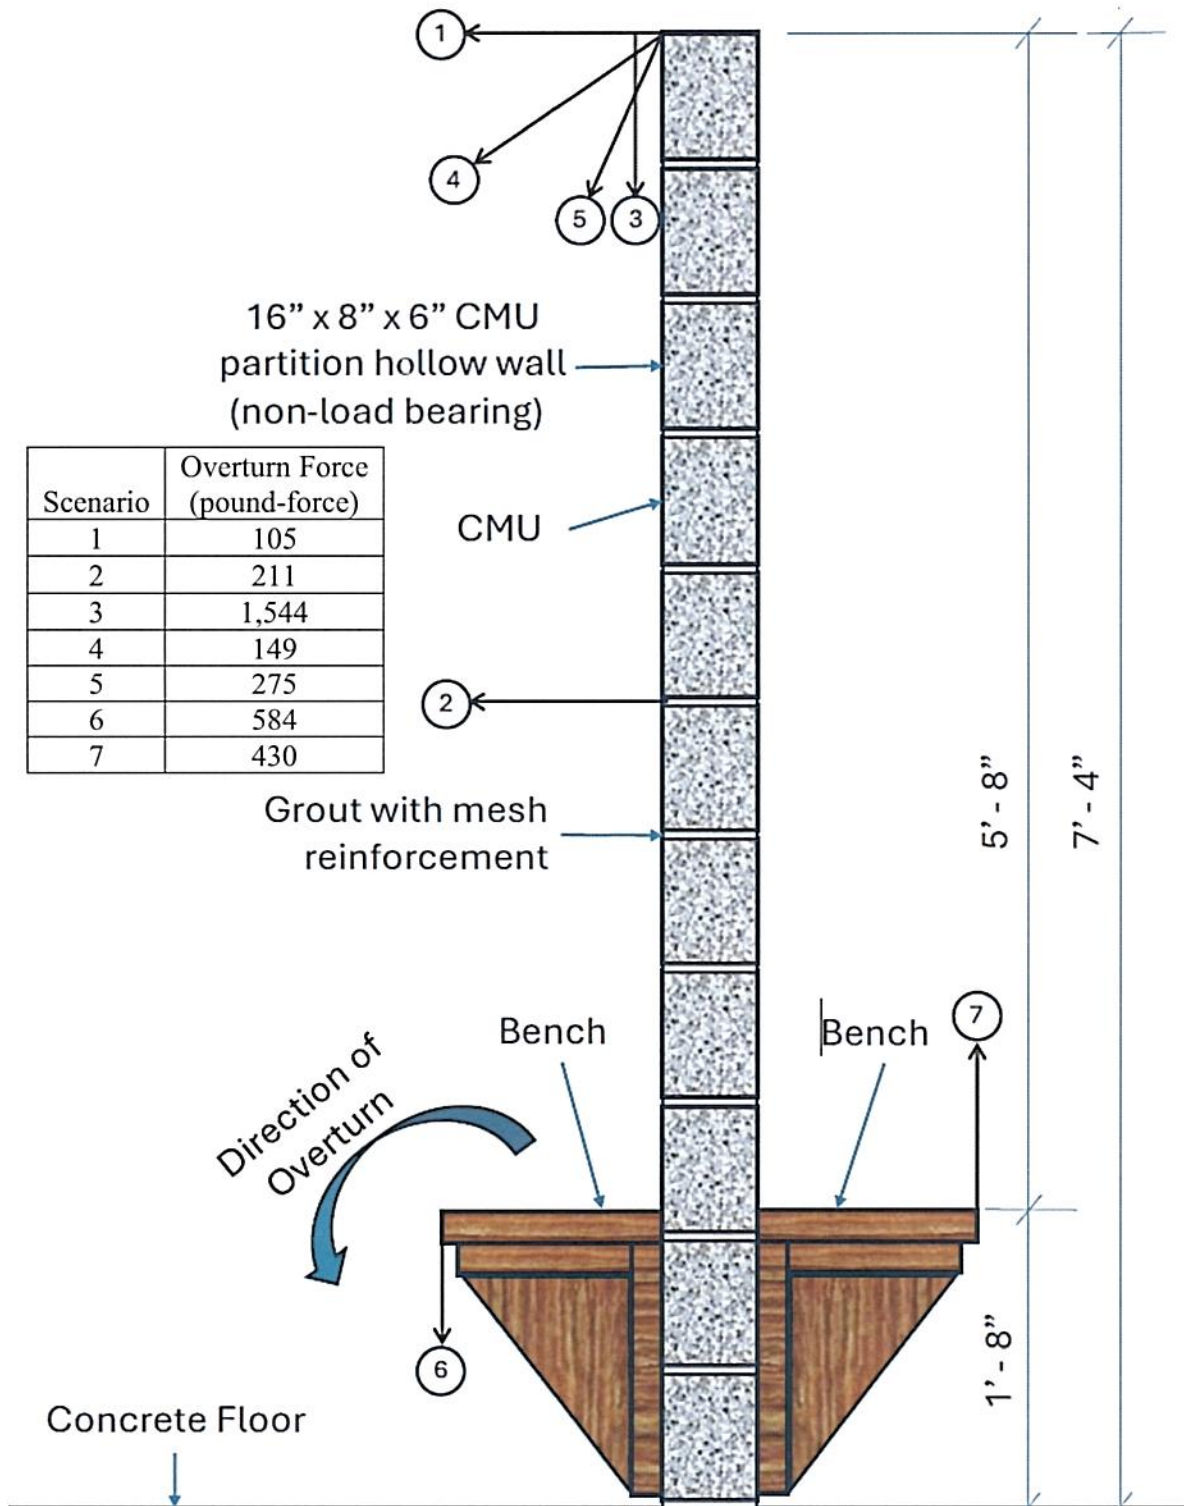
Figure 6.9: Graphical Depiction of CMU Partition Wall Overturn Scenarios (Tab EE-22)

Varying witness testimonies resulted in an unclear sight picture of activities in the changing area prior to the MW falling (Tab V-1.18, V-4.6 and V-4.9, V-6.8, V-7.19, V-12.4 to V-12.5, V-16.8 to V-16.9, V-20.6 to V-20.7, V-21.6 to V-21.7, and V-22.6 to V-22.7). As such, seven scenarios were analyzed to determine the force required to overturn the MW (See Figure 6.9) (Tab EE-20 to EE-21). Based on the calculations, overturning forces range between 105 pound-force (scenario 1) and 1,544 pound-force (scenario 3) (Tab EE-20 to EE-21).

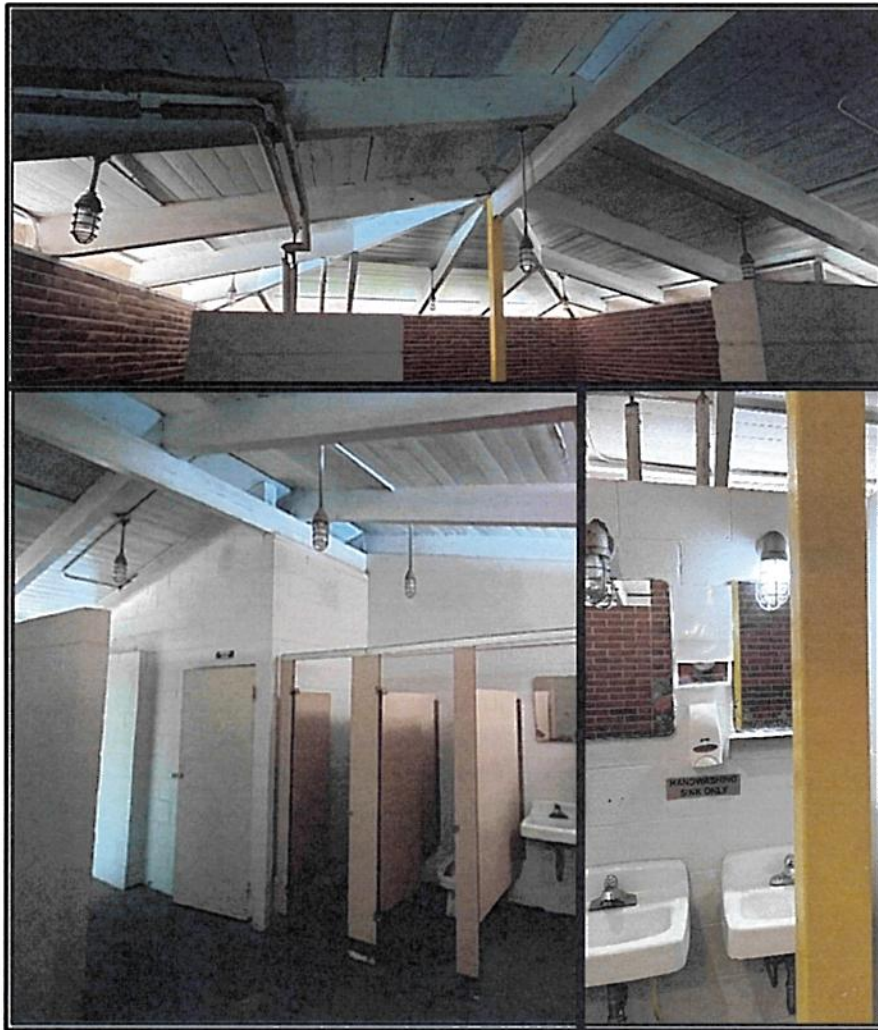
Figure 6.11 Mishap Site Lighting (Bathhouse Men's Side) (Tab Z-22)

The men's side of the bathhouse is illuminated by ten hanging lights and two wall mounted lights by the sink (Figure 6.11) (Tab Z-22). In the MS, a site visit identified direct light is provided by four of the ten hanging lights, one with a compact fluorescent lamp (CFL) bulb and three with 9-watt light-emitting diode (LED) bulbs (60-watt equivalent); the CFL was not illuminated (Tab Z-22). The two light fixtures above the sink were equipped with 100-watt incandescent light bulbs, one of which was not illuminated (Tab Z-22). Lastly, the artificial lighting was augmented by daylight entering through the gaps between the roof trusses and exterior walls (Tab Z-22).

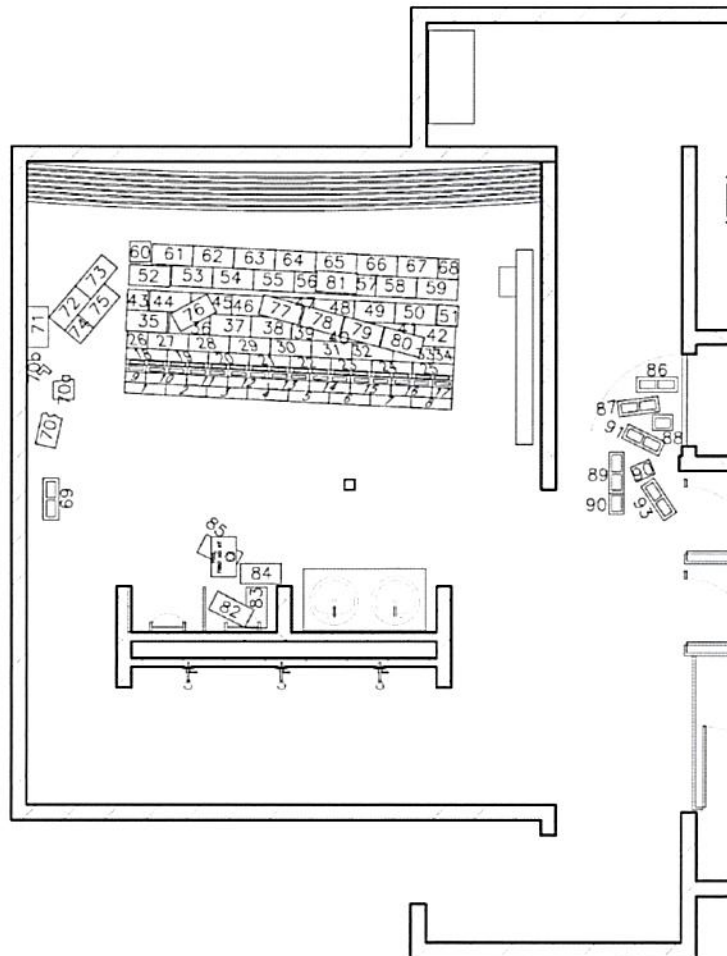
Figure 6.12 Post Mishap Impact Area (Tab Z-4)

Once the MW fell, emergency response efforts were hindered by associated damage to the back bench and MW debris occupying most of the floor space (Figure 6.12) (Tabs V-3.8, V-19.8, and Z-4). Furthermore, as part of the efforts to free MM1 from under the MW, responders discarded CMU blocks into open areas (Tab V-19.8). The damage restricted patient access and limited the number of responders in the confined space (Tab V-3.8, and V-11.5 to V-11.6). Debris was moved to facilitate extraction of MM1 from the MS (Tab V-7.17 to V-7.18, and V-19.9).
