UNITED STATES AIR FORCE
AIRCRAFT ACCIDENT INVESTIGATION
BOARD REPORT

A-29, T/N PT-ZNV-221

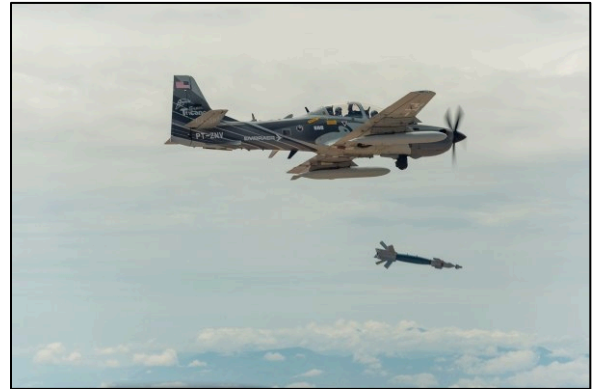
The A-29 Super Tucano is a turboprop aircraft made in the United States (US) by SNC and its partner, Embraer Defense & Security (Tab CC-14 and CC-18). The A-29 can provide close air support and execute other missions in permissive and semi-permissive environments (Tab CC-15 and CC-20). Its performance record includes more than 360,000 flight hours and more than 46,000 combat hours (Tab CC-15 and CC-20). The Super Tucano has over 150 certified load configurations and is equipped with advanced electronic, electro-optic (EO), infrared (IR), and laser system technologies, as well as secure radio systems with data links and munitions capacity (Tab CC-15 and CC-20).

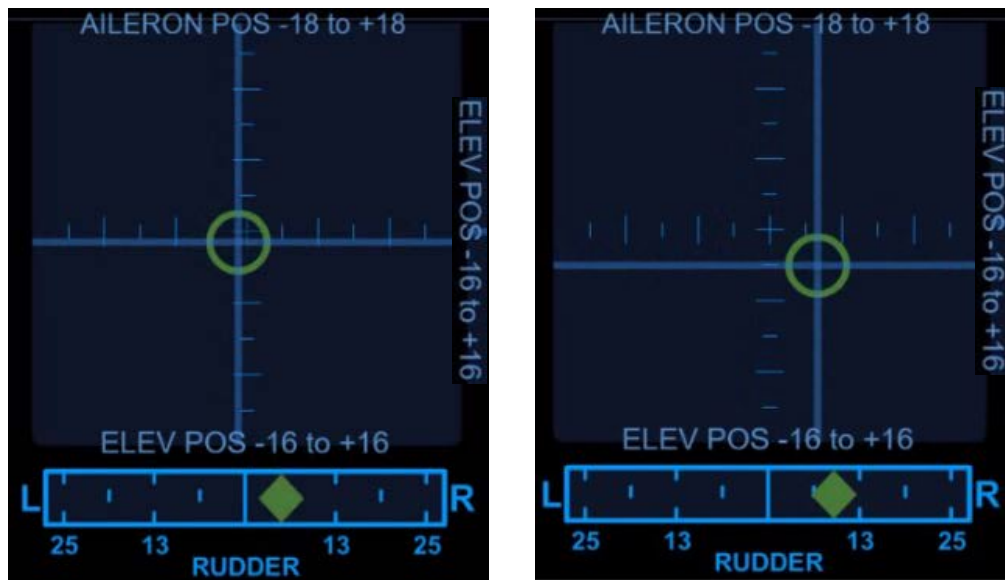
Surface deflection just prior to weapon release and one second after weapon release (Tab Z-6)
