UNITED STATES AIR FORCE
AIRCRAFT ACCIDENT INVESTIGATION
BOARD REPORT

MC-12W, T/N 09-0676

361ST EXPEDITIONARY RECONNAISSANCE SQUADRON
451ST AIR EXPEDITIONARY WING
KANDAHAR AIRFIELD (KAF), AFGHANISTAN

DATE OF ACCIDENT: 27 APRIL 2013

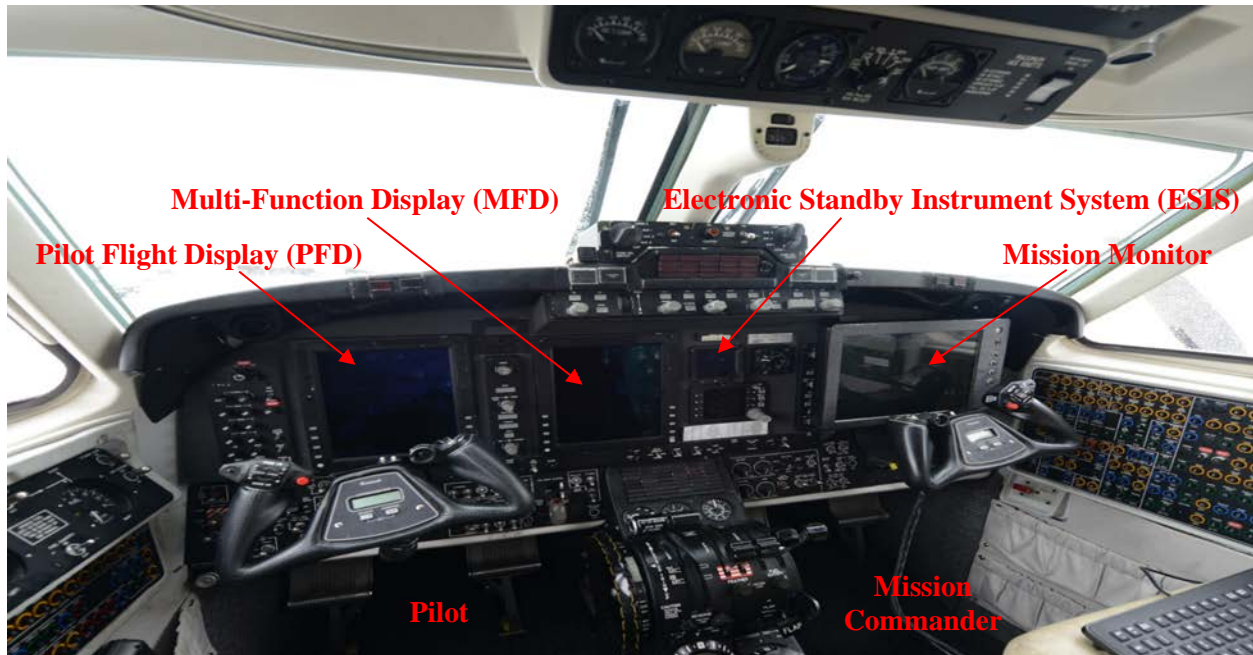
Figure 1. MC-12W Cockpit (Tab Z-5)

The Mishap Aircraft was fitted with the Rockwell Collins Pro Line 21 system, a fully-integrated "Glass Cockpit" avionics system that is designed to address a wide range of aircraft and missions (Tabs BB-33 to BB-39 and DD-56). The pilot instrumentation consists of three separate displays: a Pilot Flight Display (PFD) for each pilot, and a centrally-located Multi-Function Display (MFD). The MC-12W Mission Commander's PFD is visible during takeoff and landing; however, it is covered by a monitor throughout the "mission employment" phase of flight. In order to control the aircraft during mission employment, the Mission Commander (right seat) flies referencing the Pilot (left seat) instrumentation (see Figure 1). This is known as flying "cross-cockpit." For this reason, the Pilot is the typically the primary operator of the flight controls throughout the mission. (Tabs Z-5 and DD-56).
