**UNITED STATES AIR FORCE**  
**GROUND ACCIDENT INVESTIGATION**  
**BOARD REPORT**

**TYPE OF ACCIDENT: High Angle Belay Training Fatality**

**LOCATION: Kathmandu, Nepal**

**DATE OF ACCIDENT: 21 October 2014**

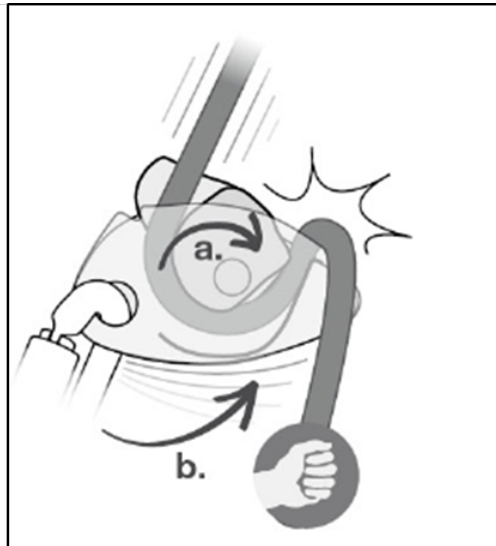
Specifically, the Gri-Gri 2 utilized friction by adding bends in the rope to “pinch” the rope, increasing the braking action until the rope stops sliding (Figure 2, Tab CC-14).

Figure 2: Example of friction applied to Gri Gri 2, or “weighting the device” to increase braking action (Tab CC-14)

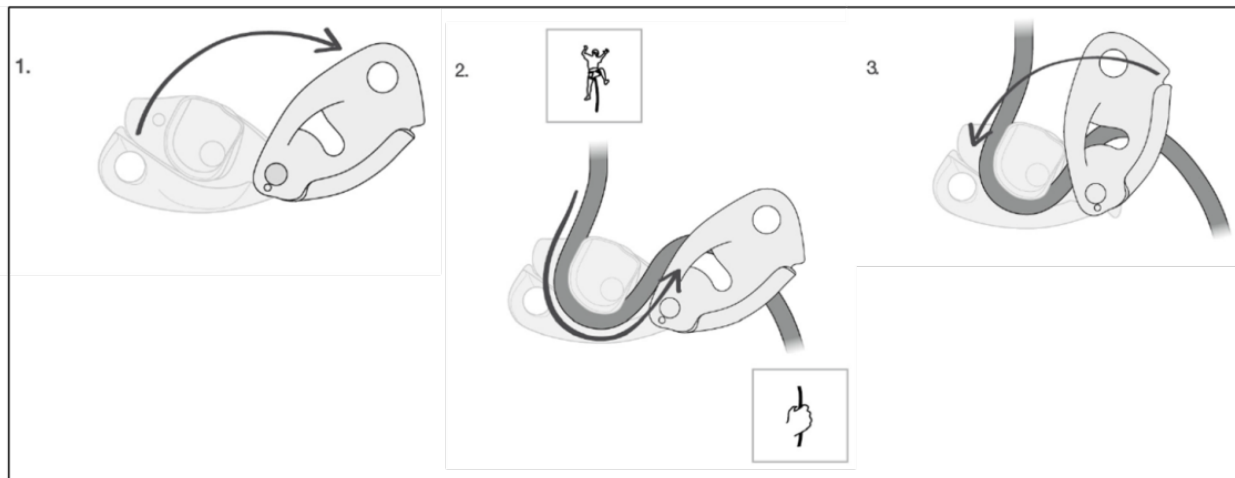
Swift pressure directly applied to the Gri-Gri 2 on the climber’s side of the rope engages the camming action subsequently locking the rope and demonstrating the rope is properly routed (Tabs CC-4 thru CC-5, CC-7 thru CC-11, CC-13 thru CC-17). This action is also known as “weighting” the device (Tabs R-5, R-22, V-2.19, V-8.4). An improperly routed rope would immediately cause the rope to slide through the Gri-Gri 2 without friction when weight was applied (Figure 3, Tab CC-4). A properly routed rope is demonstrated by Figure 3 (Figure 3, Tab CC-15).

Figure 3: Example of proper routing of the rope through the Gri-Gri 2 system (Tab CC-15)

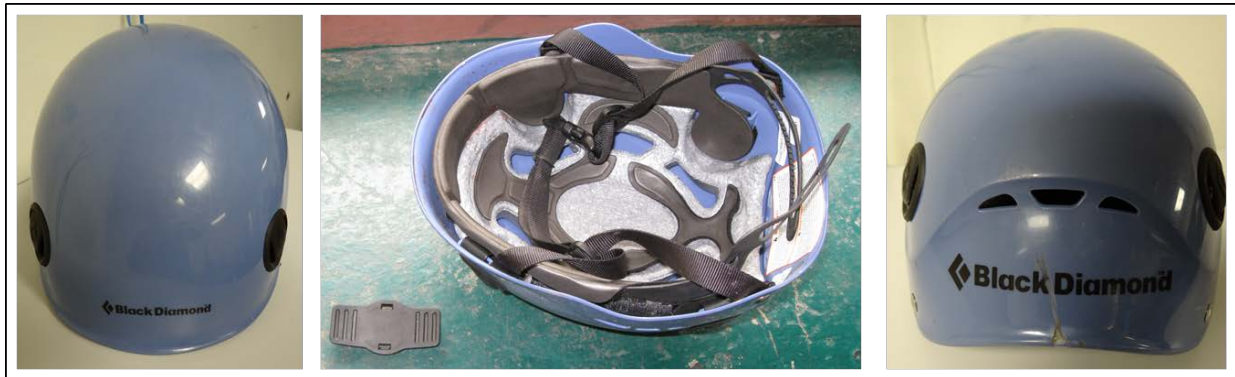
Team's use (Tabs V-2.9, AA-60). The mishap helmet was a 2007 Black Diamond Half Dome helmet (Figure 5, Tabs CC-33, CC-45).

Figure 5: Mishap helmet front, bottom, and side view (Tabs S-19 thru S-20, S-25)

Additionally, the size adjuster was damaged and non-functional with a piece of the size adjuster missing (Figure 21, Tab CC-6). However, IO used the mishap helmet prior to the mishap and did not note any missing pieces or structural issues with the helmet (Tab V-8.3).

The chinstrap buckle remained connected after the mishap and showed no obvious signs of wear and tear (Tab CC-6). There was no other visible damage to the helmet (Tab CC-6).

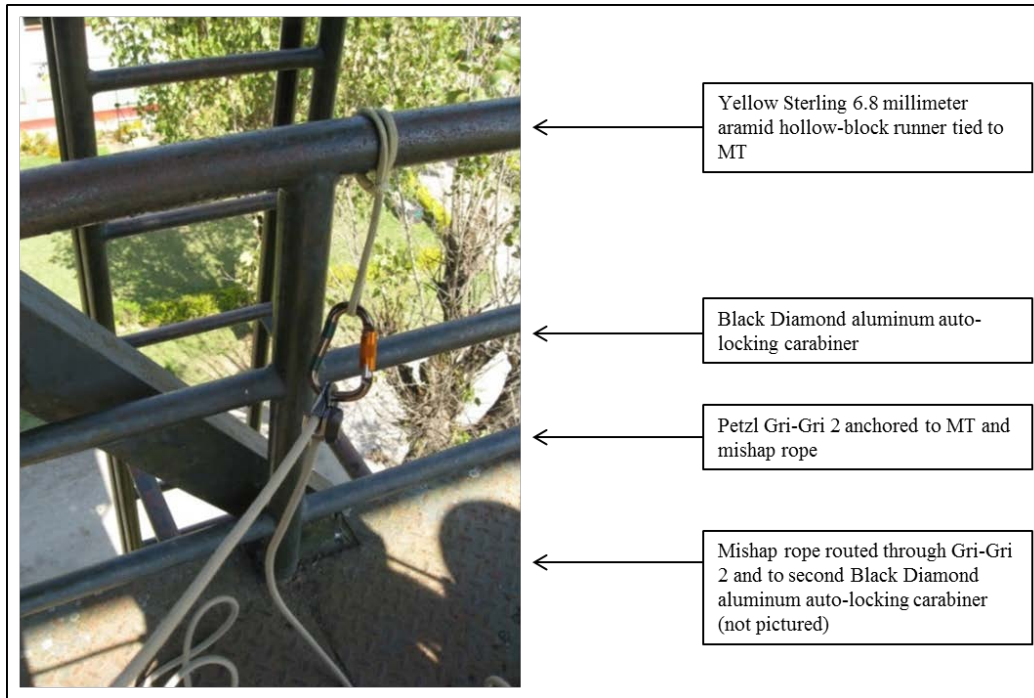
The Petzl Gri-Gri 2 attached to, and manipulated, the rope angles to control the descent of the Rangers (Tabs S-8 thru S-13, S-16 thru S-18, V-2.14). BPJ1 and BPJ2 anchored the Gri-Gri 2 to a metal railing on the MT using a yellow Sterling 6.8-millimeter aramid hollow-block runner and a Black Diamond aluminum auto-locking carabiner (Figure 9, Tabs R-4, S-8 thru S-13, V-2.14, CC-3 thru CC-6).

Figure 9: Gri-Gri 2 anchored to MT (Tabs S-11, CC-3 thru CC-6)

On 21 October 2014, BPJ1 and BPJ2 used a Black Diamond aluminum auto-locking carabiner to secure the Gri-Gri 2 to the anchor point on the MT (Figure 9, Tabs R-4, S-8 thru S-13, V-2.14, CC-3 thru CC-6). Additionally, BPJ1 and BPJ2 used a Petzl Williams tri-lock carabiner and a loop of one-inch tubular nylon tied in a water bend knot to route the mishap rope to the high point on the horizontal crossbeam (Figure 10, Tabs R-4, R-21, S-8 thru S-13, V-2.14, Y-11 thru Y-14, CC-3 thru CC-6).

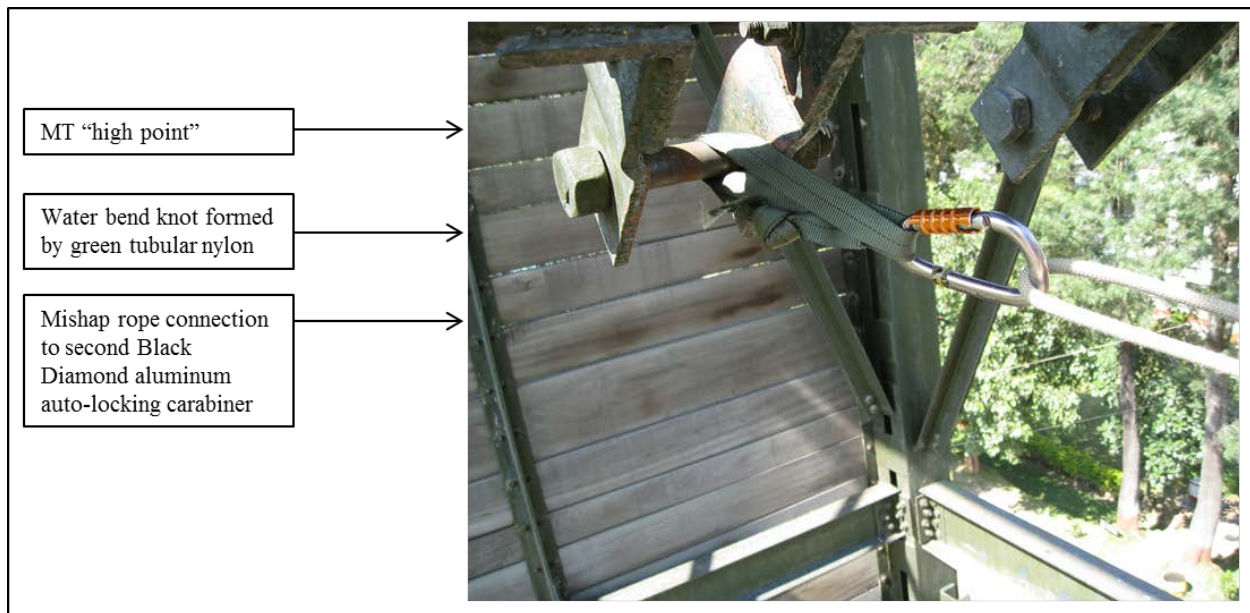
BPJ1 and BPJ2 routed the 200-foot Sterling 9.5-millimeter tactical response static rope through the Gri-Gri 2 device and through a second Black Diamond aluminum auto-locking carabiner (Figure 9, Figure 10, Tabs R-4, R-21, R-25 thru R-26, S-8 thru S-13, V-2.14, Y-11 thru Y-14, CC-3 thru CC-6). The second carabiner was secured to a horizontal metal railing on the MT, also known as the “high point,” with a water bend knot formed from an approximately 40 inch by one inch green tubular nylon strap (Figure 10, Tabs R-4, R-21, R-25 thru R-26, S-8 thru S-13, V-2.14, Y-11 thru Y-14, CC-3 thru CC-6).

Figure 10: Rope secured to the high point on the MT (Tabs S-10, Y-19)

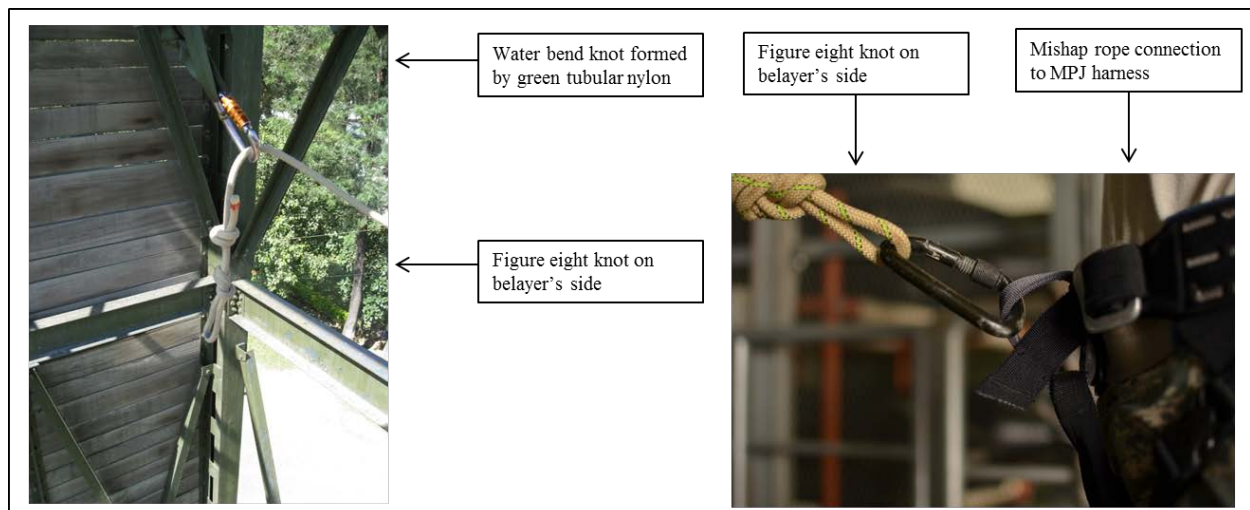
BPJ1 and BPJ2 tied a figure eight knot on the end of the rope on the belayer's side that was attached to the belayer utilizing an additional auto-locking carabiner (Figure 11, Tabs R-4, R-25 thru R-26, S-10, V-2.14, Y-14).

Figure 11: Figure eight knot connection to MPJ's harness (Tabs R-4, R-25 thru R-26, S-10, V-2.14, Y-14)

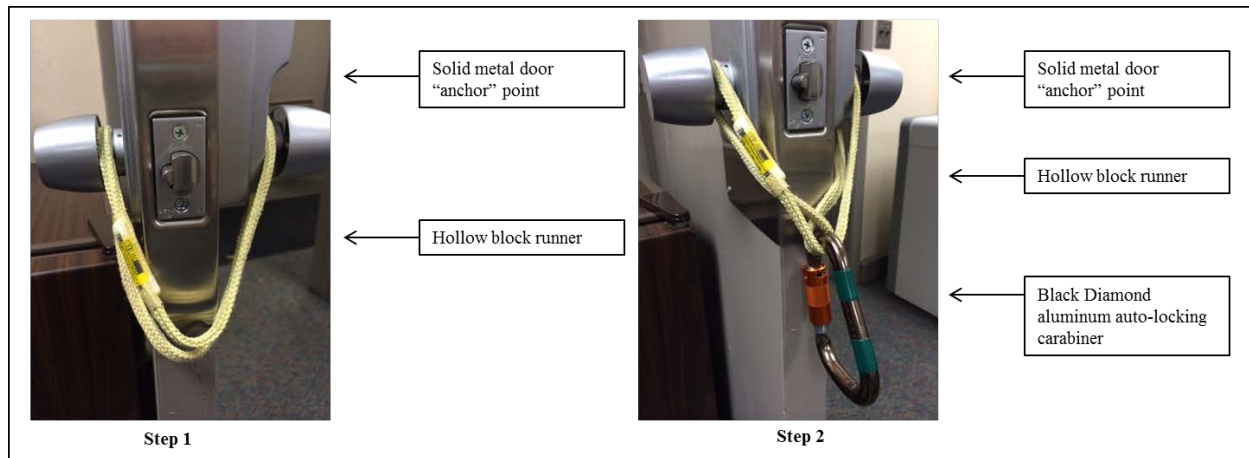
i. PJA utilized a solid metal door as an anchor point by looping a 6.8 millimeter thick hollow block runner to each side of the door handle (Figure 15 - Step 1, Tabs CC-4, CC-7).

ii. PJA attached a Black Diamond aluminum auto-locking carabiner to the 6.8 millimeter thick hollow block runner (Figure 15 - Step 2, Tabs CC-4, CC-7).

Figure 15: Petzl Gri-Gri 2 evaluation steps 1-2 (Tabs CC-4, CC-7)

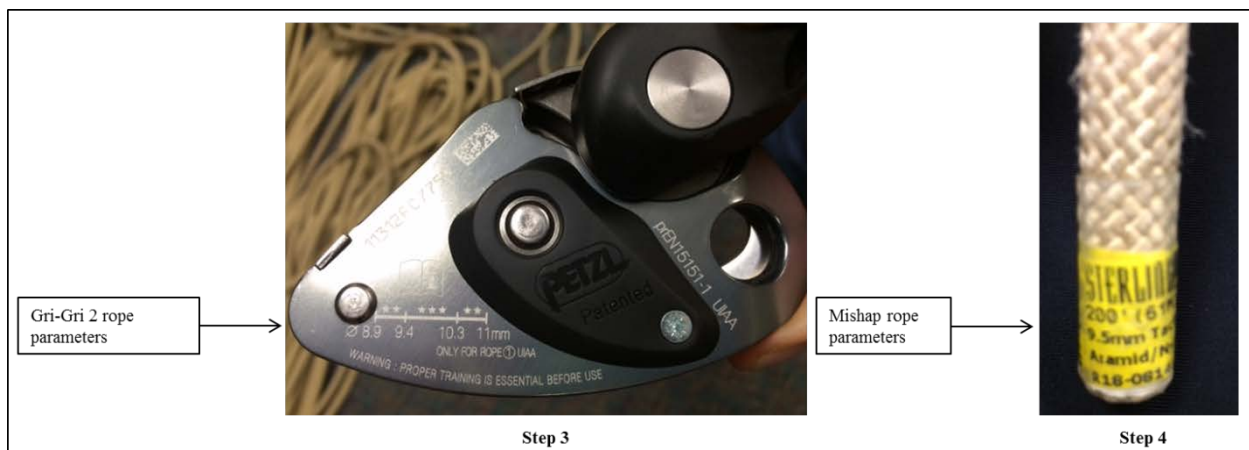
iii. Next, the parameters of the Gri-Gri 2 were evaluated to determine the appropriate size of the rope (Figure 16 - Step 3, Tabs CC-4, CC-8). The mishap Gri-Gri 2 was designed for 8.9 millimeter to 11 millimeter dynamic ropes (Figure 16 - Step 3, Tabs CC-4, CC-8). The mishap rope was a 200 foot, 9.5 millimeter Sterling tactical response aramid/nylon rope (Figure 16 - Step 4, Tabs CC-4, CC-8). The mishap rope was within the Gri-Gri 2's parameters of use (Figure 16, Tabs CC-4, CC-8).

Figure 16: Petzl Gri-Gri 2 evaluation steps 3-4 (Tabs CC-4, CC-8)

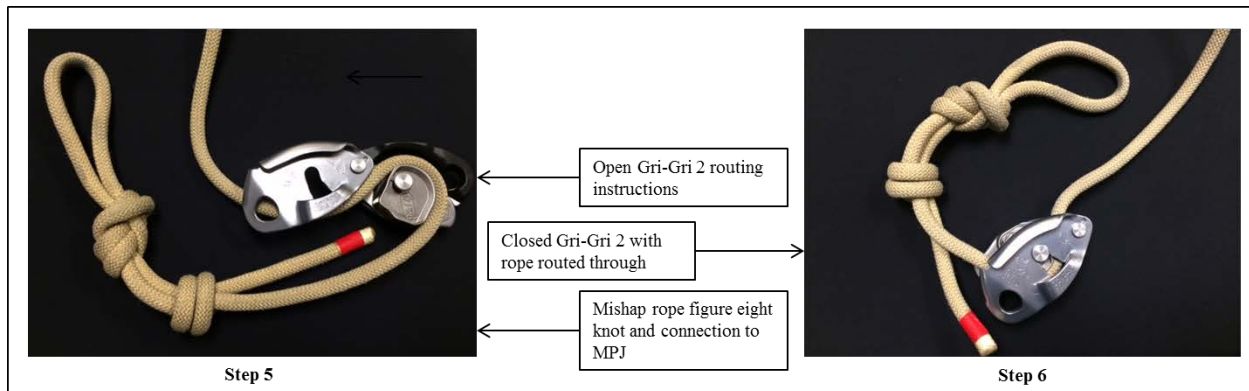
iv. The mishap rope was routed through the Gri-Gri 2 following the directions etched in the device panels, and then properly closed (Figure 17 - Step 5 thru Step 6, Tabs CC-4,

CC-9). An improperly routed rope would immediately cause the rope to slide through the Gri-Gri 2 without friction when weight was applied (Tab CC-4).

Figure 17: Petzl Gri-Gri 2 evaluation steps 5-6 (Tabs CC-4, CC-9)

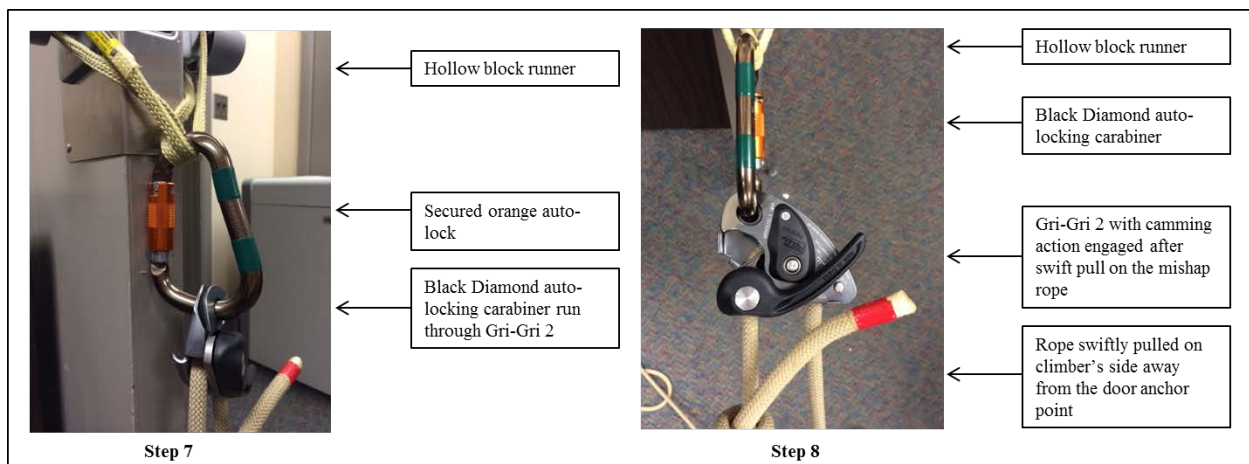
v. The Black Diamond aluminum auto-locking carabiner was run through the Gri-Gri 2 device ensuring the orange auto-locking gate on the carabiner was secure (Figure 18 - Step 7, Tabs CC-4, CC-10).

vi. Pressure was directly applied to the Gri-Gri 2 through a swift pull on the climber side of the rope engaging the camming action subsequently locking the rope (Figure 18 - Step 8, Tabs CC-4, CC-10). This is also known as “weighting” the device (Tabs R-5, R-22, V-2.19, V-8.4, CC-4). While the rope was able to freely move with minimal pull on the climber side of the rope, a direct hard pull immediately engaged the camming action (Figure 18 - Step 8, Tabs CC-4, CC-10).

Figure 18: Petzl Gri-Gri 2 evaluation steps 7-8 (Tabs CC-4, CC-10)

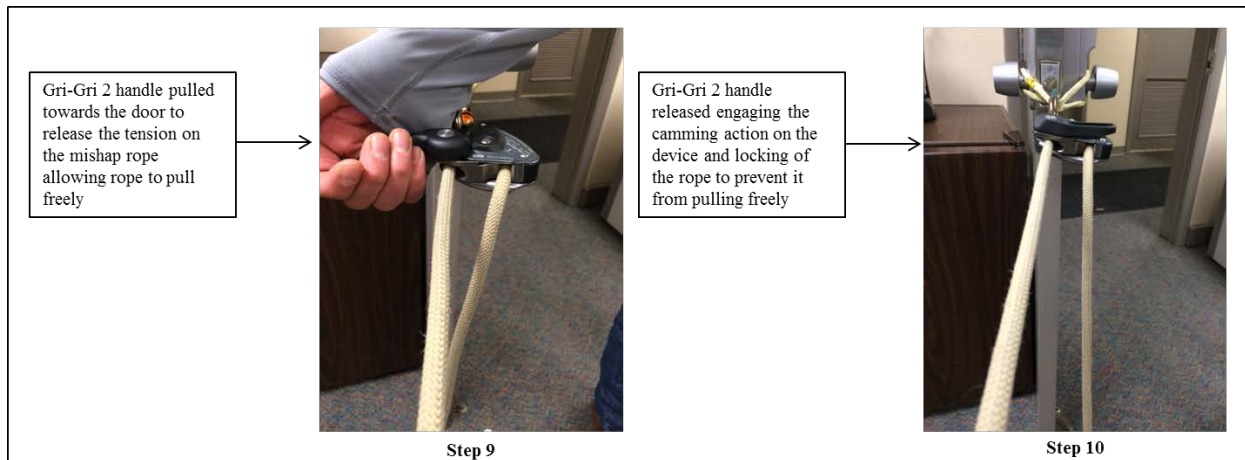
vii. After the Gri-Gri 2 was weighted, the handle was maneuvered to release tension off the rope allowing the rope to travel through the Gri-Gri 2 (Figure 19 - Step 9, Tabs

CC-5, CC-11). The camming device reengaged as soon as the handle was released (Figure 19 - Step 10, Tabs CC-5, CC-11).

Figure 19: Petzl Gri-Gri 2 evaluation steps 9-10 (Tabs CC-5, CC-11)

The Gri-Gri 2 appeared to be in good working condition, and there is no evidence to indicate it failed to function properly on the day of the mishap (Tabs CC-4 thru CC-5, CC-7 thru CC-11).
