UNITED STATES AIR FORCE
AIRCRAFT ACCIDENT INVESTIGATION
BOARD REPORT

B-1B, T/N 85-0085

34TH BOMB SQUADRON
28TH BOMB WING
ELLSWORTH AIR FORCE BASE

DATE OF ACCIDENT: 4 JANUARY 2024

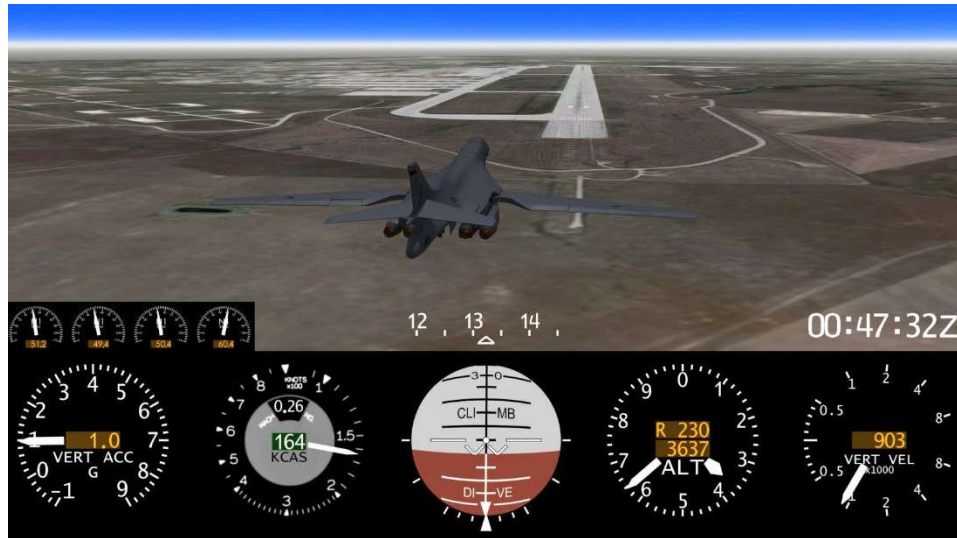
Figure 3. MFOQA MA Animation. (Tab S-21)

During an instrument approach, a pilot flying incorporates various instruments into a composite crosscheck to estimate the overall perceived performance of the aircraft at any given time and uses these outputs to determine what needs to happen with the throttles and control stick to achieve the desired performance (Tab AA-5 to AA-6). An effective composite crosscheck was not adhered to by any of the MC. According to testimony from the MP, airspeed is a performance indicator that the MC incorporated into their crosscheck (Tab V-29.10). Had the MC done this, they should have recognized the MA slowing below the approach speed of 164 KIAS to ultimately 152 KIAS on final, leading to excessive negative vertical velocity and impact prior to the threshold for Rwy 13 (Tab AA-5). For reference, 152 KCAS is the approach speed for a B-1B that is 40,000 lbs lighter than the MA at the time of the mishap (Tab AA-5). The MOSO utilized the MDSO’s altimeter to back up the MP on required altitude calls (Tab V-34.6). At 17:46:50L, the MA’s airspeed was 164 KCAS (Figure 2 above), and at 17:47:32L, the MA’s airspeed was 164 KCAS (Figure 3 below). These two times were the only instances during the last 55 seconds of the MA’s flight that its airspeed was equal to the calculated approach speed of 164 KIAS. Additionally, the MA’s glideslope began to indicate it was half a dot below the ideal glideslope at 17:47:36L, 10 seconds before impact (Tab AA-6). “Dots” appear on the pilot’s display to indicate how far above or below the target glideslope the aircraft is currently traveling, and a smaller deviation has a much larger impact the closer the aircraft gets to the runway. The MA’s Flight Path Angle (FPA) began to drop below the ideal -3 degrees at 17:47:33L and reached -5.2 degrees at 17:47:44L (Tab AA-6).

From 17:47:30L to 17:47:44L, there was a slight aft stick motion from approximately one-half-inch aft stick deflection to one-inch aft stick deflection. During this same time, the MA's angle of attack (AOA) increased from 7.7 degrees (ideal is 7 degrees) to 9.2 degrees, and the MA's pitch indication decreased from 5.5 degrees nose high (NH) to 3.7 degrees NH (Figure 4 below and Tab AA-7). Moving the control stick aft while the AOA increases and pitch decreases indicates the aircraft is approaching stall onset due to thrust deficiency (Tab AA-6). Additionally, the MP never briefed the vertical velocity indicator (VVI) as required by the B-1B Flight Manual, so the aft station MOSO and MDSO would not have known what VVI indicates a normal VVI for the approach (Tabs N-4 and AA-7). Furthermore, they were not instructed to monitor VVI for the approach (Tab N-4). The aft station can reference VVI in "Prime Data" at the top of the tactical display but would have to select VVI to be displayed as it is normally not shown (Tab AA-7). The radar altimeter was turned on during the Descent Before Landing checklist, but the "bugged," or commanded, altitude was never changed from 400ft to an altitude that would assist on the approach in accordance with B-1B procedures, typically 200ft (the DA) (Tab AA-7). Had either pilot set the radar altimeter bug to 200ft, they would have received a MIN DESN HGT (minimum decision height) light when the radar altimeter indicated 200ft AGL, corresponding to the DA for the approach to Rwy 13 (Tab AA-7 to AA-8). Additionally, neither the MP nor the MIP bugged their altitude MSL for what they believed to be the DA for the ILS approach to Rwy 13 (Tab AA-7 to AA-8). Instead, their altitude bug was set to 5,300ft MSL, which did not assist with the final segment of the approach (Tab AA-8). The MDSO testified he was not performing a crosscheck on the final approach and, instead, referencing the After Landing checklist on his EFB (Tab V-31.10).
