**UNITED STATES AIR FORCE**  
**AIRCRAFT ACCIDENT INVESTIGATION**  
**BOARD REPORT**

**CV-22B Osprey/ T/N: 08-000039**  
**27TH SPECIAL OPERATIONS WING**  
**CANNON AIR FORCE BASE (AFB), NEW MEXICO**

**LOCATION: INYOKERN AIRFIELD, CA**  
**DATE OF ACCIDENT: 17 AUGUST 2023**  
**BOARD PRESIDENT: COLONEL JEFF D. MCMASTER**  
**Conducted IAW Air Force Instruction 51-307**

**CV-22B, TN 08-000039  
INYOKERN AIRFIELD, CALIFORNIA  
17 AUGUST 2023**

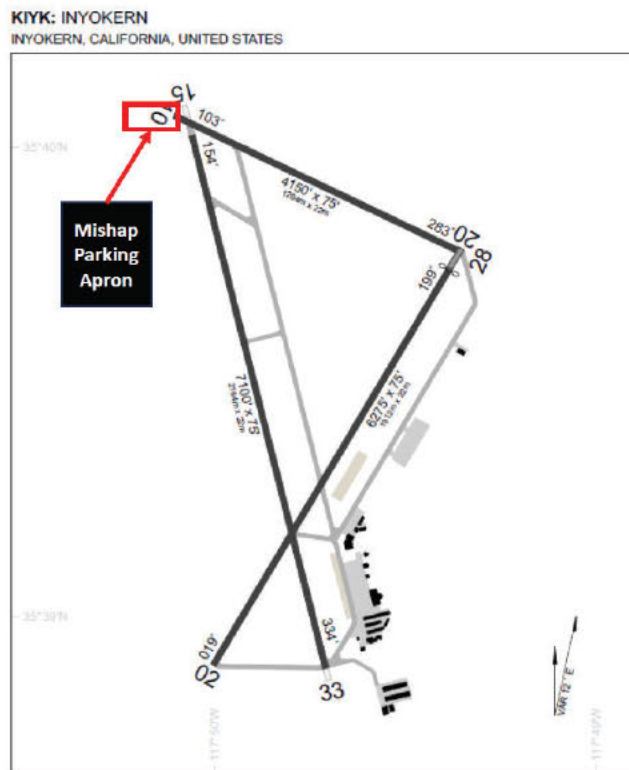
**Figure 1.0 – Inyokern Airfield Diagram**

Inyokern also has a large concrete apron located on the Northern end of the airfield off the approach end of RWY10 (Figure 1.0) (Tab Z-1). This parking location is not used during normal airfield operations. No taxi lines or airfield markings are present, and no airfield lighting is available for nighttime operations (Figure 2.3). The apron’s concrete surface is deteriorating with loose gravel, uneven surfaces, large cracks, and chunks of concrete prevalent throughout (Tab Z-1). Additionally, an approximately two-inch deep trench separates the parking apron from the approach end of RWY10 (Tab Z-1). On the south side of this transition is a larger hole requiring aircrew to offset to the north side of the taxiway to avoid (Tab Z-1). This trench exceeds the 1.5-inch taxi obstacle height restriction listed in the 1V-22(C)B-1 aircraft technical orders; “traversing or taxi over obstacles greater than 1.5 inches in height is prohibited” (Tab BB). Parking apron conditions are shown in Figure 2.1 below (Tab Z-1).

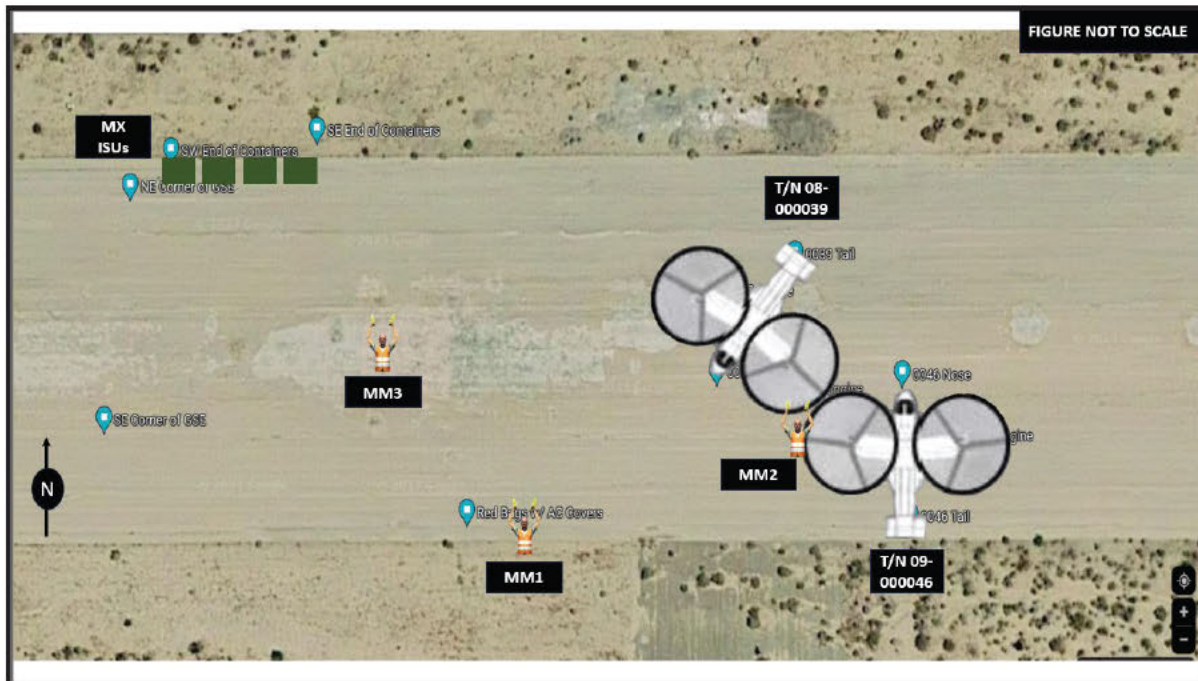
Figure 4.0 – Mishap Overview Diagram

This new marshalling configuration placed the aircraft marshaller (MM1) in the parking spot at the tail position, MM2 was performing wing walker duties and posted under T/N 09-000046's proprotor blades, and MM3 was stationed with the fire extinguisher near the maintenance Internal Stability Unit (ISU) as shown in Figure 4.0 (Tab V1, Tab V2 and Tab V3).

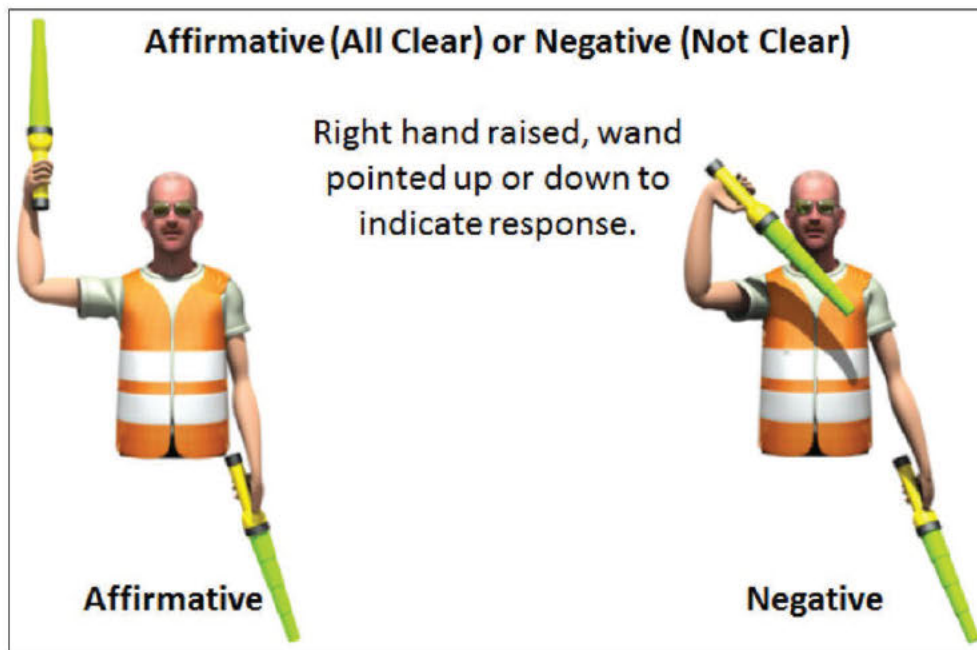
Figure 5.1 – Ground Marshalling Procedures

As an example, the wing walkers typically provided either no signal or inconsistent hand signals to notify taxiing aircrew of sufficient obstacle clearance while taxiing. This is in deference to the “Affirmative” signal with the right hand raised as directed by AFMAN 11-218 to confirm adequate clearance between aircraft during taxi operations (Figure 5.1). This lack of standardization introduced a false sense of security by the crew when no signals were provided by the wing walkers. Additionally, the aircraft marshaller and wing walkers did not use the required daylight-fluorescent wands available in their deployed kits as directed by AFMAN 11-218 for signaling by all participating ground personnel during daylight hours. Figure 9.0 shows an example of daylight-fluorescent wands directed for use by AFMAN 11-218 and Figure 9.1 shows the wands available to maintenance personnel at the time of the mishap. The inconsistent hand signals by ground personnel and lack of directed marshalling equipment were significant contributing factors in this mishap.
