UNITED STATES AIR FORCE
AIRCRAFT ACCIDENT INVESTIGATION
BOARD REPORT

F-16C, T/N 87-0358

DATE OF ACCIDENT: 30 APRIL 2024

SUMMARY OF FACTS AND STATEMENT OF OPINION
F16C, T/N 87-0358
HOLLOMAN AFB, NEW MEXICO
30 APRIL 2024

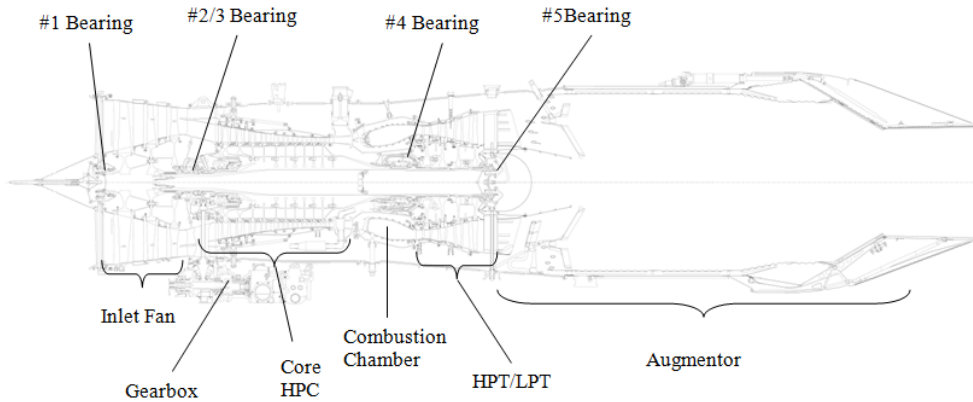
Figure 5. The Pratt & Whitney F100-PW-220 engine (Tab J-45)

While installed in a different aircraft, this specific Pratt & Whitney (P&W) F100-PW-220 engine (Figure 5) experienced a foreign object damage (FOD) event in August 2022. (Tabs J-75, BB-26 to BB-27, and DD-2). Damage from this event was limited to only the first stage of the inlet fan – the inlet fan consists of stages one through three of the engine’s thirteen stages of compression. (Tabs J-76, V-9.3, V-10.3, 10.5, and DD-2). As required in the applicable AFTOs, repairs were limited to blending the first stage blade damage to within allowable limits. (Tabs U-45 to U-66, V-10.5, V-10.6, BB-26 to BB-27, and DD-2).

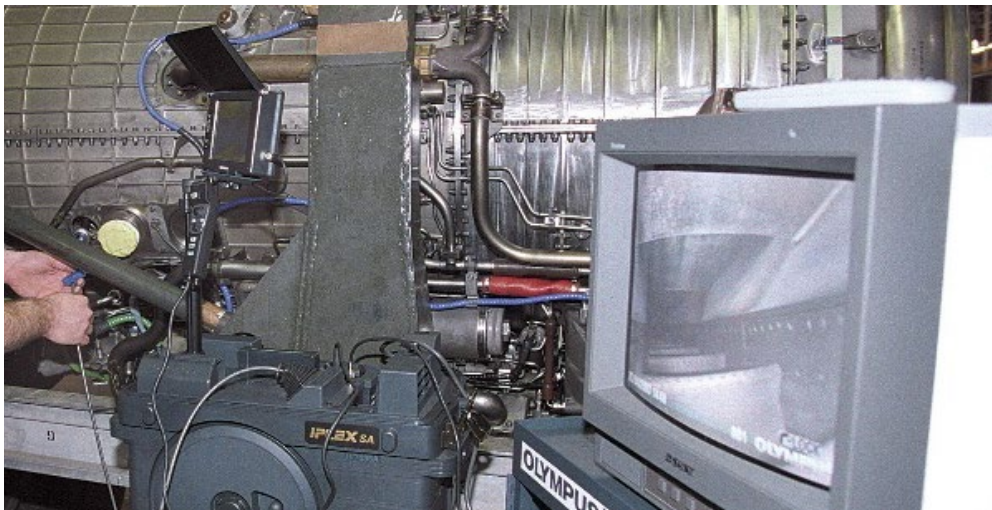
Figure 6. Borescope inspection of an unknown engine type (U.S. Air Force stock photo)

Following these repairs, the engine was subjected to borescope inspections where a camera was inserted into access ports, looking for nicks and cracks on blades and vanes. (Figure 6) (Tabs V-10.2 to V-10.4, and BB-26 to BB-27).

While completing inspections of the inlet fan's first stage FOD repair, 49 MXS also accomplished 100, 200, and 400-hour borescope inspections. (Tabs U-19 to U-22 and DD-2). The inspections on 14 December 2022 at 6,432.2 hours of engine IFT noted no discrepancies in any of the borescope inspectable engine stages, and depot-level maintenance, was not required. (Tabs U-19 to U-22, U-45 to U-66, and DD-3).

Due to the F100-PW-220 engine's absence of an access port permitting a fifth stage borescope inspection, the fifth stage is only inspected through engine core teardown and HPC disassembly accomplished during depot-level maintenance at Tinker AFB, OK. (Tabs V-9.4, V-10.1 to V-10.6, V-11.2, V-12.6, V-13.5, and DD-3). A depot-level inspection of the MA engine's fifth stage was not prescribed after the FOD event due to the absence of damage to the second through fourth stages as well as the sixth stage and beyond. (Tabs U-19 to U-22, U-45 to U-66, and DD-3).
