UNITED STATES AIR FORCE
GROUND ACCIDENT INVESTIGATION
BOARD REPORT

TYPE OF ACCIDENT: Pool Bathhouse Wall Mishap

LOCATION: Heritage Pool Bathhouse, Robins AFB, Georgia

DATE OF ACCIDENT: 22 July 2024

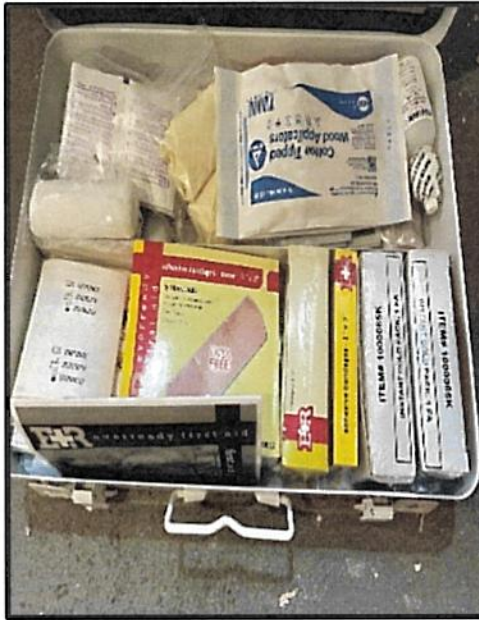
Figure 6.1: First Aid Kit

Prior to each season, the Facility Manager purchased new first aid kits (Tab V-1.14). The GAIB Medical Member (MDM) confirmed all items within the first aid kit were current (Figure 6.2) (Tab Z-14).

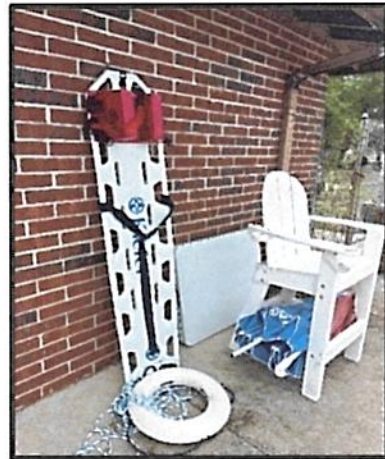
Figure 6.4: Rescue Backboard

MDM assessed the condition of the equipment used on scene: the backboard with head and neck immobilization system and torso strap was intact; the suction unit appeared in good condition; and the AED, Philips HS1 (Serial Number: A06C-02415) also appeared in good condition (Tabs X-3, and DD-5). The battery of the AED was removed prior to inspection and therefore, expiration dates and function were not able to be assessed (Figure 6.5) (Tabs X-3, and Z-16). A search was run on the AED serial number, which indicated this device was manufactured in 2006 (Tab U-59). Philips issued a recall on this device in February 2018, due to isolated failures with one of the device's electrical components (a resistor), which could result in the device not delivering a shock (Tab U-60 to U-63). The AED pads used were Philips HeartStart OnSite Adult Smart Pads (M5071A), which expired in February 2021 (Tab Z-17). An additional Philips recall on the M5071A adult AED pads were issued in February 2022 for gel separation from the tin backing when peeled from the plastic liner (Tab U-64 to U-67). Lastly, no post event AED electronic data recording was performed (Tabs O-34, and V-17.8).

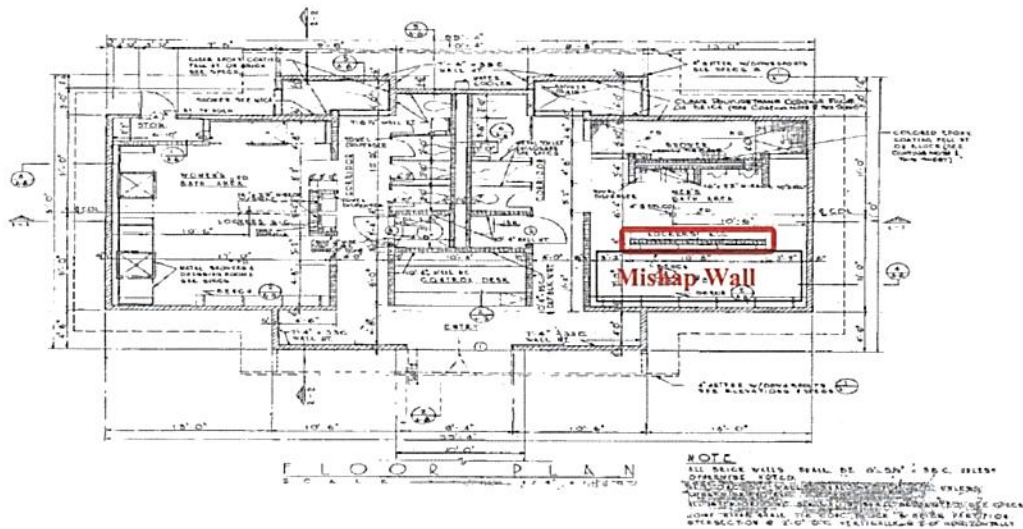
Figure 6.6: Bathhouse Floor Plan (Tab Z-18)

The bathhouse is a one-story building approximately 55'-4" wide by 31'-0" long and was constructed in 1969 (Figure 6.6) (Tab EE-6 to EE-7). The facility contains a women's bath area on the north half of the building and a men's bath area on the south half (Tab EE-8). Both sides have showers, sinks, toilets, and a changing area (Tab Z-18). The bathhouse also serves as the lifeguards' emergency shelter in the case of inclement weather (Tab O-16).

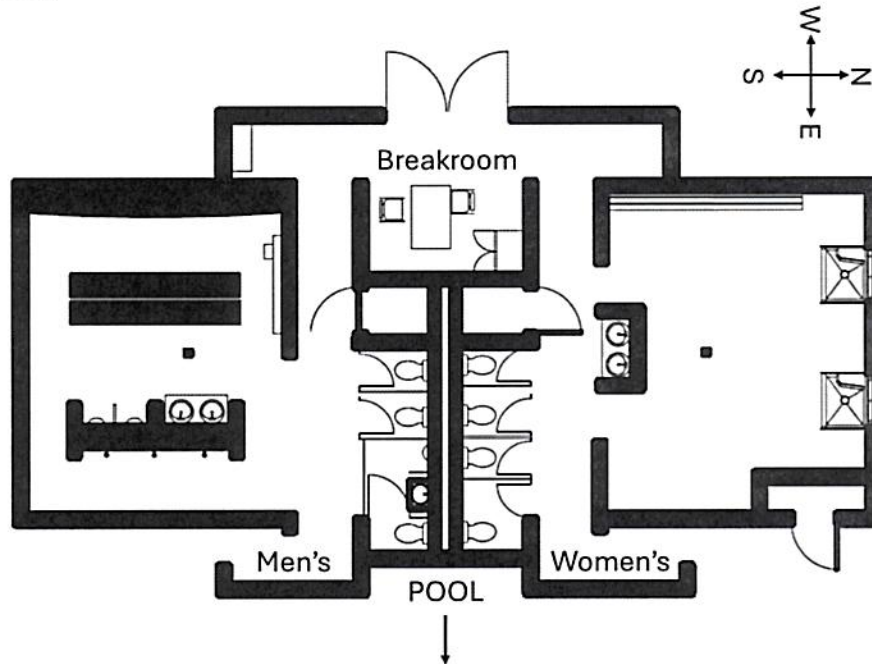
Figure 6.10 Heritage Pool Bathhouse Floorplan (Tab Z-21)

The MS is 13'-10" x 17', with a partition wall, which is the MW, in the middle of the space and benches mounted to three surfaces – the back exterior wall and either side of the MW (Tab Z-20). Opposite one side of the MW are two urinals and two sinks (Tab Z-20). Additionally, the poolside entrance is perpendicular to the bathhouse, preventing a straight path to the MS (Tab Z-21). Patrons enter through a small vestibule, make a 90-degree turn left, walk past the toilets, then make another 90-degree turn left into the bath area (Tab Z-21). The narrowest door is 3'-2" wide (Tab Z-20).
