**UNITED STATES AIR FORCE**  
**ABBREVIATED AIRCRAFT ACCIDENT**  
**INVESTIGATION BOARD REPORT**

**MQ-1B T/N 06-3174**  
**432D WING**  
**CREECH AIR FORCE BASE, NEVADA**

**DATE OF ACCIDENT: 10 JULY 2011**

### ABBREVIATED AIRCRAFT ACCIDENT INVESTIGATION MQ-1B T/N 06-3174, JALABAD, AFGHANISTAN 10 JULY 2011

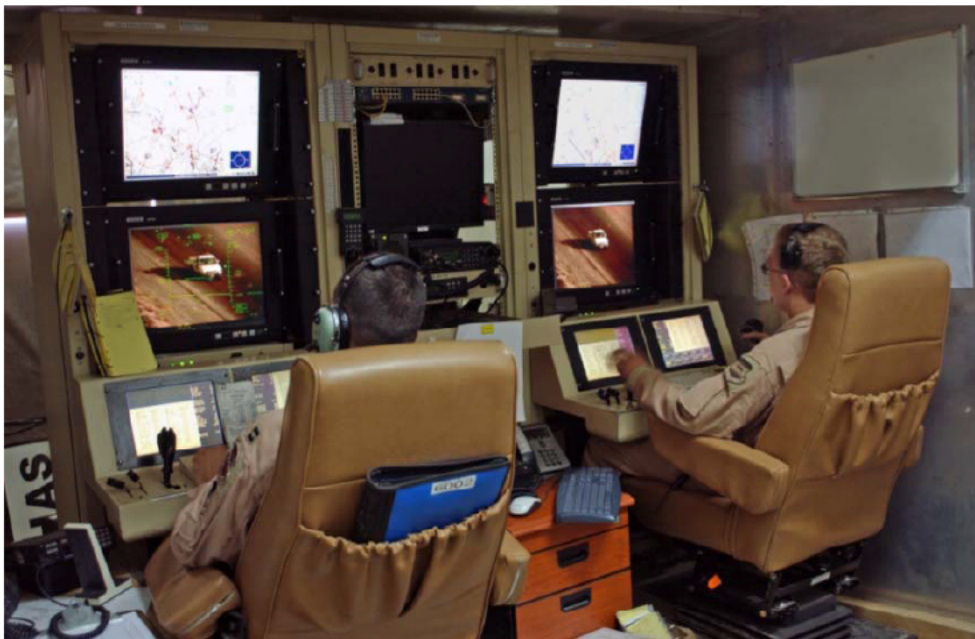
**Figure 2. Inside View of Ground Control Station**

The basic crew for the Predator consists of a pilot to control the aircraft and command the mission and an enlisted aircrew member to operate sensors and weapons plus a mission coordinator, when required. The crew employs the aircraft from inside a GCS via a line-of-sight data link or a satellite data link for beyond line-of-sight (LOS) operations. The MQ-1B carries the Multi-spectral Targeting System (MTS-A) which integrates an infrared sensor, a color/monochrome daylight television (TV) camera, an image-intensified TV camera, a laser designator and a laser illuminator into a single package. The full motion video from each of the imaging sensors can be viewed as separate video streams or fused together. The aircraft can employ two laser-guided AGM-114 Hellfire missiles which possess a highly accurate, low collateral damage, and anti-armor and anti-personnel engagement capability. The aircraft has a wingspan of 55 feet, a maximum takeoff weight of 2,250 pounds, and cruises at 84 miles per hour. (Tab CC-3 to CC-4)
