**SUBJECT: Accident Investigation Board Report: MQ-1B, T/N 98-3047, 111 RS,
432 WG, Creech AFB, NV, 20 April 2009**

AIRCRAFT ACCIDENT INVESTIGATION MQ-1B, "PREDATOR," T/N 98-3047 SOUTH OF KABUL AB, AFGHANISTAN 20 APRIL 2009

SUMMARY OF FACTS AND STATEMENT OF OPINION
MQ-1B, T/N 98-3047
20 APRIL 2009

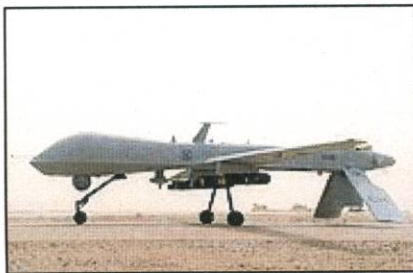
c. Predator System

The MQ-1B Predator aircraft is a medium-altitude, long endurance, unmanned aircraft system. Its primary mission is conducting armed reconnaissance and interdiction against critical perishable targets. When the MQ-1B is not actively pursuing its primary mission, it augments the MQ-9 Reaper as a Joint Forces Air Component Commander-owned theater asset for reconnaissance, surveillance and target acquisition in support of the Joint Forces Commander.

The MQ-1B Predator is a system, not just an aircraft. A fully operational system consists of four aircraft (with sensors), a GCS, a Predator Primary Satellite Link (PPSL), along with operations and maintenance crews for deployed 24-hour operations.
